**CALSPAN REMOTE DEPOWERED AIR BAG DEPLOYMENT  
INVESTIGATION**

**CALSPAN CASE NO. CA98-009**

**SUBJECT VEHICLE - 1998 SATURN SL2**

**CALSPAN REMOTE DEPOWERED AIR BAG DEPLOYMENT INVESTIGATION**  
**CALSPAN CASE NO. CA98-009**  
**SUBJECT VEHICLE: 1998 SATURN SL2**  
**LOCATION: STATE OF FLORIDA**  
**CRASH DATE: DECEMBER, 1997**

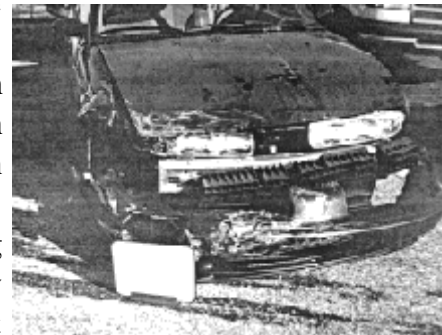
**Figure 1.** Damage sustained by the frontal plane of the Saturn SL2.

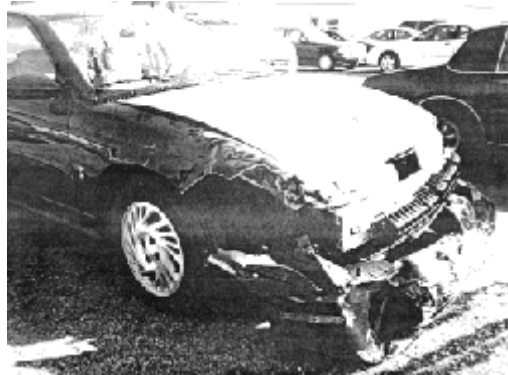
Contact to the frontal plane of the Saturn generated direct contact damage which insurance photographs identify at the front right bumper corner extending approximately 20 cm (8 in) left of the bumper fascia's center point. Maximum crush was estimated at 5 cm (2 in) located at the front right bumper corner (**Figure 3**). Laterally oriented abrasions were evident on the Saturn's hood face resultant from contact with the right plane of the pickup truck. Minor longitudinal damage was noted at the right aspect of the upper radiator support (**Figure 4**) and had an estimated crush value of 2.0 cm (0.8 in). In addition, the forward aspect of the composite right front fender fractured. The Collision Deformation Classification (CDC) for this impact was 11-FZEW-1. The cost of repair to the vehicle was \$4188.00. Damage data or documentation for the right side impact to the pickup truck was not available.

**Figure 3.** Damage to the frontal plane and right fender of the Saturn.

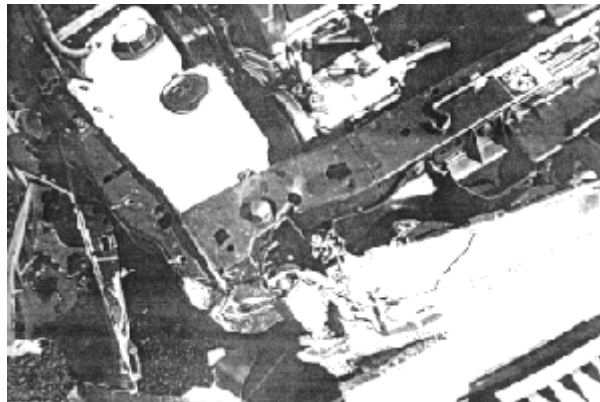
**Figure 4.** Longitudinal damage to the right aspect of the upper radiator support.
