DEPOWERED AIR BAG REPORT

CASE NUMBER - IN98-011
LOCATION - Texas
VEHICLE - 1998 CHEVROLET CAVALIER
CRASH DATE - December, 1997

1. <i>Report No.</i> IN98-011	2. <i>Government Accession No.</i>	3. <i>Recipient's Catalog No.</i>	
4. <i>Title and Subtitle</i> On-Site Depowered/Second Generation Air Bag Investigation Vehicle: 1998 Chevrolet Cavalier Location: Texas		5. <i>Report Date:</i> April 16, 1998

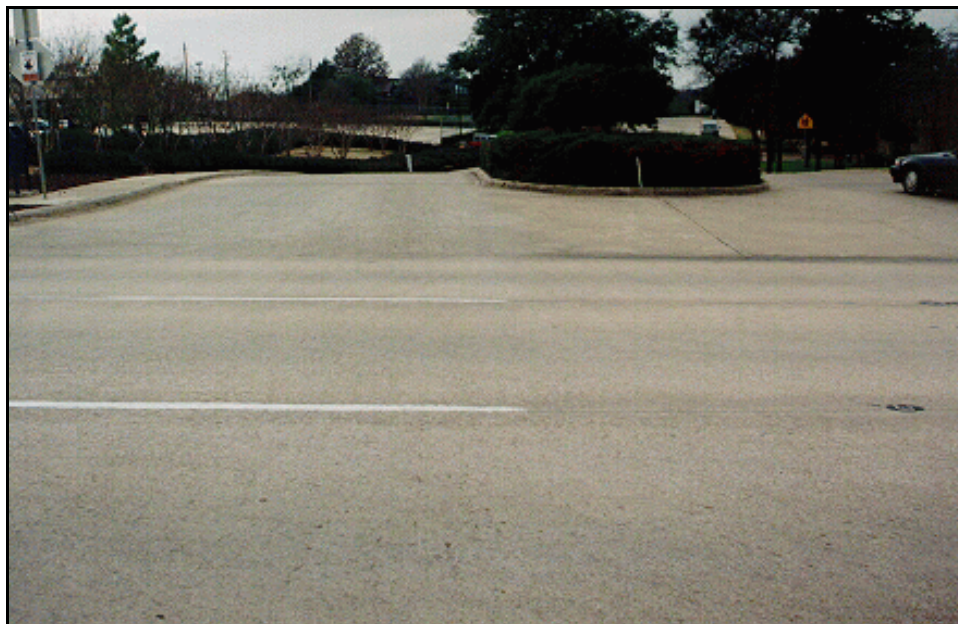
Figure 1: Looking back along case vehicle's approach; note: impact occurred in middle foreground of this view (case photo #3)

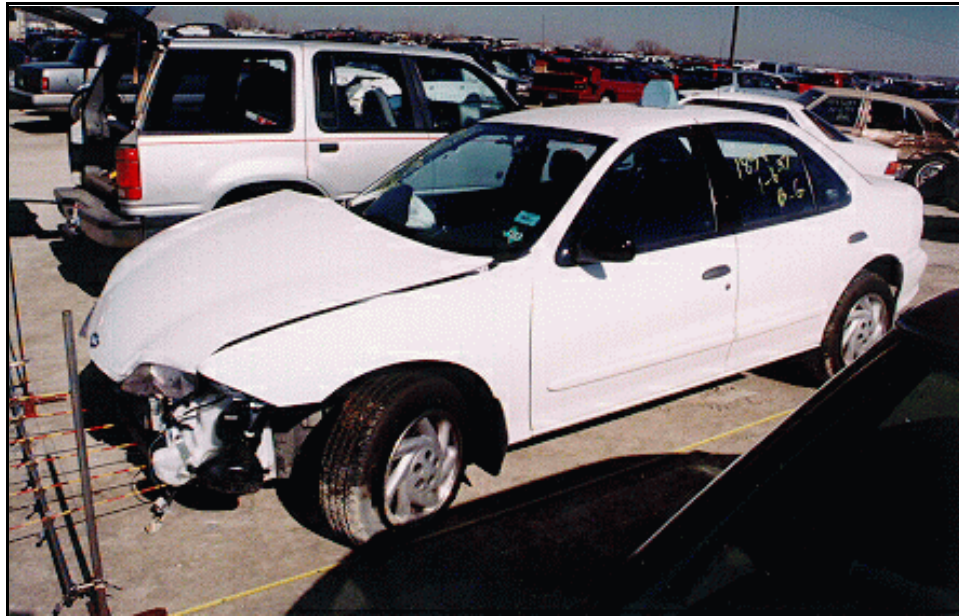
The case vehicle was a front-wheel-drive 1998 Chevrolet Cavalier four-door sedan equipped with four-wheel anti-lock brakes (VIN: 1G1JF52T5W7-----). Direct damage was confined to the left half of the front of the case vehicle. The entire front bumper and grille assembly was torn away, with damage to the radiator support brackets and displacement of the radiator. In addition, there was minor buckling and displacement of the engine hood and a small stress crack in the windshield, at the lower edge near the center. All doors remained closed and operational, and

Figure 2: Front and left side of case vehicle; note: bumper and grille assembly torn off by impact (case photo #9)

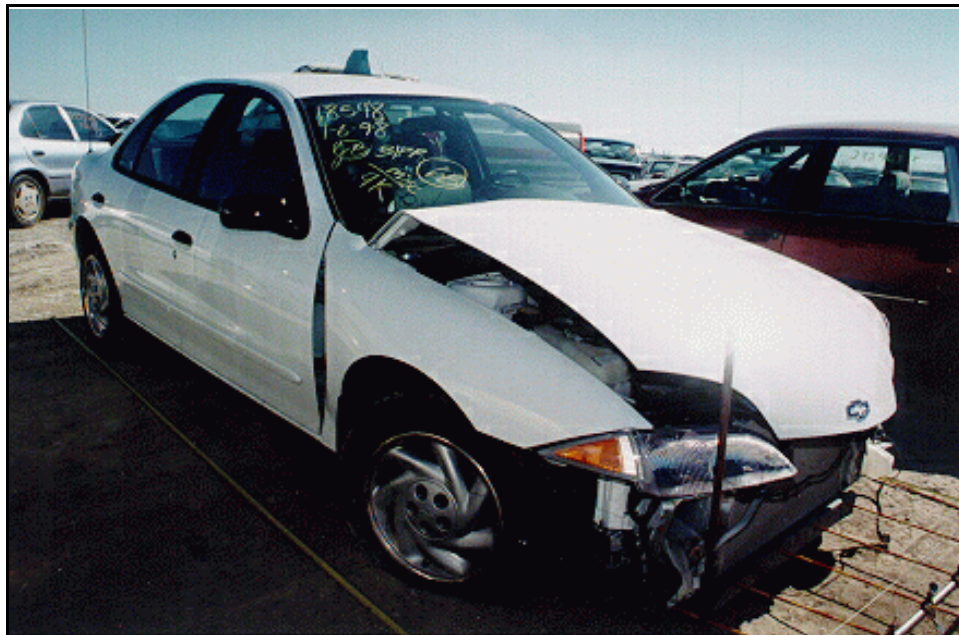
Figure 3: Front and right side of case vehicle (case photo #14)

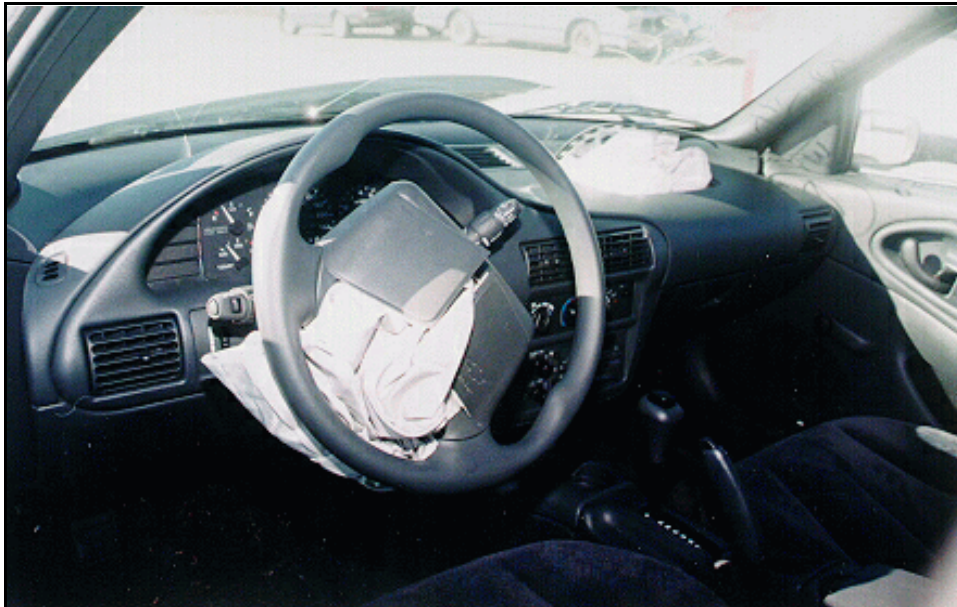
Figure 4: Case vehicle's steering wheel and driver air bag cover flaps (case photo #15)

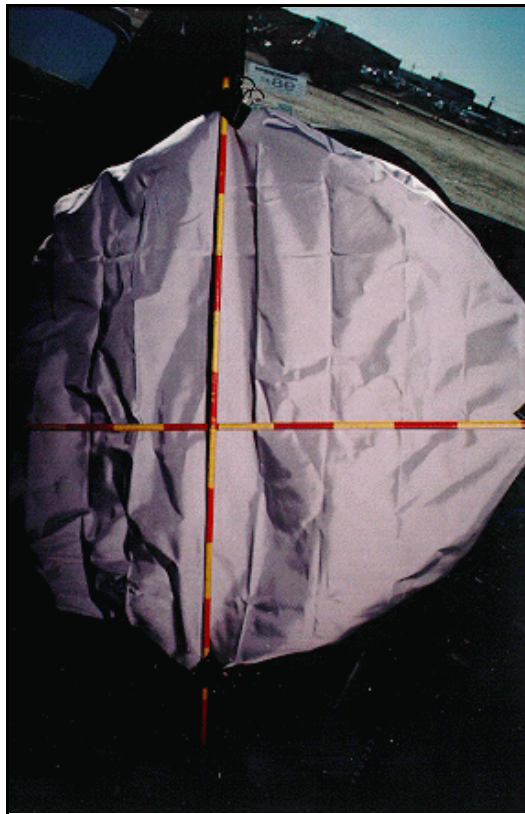
Figure 5: Front surface of driver's air bag (case photo #18)

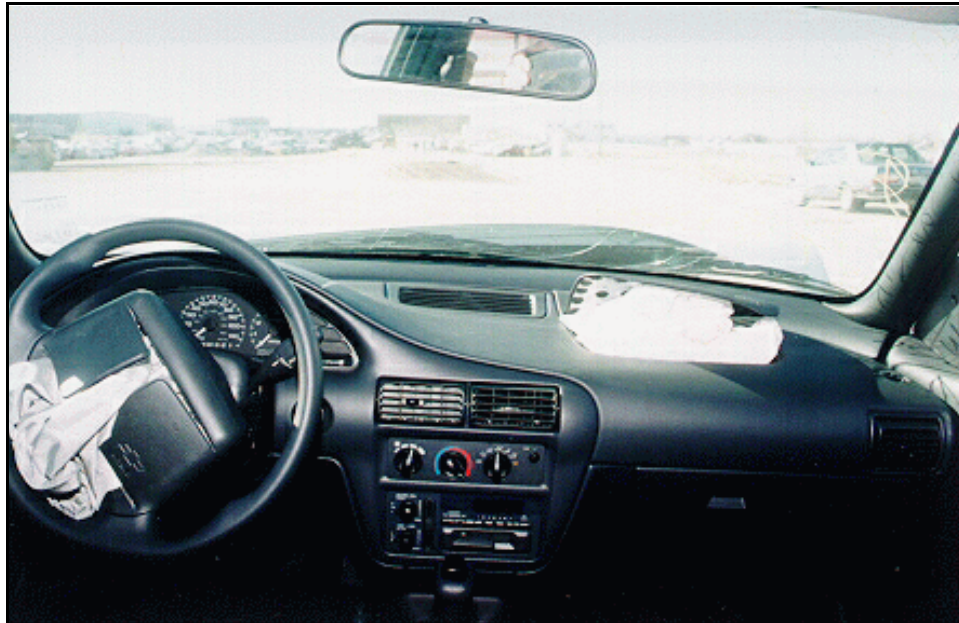
Figure 5: Entire instrument panel; note: front right air bag cover flap (case photo #19)

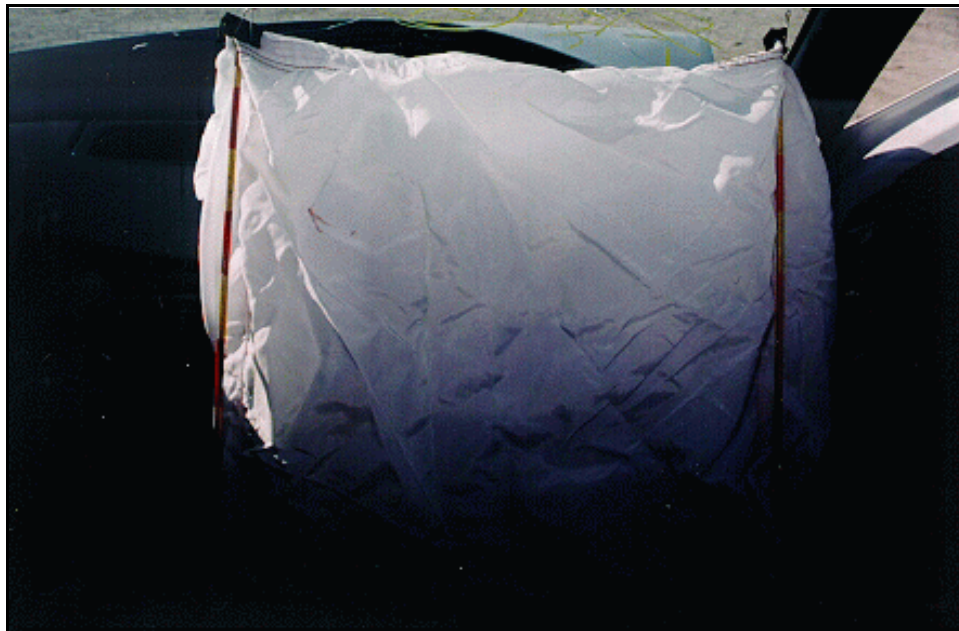
would have moved toward the center of the instrument panel. Because it is not known if the passenger was restrained, the passenger's movements are not known. Presumably, she encountered the deployed passenger air bag leaning somewhat forward and leftward of upright. There was a small blood stain in the upper left area of the front of the passenger's air bag, with no other evidence of contact anywhere in the vehicle. The location of the blood stain is consistent with the presumed location of the front right passenger's face. It is speculated that the police-reported "C" injury for the passenger may indicate a small laceration on her face, perhaps a split lip.

Figure 7: Front surface of front right air bag (case photo #22)
