**CALSPAN ON-SITE DEPOWERED AIR BAG DEPLOYMENT
INVESTIGATION**

CALSPAN CASE NO. CA98-012

SUBJECT VEHICLE - 1998 PONTIAC SUNFIRE

LOCATION - STATE OF NEW YORK

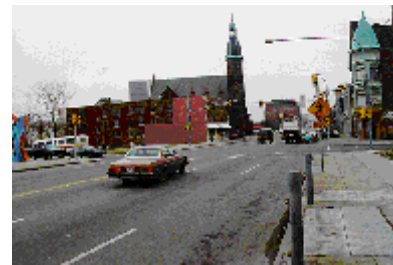
Figure 1. Overview of the crash scene.

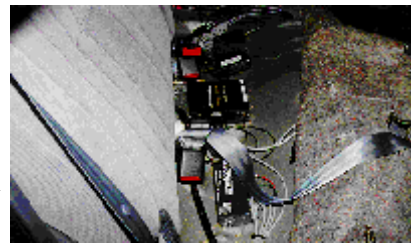
Figure 2. View of the installed position of the ACN unit's IVM, backup battery, and cellular phone transceiver.

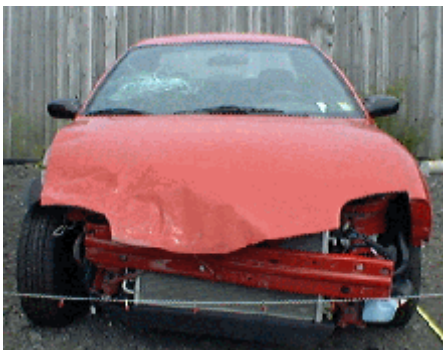
The Pontiac Sunfire sustained moderate damage to its frontal plane resultant of its initial impact with the Taurus. Direct contact damage began at the front right bumper corner and extended 93.3 cm (36.7 in) to the left. The bumper fascia was separated from the vehicle's reinforcement bar and direct damage was located vertically from the lower bumper fascia to the right aspect of the hood face. Maximum crush was measured at 37 cm (14.6 in) at the bumper reinforcement bar and was located 10.5 cm (4.1 in) right of the vehicle's center. The damage resulted in a 12 o'clock direction of force with a Collision Deformation Classification (CDC) of 12-FZEW-2. The minor secondary impact sequence resulted in direct contact damage that began at the front left bumper corner and extended right approximately 30.0 cm (11.8 in). The damage resulted in an 11 o'clock direction of force with a CDC of 11-FLLW-1. **Figures 3 and 4** identify the damage sustained to the frontal plane of the Sunfire.

Figure 3. Damage to the frontal plane of the Sunfire

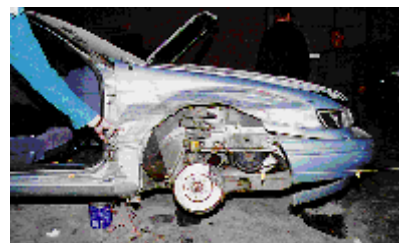
The Ford Taurus sustained moderate damage to its right side plane resultant of impact with the Sunfire. The initial impact to the right fender and right front door generated direct contact damage which consisted of red paint transfers and began 102 cm (40 in) forward of the right rear axle and extended 243 cm (96 in) forward. Maximum crush was measured at 14.5 cm (5.7 in) and was located 247.8 cm (97.6 in)

Figure 5. Right fender damage sustained by the ACN equipped Ford Taurus.

forward of the right rear axle on the right front fender. The damage resulted in a 2 o'clock direction of force with a Collision Deformation Classification (CDC) of 02-RYEW-2. **Figure 5** identifies the right fender damage sustained by the Taurus. The secondary impact sequence generated direct contact damage which began 44.5 cm (17.5 in) forward of the right rear axle and extended 147 cm (58 in) rearward. Residual crush was not present from this impact, however, a CDC of 03-RZEW-1 resulted.

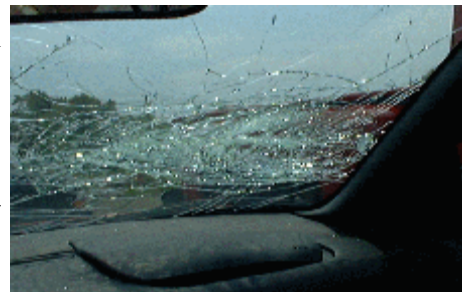
A fracture was evident on the right side of the windshield which resulted from contact with the front right air bag module cover flap as it opened to deploy the air bag. The center of the fracture was located 34.0 cm (13.4 in) right of the vehicle's center and 86.0 cm (33.9 in) above the floor of the Sunfire. The fracture had a measured width of 52 cm (20.5 in) and height of 24 cm (9.4 in). **Figure 6** identifies the fractured windshield and the front right air bag module cover flap.

Figure 6. Right side windshield fracture and front right air bag module cover flap.

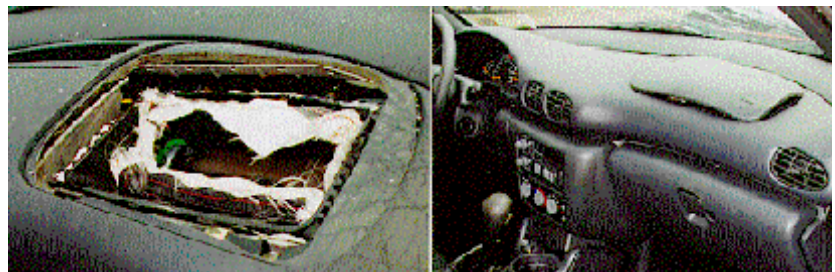
Figure 9. Front right air bag module and its cover flap of the Sunfire.

The front right air bag deployed from a top mounted module assembly that was incorporated within the upper right instrument panel. The single flap was hinged at the forward edge and opened in an upward direction toward the windshield. The flap had a measured maximum width of 33 cm (13 in) and maximum height of 27 cm (10.6 in) and it was identified by 22603255 05 97. The leading edge of the cover flap sustained abrasions resultant of windshield contact as it opened to deploy the air bag. The front right air bag was not available for inspection and insurance photographs which captured the air bag were not useful for identification purposes. **Figure 9** identifies the front right air bag module and its cover flap.
