ON-SITE AIR BAG INVESTIGATION

CASE NUMBER - IN98-013
LOCATION - ILLINOIS
VEHICLE - 1995 JEEP GRAND CHEROKEE LIMITED
CRASH DATE - January, 1998

1. <i>Report No.</i> IN98-013		2. <i>Government Accession No.</i>		3. <i>Recipient's Catalog No.</i>	
4. <i>Title and Subtitle</i> On-Site Air Bag Fatality Investigation Vehicle - 1995 Jeep Grand Cherokee Limited Location - Illinois			5. <i>Report Date:</i> August 28, 2000; July 30, 2002

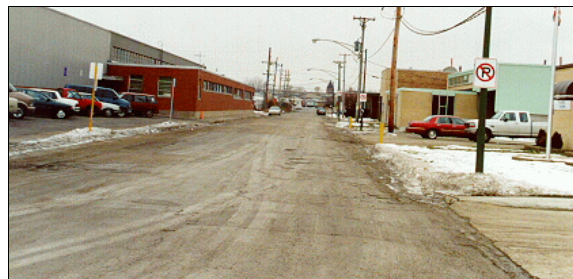
Figure 1: Case vehicle's southward approach path; Note: case vehicle struck Chevrolet which was illegally parked along east (left) side of roadway and then struck and came to rest near corner of red brick building in background (case photo #01)

The city roadway was straight and level at the area of impact. The pavement was bituminous, and the width of the unmarked roadway was 10.6 meters (33.5 feet). The roadway was bordered by 10.2 centimeter (4 inches) high mountable curbs. There were no pavement markings. The estimated coefficient of friction was 0.85 when dry. This coefficient of friction was higher than normal but occurred as a result of the heavy truck traffic and fluctuating temperatures which resulted in the middle portion of the roadway having a generous amount of cracks and potholes. The only traffic controls were regulatory NO PARKING signs (Manual on Uniform Traffic Control Devices, R7-2) on the east and west sides of the roadway in the immediate area of the crash. The statutory speed limit was 48 km.p.h. (30 m.p.h.); however, no regulatory speed limit sign was posted near the crash site. At the time of the crash the light condition was daylight, the atmospheric condition was clear, and the road pavement was dry. According to the Police Crash Report the roadway was icy, but based on the on-scene insurance photos, the roadway looked primarily dry with the ice and snow along the curb areas and sidewalks only. Traffic density was light, and the site of the crash was urban industrial. In addition, there were numerous loading dock driveways and parking lot entrances lining both sides of this city street in the industrial park.

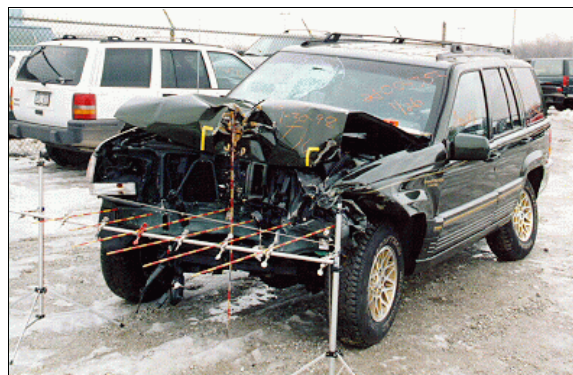
Figure 2: Case vehicle's frontal damage viewed from left of front with contour gauge present; Note: yellow tape on hood near left front wheel indicates direct damage from impact with parked van; yellow tape toward center of hood indicates direct damage from impact with corner of brick building; and angled left rear wheel (case photo #15)

The front left corner of the case vehicle (**Figure 2** above and **Figures 3** and **4**) impacted the right front door and wheel area of the Chevrolet, rearward of the right “A”-pillar (**Figure 5**). The case vehicle swiped forward into and momentarily snagged the Chevrolet's right front wheel assembly. This initial impact triggered the case vehicle's driver supplemental restraint (air bag) to deploy. The Chevrolet was illegally parked and heading south on the east (left) side of the street. The initial impact occurred 2.1 meters (7 feet) north of the north side of a parking lot driveway that intersected the roadway from the east roadside.

The case vehicle's initial contact with the Chevrolet involved the front left corner. Direct damage extended from the left bumper corner to the right (**Figures 2** and **3** above) 26 centimeters (10.2 inches). The residual crush extended down the left side (i.e., C₁) and was measured at 18 centimeters (7.1 inches). The case vehicle's primary impact with the brick wall involved approximately two-thirds of the case vehicle's front end. The direct damage started near the front left bumper corner and extended to the right (**Figures 2** through **4** above) 93 centimeters (36.6 inches). The case vehicle's entire front end was damaged as a result of its impact with the wall. Maximum crush was 50 centimeters (19.7 inches) near C₄ (**Figure 4** above).

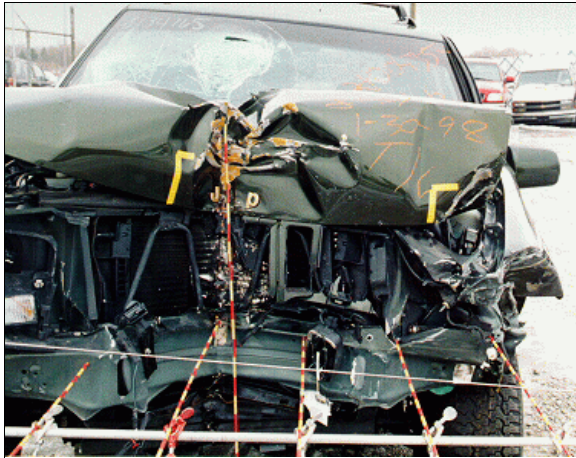
Figure 3: Close-up of case vehicle's front showing deformation from both frontal impacts; Note: yellow tape toward right indicates width of direct damage from impact with parked van, yellow tape near center of vehicle indicates direct damage width from impact with corner of brick building, and slit in windshield near center is from head contact by front right passenger (case photo #12)

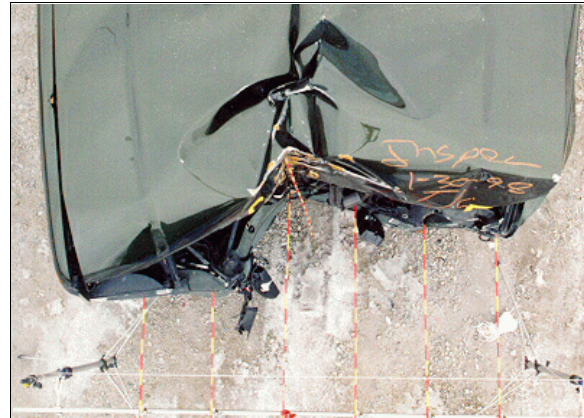
Figure 4: Overhead view of case vehicle's front damage, with contour gauge present, from both frontal impacts; Note: overlapping damage at front left corner (case photo #14)

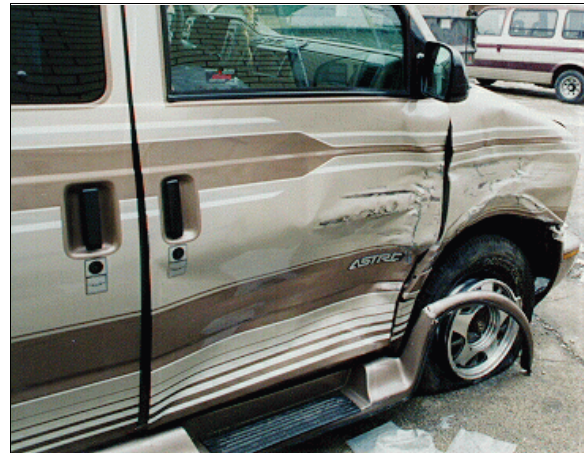
Figure 5: Close-up of damage to Chevrolet's right front door, fender, and wheel from impact by case vehicle's front left (case photo #62)

The Chevrolet's right front side impact from the case vehicle broke the front axle, broke the right front wheel rim, and aired out the tire. Direct damage started 26 centimeters (10.2 inches) forward of the right rear axle on the sliding door and extended forward 314 centimeters (123.6 inches). Half of this measured direct damage was from the case vehicle's left outside rearview mirror slapping and then scraping down the Chevrolet's right side (**Figure 20**). The maximum crush was measured at 10 centimeters (3.9 inches) near the right front wheel well (**Figure 5** above). The total field L and direct L was measured at 314 centimeters (123.6 inches). Based on the vehicle inspection, the CDCs for the Chevrolet were determined to be: **05-RFEW-2 (160)** and **04-RPMN-1 (120)** [maximum crush was 18 centimeters (7.1 inches) for its initial impact with the case vehicle]. The WinSMASH reconstruction program, damage only algorithm, was used on the Chevrolet's highest severity impact with the case vehicle. The Total, Longitudinal, and Lateral Delta Vs are, respectively: 10.0 km.p.h. (6.2 m.p.h.), +9.4 km.p.h. (+5.8 m.p.h.), and -3.4 km.p.h. (-1.3 m.p.h). The Chevrolet was initially left at the scene, but subsequent, it was towed due to damage.

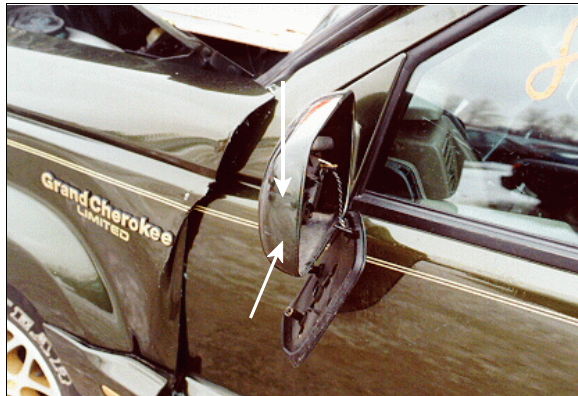
The case vehicle's left outside rearview mirror (**Figure 6** below) side slapped (i.e., more like a side swipe than a slap) the right side of the parked van (**Figure 7** below) just before the case vehicle was redirected slightly to its right after knocking the Chevrolet out of its path. The case vehicle traveled south-southeastward, departing the east side of the road, and continued an additional 13.1 meters (43 feet) prior to impacting the corner of a brick building (**Figure 1** above and **Figure 8** below). The case vehicle rotated slightly counterclockwise before it essentially came to rest against the building. The case vehicle's impact to the right front door and wheel areas of the Chevrolet was forceful enough that it knocked (i.e., lifted and rotated) the left half of the Chevrolet's front end [i.e., the Chevrolet weighted at least 1,814 kilograms (4,000 pounds)] over a 10.2 centimeter (4 inch) high curb and onto the sidewalk where it came to rest (**Figure 9** below).

Figure 6: Close-up of case vehicle's damaged left outside rearview mirror from side slap impact with right side of Chevrolet (case photo #19)

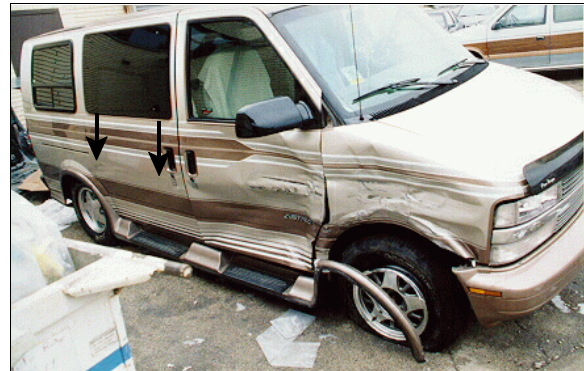
Figure 7: Damage to Chevrolet's right front and narrow area of side slap damage (case photo #63)

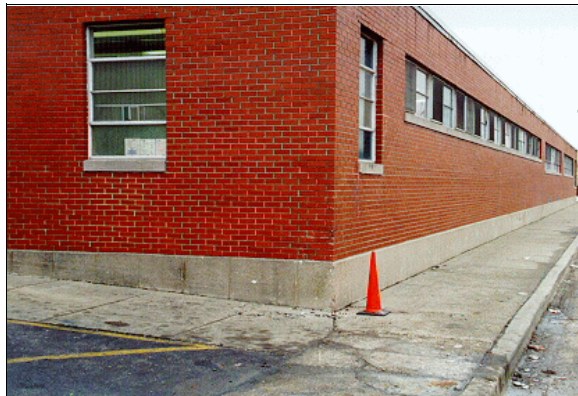
Figure 8: Red brick building which case vehicle hit and came to rest near (case photo #06)

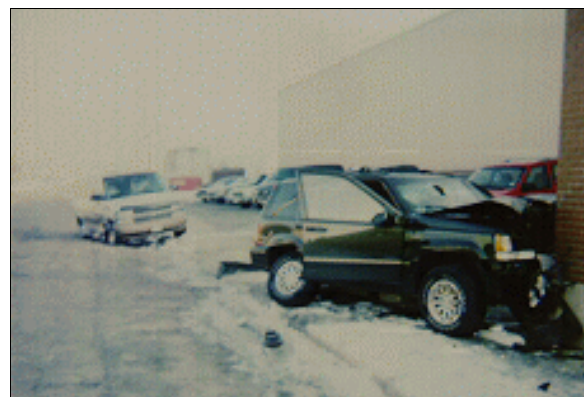
Figure 9: On-scene view of case vehicle at final rest against corner of brick building; Note: struck parked van in background and angled right rear wheel (case photo #09)

The front bumper fascia, grille, and radiator were crushed rearward. Both front fenders were pulled inwards because of the case vehicle's centered hit with the corner of the brick wall. As mentioned, the windshield had two spider web cracks from the front right passenger striking it when the vehicle hit the wall. The left front tire was physically restricted from the vehicle's front end impact to the brick wall. The wheelbase was altered 12 centimeters (4.7 inches) on the left side from both the vehicle impacts with the parked van and wall. At some point during the crash the case vehicle's right rear shock absorber broke away and the rear axle/drive train was broken. As a result, the left and right rear wheels were toed inwards at their top (**Figures 1** and **9** above).

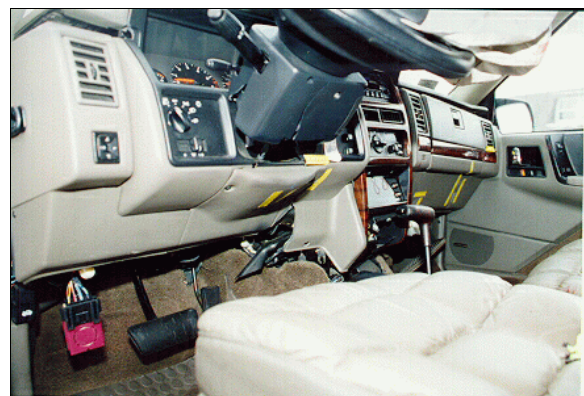
Figure 10: Case vehicle's front seating area showing damage from driver's contact to steering column and knee bolster; Note: damage to front right instrument panel (case photo #29)

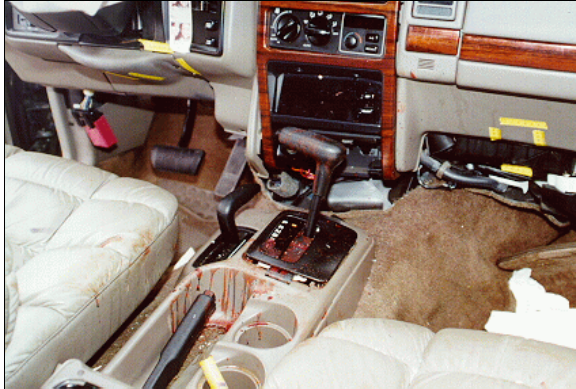
Figure 11: Case vehicle’s center console and floor areas showing blood evidence on console and contacts under right side of steering column and below right instrument panel; Note: distortion to center instrument panel and toe pan intrusions (case photo #38)

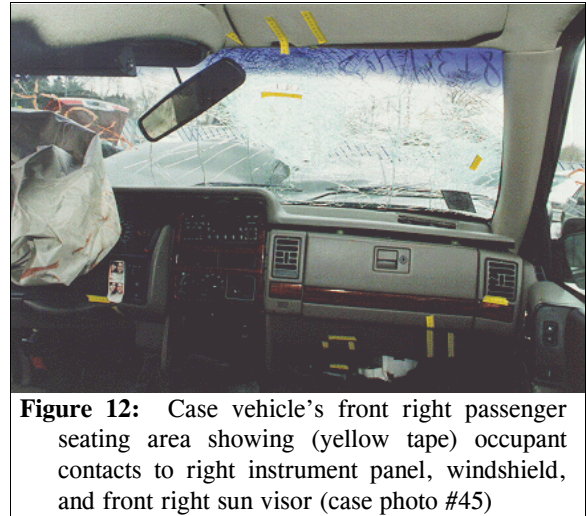
Figure 12: Case vehicle’s front right passenger seating area showing (yellow tape) occupant contacts to right instrument panel, windshield, and front right sun visor (case photo #45)

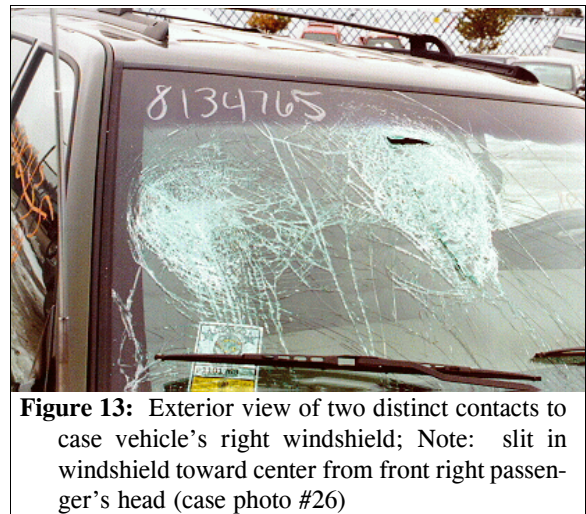
Figure 13: Exterior view of two distinct contacts to case vehicle’s right windshield; Note: slit in windshield toward center from front right passenger’s head (case photo #26)

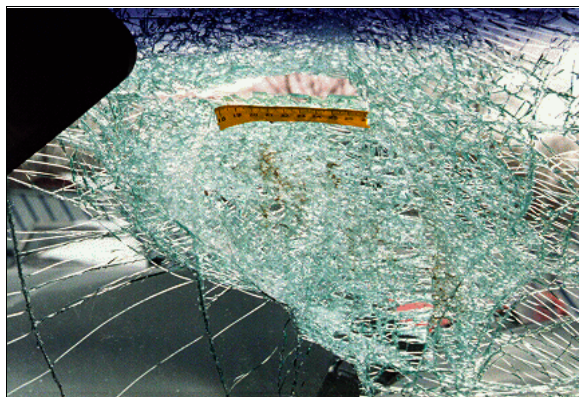
Figure 14: Close-up of interior surface of case vehicle's windshield, just to the right of center, showing front right passenger's head contact; Note: approximate 13 cm (5 in) opening above yellow tape (case photo #48)

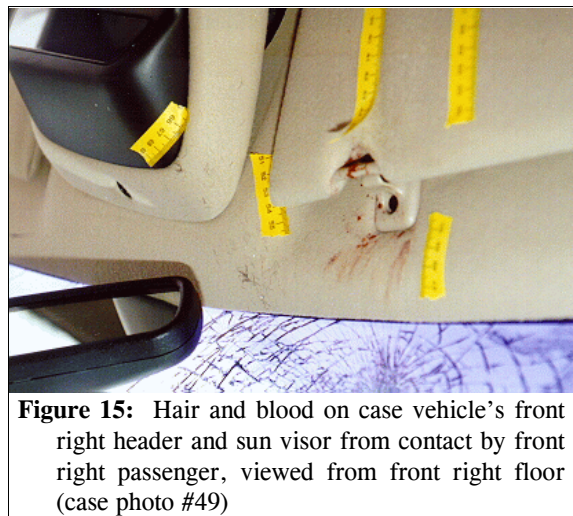
(**Figure 15**) from contact by the front right passenger. In addition, there were several unknown black scuffs to the roof near the windshield header and the driver's sun visor. Finally, the overhead console located in the center of the case vehicle's roof fell down with only the electrical wires holding it to the roof. The toe pan in driver and front right passenger foot wells showed different amounts of intrusion with the most significant being 17 centimeters (6.7 inches) to the front right passenger's toe pan (**Figure 11** above). The intrusion to the case vehicle's left and center instrument panel measured 4 centimeters (1.6 inches).

Figure 15: Hair and blood on case vehicle's front right header and sun visor from contact by front right passenger, viewed from front right floor (case photo #49)

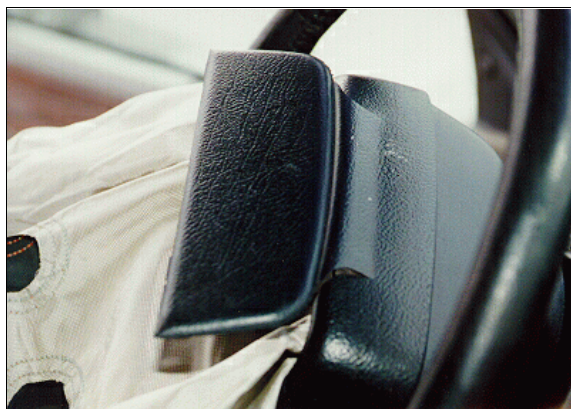
Figure 16: Case vehicle driver air bag module's top cover flap, viewed from front center, showing unknown body fluid splatter on cover flap and air bag's two vent ports (case photo #34)

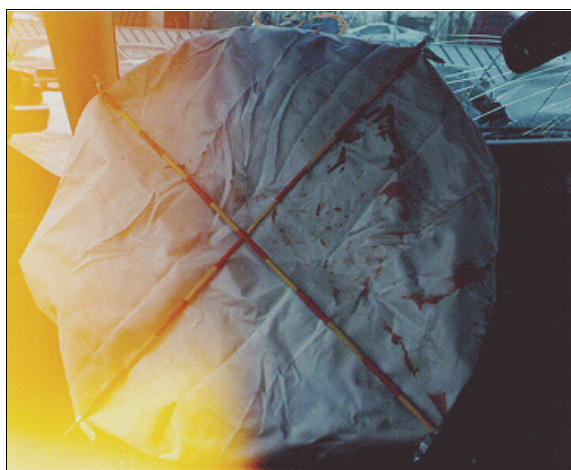
Figure 17: Case vehicle's driver air bag showing blood smears on upper right quadrant; Note: steering wheel rotated clockwise (to right) approximately 45 degrees (case photo #37)

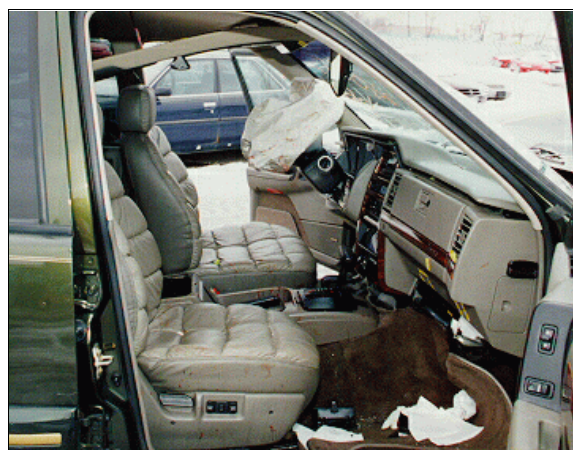
Figure 18: Case vehicle's interior showing deployed driver air bag, close proximity of driver's seat to steering column, and upward movement of steering column (case photo #51)

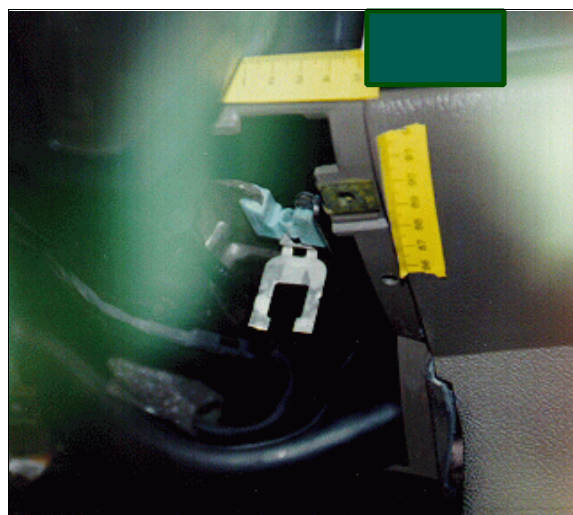
Figure 19: Close-up of separated shear capsule on case vehicle's steering column (case photo #32)

(Figure 19 above) but did not cause deformation to the steering wheel rim. In addition, the forward momentum caused the driver's right knee to deform the rigid knee bolster (Figure 10 above). Upon removing the screws holding the driver's knee bolster, the entire steering column dropped downward. The impact with the corner of the wall resulted in the case vehicle rotating counterclockwise approximately 5 degrees to final rest. The driver rebounded backwards off the steering wheel assembly and, at final rest, the lower torso of the case vehicle's driver was seated forward on the front of the seat cushion with her upper torso leaning back and turned slightly to her left leaning against her seat back and the interior surface of the driver's door. She was unconscious and unable to exit the case vehicle.
