CALSPAN REMOTE SIDE IMPACT AIR BAG DEPLOYMENT INVESTIGATION

CALSPAN CASE NO. CA98-013

VEHICLE - 1998 VOLVO S90

LOCATION - FLORIDA

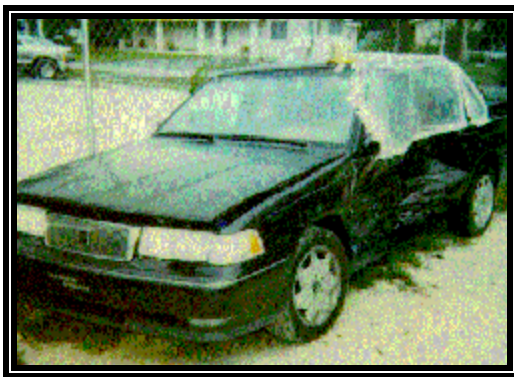
Figures 1 through 3 are the left front, left rear and left side views of the damaged 1998 Volvo S90. The insurance company’s repair estimate for the Volvo indicated the total cost of the Volvo’s repair (parts and labor) was approximately \$21,800. Investigation revealed, the Volvo was repaired and subsequently sold, it was not available for inspection. The replaced exterior components included the left front quarter panel, left front and rear doors, and the left rear quarter panel. The damaged structural body components replaced included: the center floor member, center rocker panel, center pillar (B-pillar), and roof member. The interior components replaced included the windshield, left window glazings, instrument panel, left front seat, and the Supplemental Restraint System. The specific components of the SRS replaced were the driver air bag module, front passenger air bag module, clock spring, front air bag impact sensor and left side air bag module. Neither the front nor rear suspension required repair, other than realignment.

Figure 1: Left front view of the 1998 Volvo S90.

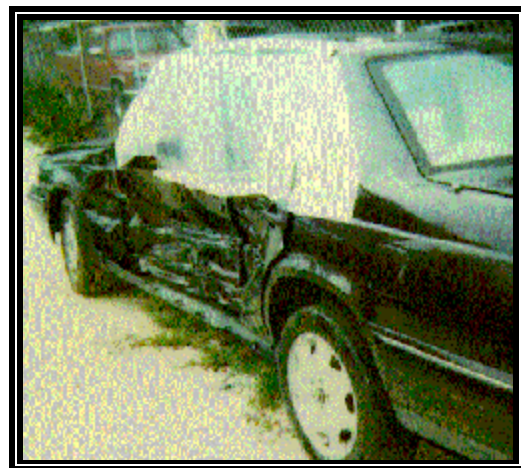
Figure 2: Left rear view of the Volvo.

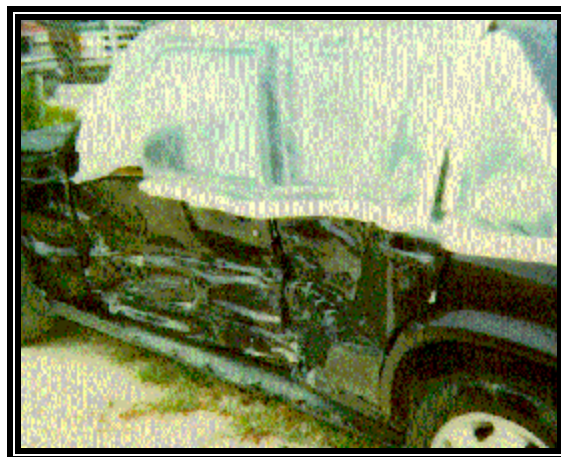
Figure 3: View of the left side damage.

The direct contact damage to the Volvo S90 was centered between the vehicle's axles and was approximately 190 cm (75 in) in width. The maximum lateral deformation was estimated to be 25 cm (10 in) and occurred approximately at the B-pillar. The Collision Deformation Classification (CDC) of the vehicle was 09-LPEW-03. Forensic analysis of the Volvo's damage indicated the barrier equivalent delta V of the vehicle was approximately 16 to 24 km/h (10 to 15 mph).
