ON-SITE AIR BAG INVESTIGATION

CASE NUMBER - IN98-014
LOCATION - TEXAS
VEHICLE - 1995 FORD EXPLORER XL
CRASH DATE - February, 1998

1. Report No. IN98-014		2. Government Accession No.		3. Recipient's Catalog No.	
4. Title and Subtitle On-Site Air Bag Fatality Investigation Vehicle - 1995 Ford Explorer XL Location - Texas			5. Report Date: January 28, 2002; July 31, 2002

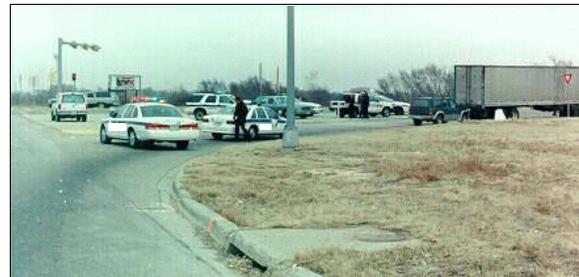
Figure 1: On-scene north-northeast view of channelized right-hand turn lane showing case vehicle and tractor-trailer at final rest (case photo #01)

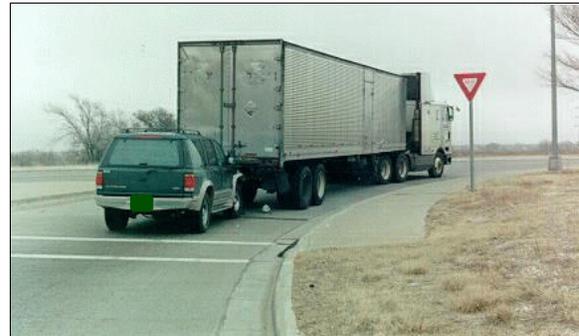
occurred in the channelized turn lane, near the mouth of the merging area (**Figure 2**) between the channelized lane and eastbound roadway of the U.S. trafficway; see **CRASH DIAGRAM** below.

Figure 2: On-scene northeast view of channelized right-hand turn lane showing case vehicle and tractor-trailer at final rest (case photo #03)

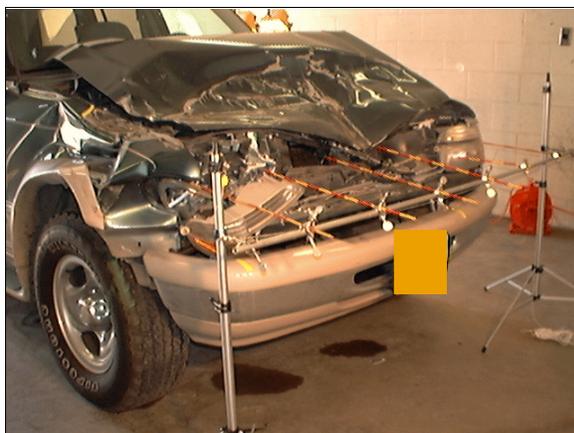
Figure 3: Case vehicle's underride (above bumper) damage pattern viewed from right of center with contour gauge present (case photo #17)

The case vehicle's contact with tractor-trailer involved the entire front width of the vehicle and exhibited a distinct heavy truck underride type pattern (**Figure 3** above). Direct damage extended from bumper corner to bumper corner, a measured distance of 151 centimeters (59.5 inches), across the entire width of the hood. Direct damage to the hood extended rearward 81 centimeters (31.9 inches). Maximum (i.e., residual) crush on the hood was measured as 62 centimeters (24.4 inches) at C₆. Maximum residual crush to the case vehicle's grille area was measured as 23 centimeters (9.1 inches) between C₃ and C₄. Direct damage to the bumper involved the top surface only (i.e., scratches). Direct damage began at the front right bumper corner and extended, 97 centimeters (38.2 inches), along the bumper to the left. There was no measurable crush to the front bumper. Neither the wheelbase on the case vehicle's left nor right sides was shortened. The case vehicle's front bumper fascia, grille, hood, radiator, right headlight and turn signal assemblies, and right fender were directly damaged and crushed rearward. None of the case vehicle's tires were physically restricted or deflated.

Based on the vehicle inspection, the CDC for the case vehicle was determined to be: **12-FDMW-4 (0)**. The WinSMASH reconstruction program could not be used, first, because of the underride-type impact configuration, and second, because one vehicle is out-of-scope. This contractor's visually estimated Delta V is between 21 km.p.h. (13 m.p.h.) and 27 km.p.h. (17 m.p.h.). The case vehicle was towed due to damage.

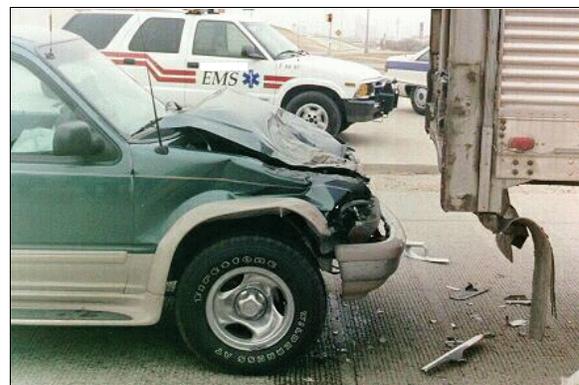
Figure 4: On-scene view of case vehicle and Great Dane's trailer at final rest; Note: trailer's under-ride guard damaged and bent underneath trailer (case photo #04)

The front of the case vehicle (**Figure 3**) impacted the underride guard on the back of the Great Dane's trailer (**Figure 4**), bending it forward and causing the case vehicle's driver and front right passenger supplemental restraints (air bags) to deploy. The case vehicle and the tractor-trailer came to rest essentially at impact.

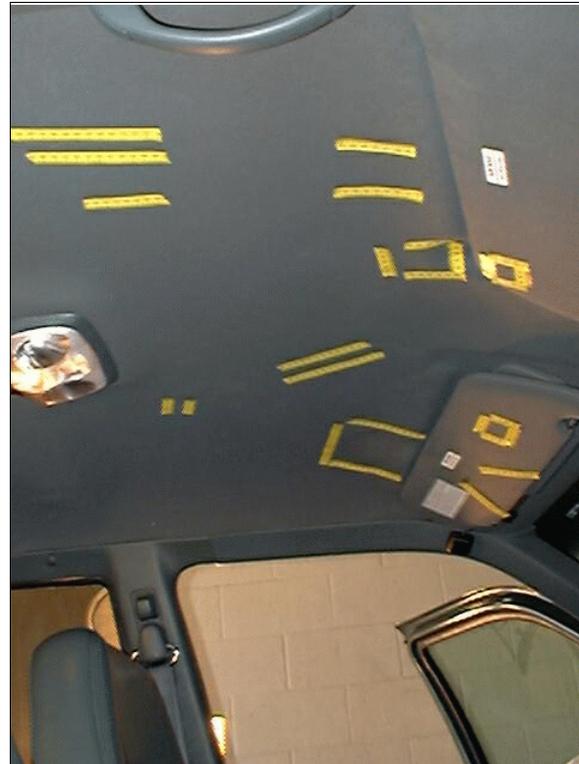
Figure 5: Vertical view from right of contact evidence on case vehicle's sun visors and roof (case photo #23)

Inspection of the case vehicle's interior revealed that there was a scuff (i.e., possibly skin or makeup) along the roof over the driver's seating area and on the driver's sun visor (**Figure 5** above). Scuffs (i.e., possibly skin) were also present along the roof over the front right passenger's seating area and on the front right sun visor (**Figure 5** above). Furthermore, there was an unknown liquid (e.g., saliva from the baby) present on the front surface of the front right seat's back support (**Figure 6**) and there was a scuff on the back surface of the front right seat's back support from contact by the back right passenger (**Figure 7**). There were blood smears to the driver's seat cushion and door sill. In addition, the back surface of the rear view mirror was contacted by the child safety seat and the seat's blanket as a result of the seat being lifted upwards by the deploying front right passenger air bag (**Figure 8**). The right side of the rearview mirror was rotated into the windshield, cracking the glazing. Finally, the upper portion of the steering wheel rim was bent toward the left instrument panel, 1.5 centimeters (0.6 inches), as a result of the driver loading the air bag, momentarily blocking the air bag's forward expansion, and causing the air bag to expand against and bend the steering wheel rim. This contractor was not allowed to pull apart the knee bolster; as a result the energy absorbing shear capsules could not be assessed.

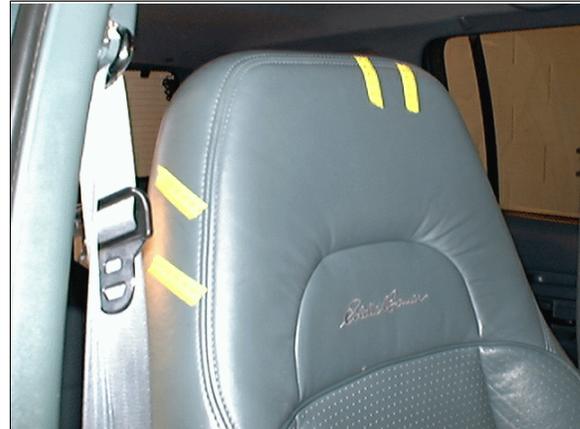
Figure 6: Unknown body fluids on case vehicle's front right seat back most likely from front right infant passenger (case photo #28a)

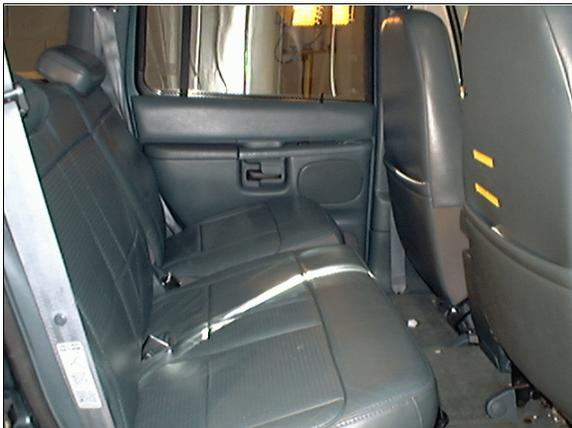
Figure 7: Case vehicle's back seating area showing scuff to front right seat back from unrestrained back right passenger (case photo #28b)

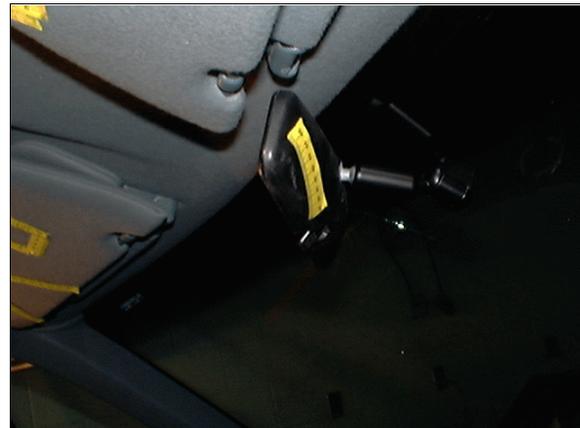
Figure 8: Backside of case vehicle's rearview mirror which was contacted by child safety seat after being lifted upwards by deploying front right passenger's air bag; Note: driver's side of mirror cracked windshield's glazing (case photo #22)

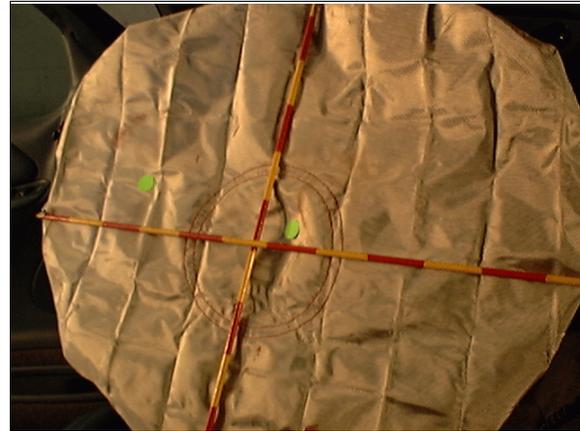
The case vehicle was equipped with a Supplemental Restraint System (SRS) that contained frontal air bags at the driver and front right passenger positions. Both air bags deployed as a result of the front underride impact with the tractor-trailer. The case vehicle's driver air bag was located in the steering wheel hub. The module cover consisted of roughly asymmetrical "H"-configuration cover flaps made of thick vinyl. The top cover flap was hexagonal in shape with dimensions of 24 centimeters (9.4 inches) along the top horizontal seam and 9 centimeters (3.5 inches) vertically on each side. The bottom cover flap was somewhat rectangular, except that the bottom surface was curvilinear. The width of the horizontal curved bottom dimension was 18 centimeters (7.1 inches) and 5 centimeters (2.0 inches) vertically for each side. An inspection of the air bag module's cover flaps and air bag revealed that the cover flaps opened at the designated tear points, and there was no evidence of damage during the deployment to the air bag; however, there was a scuff, possibly previous to this crash, and makeup on the driver air bag module's top cover flap. The driver's air bag was designed with four tethers, each approximately 2 cm (0.8 inches) in width. Each tether was connected to the circular center and stitched to the interior of the driver's air bag. The driver's air bag had two vent ports, approximately 1.5 centimeters (0.6 inches) in diameter, located at the 11 and 1 o'clock positions. The deployed driver's air bag was round with a diameter of 60 centimeters (23.6 inches). Inspection of the deployed driver's air bag indicated that there was blood and a large amount of makeup evidence readily apparent on the front surface of the air bag (**Figure 9**). Specifically, there was a 7 x 9 centimeter (2.8 x 3.5 inch) area of makeup with blood located in the left upper quadrant toward the 10 o'clock position. Furthermore, there was a 9 x 8 centimeter (3.5 x 3.1 inch) area of makeup just outside the center of the air bag in the right upper quadrant toward the 1:30 o'clock position. Finally, there were scattered blood drops located between the center and perimeter of the air bag toward the 6 o'clock position.

Figure 9: Case vehicle's deployed driver air bag showing areas containing makeup smears (i.e., dots) and blood transfers (case photo #21)

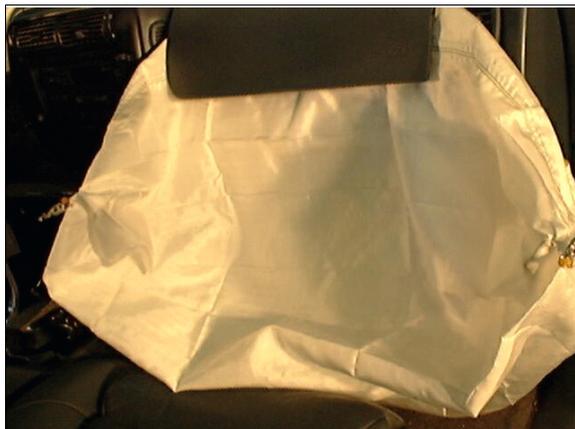
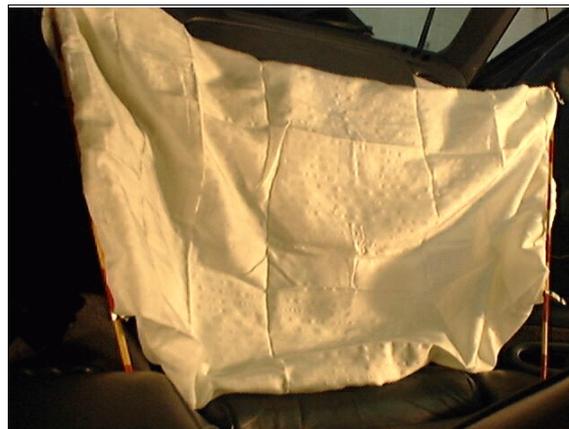
The deployed front right air bag was rectangular with a height of approximately 48 centimeters (18.9 inches) and a width of approximately 93 centimeters (36.6 inches). An inspection of the front right air bag revealed no contact evidence readily apparent on the air bag's fabric (**Figures 10 and 11**).

Figure 10: Top surface of case vehicle's deployed front right passenger air bag showing no obvious evidence of damage or contact (case photo #30)

Figure 11: Front surface of case vehicle's deployed front right passenger air bag showing no obvious evidence of damage or contact (case photo #29)

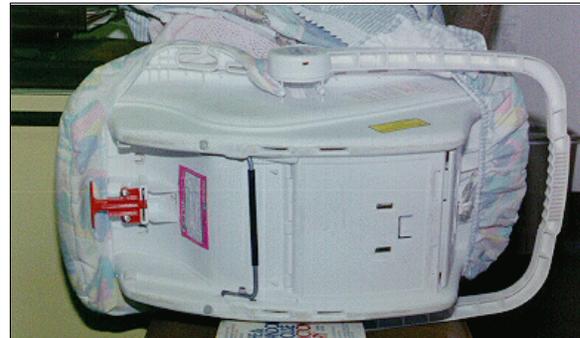
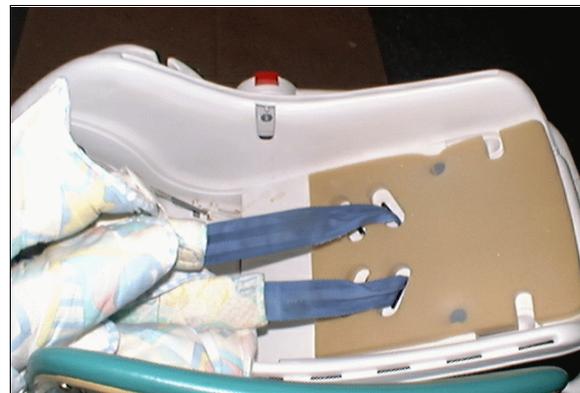
There was no discernable damage to the infant child safety seat as a result of this crash (Figures 12 and 13).

Figure 12: Backside of case vehicle's infant child safety seat showing no evidence of damage to seat during crash sequence (case photo #42)

Figure 13: Overhead view of interior shell of case vehicle's infant child safety seat showing no evidence of damage to seat during crash; Note: seat cover removed (case photo #44)

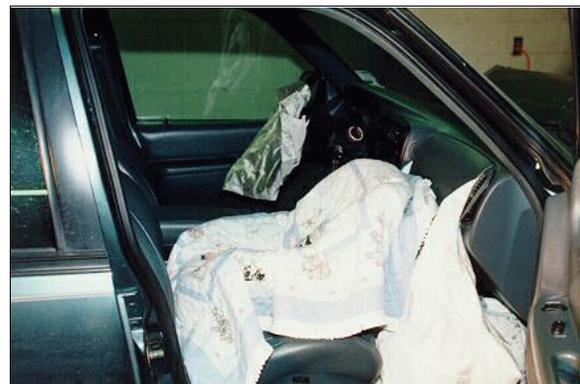
Figure 14: Case vehicle's front seating area showing deployed air bags and child safety seat's location in front right seat (case photo #37)

been, would have been located approximately 10.2 centimeters (4 inches) forward of the upright, front right seat back (**Figure 14** above). According to the manufacture’s use guidelines, printed on a sticker attached to the seat, the maximum height and weight allowed for a child using this seat is: height up to 66.0 centimeters and weight up to 9.1 kilograms (26 inches and 20 pounds). The front right infant passenger exceeded the weight limitation. The front right seat track was located in its rearmost position.

seat which had fallen to the seat and, finally, tumbled into the floor pan area. At final rest the child was laying in the floor pan of the front right passenger seating position. The case vehicle’s driver immediately picked up the infant, held her in her lap, and then called 911. The child safety seat came to rest in the front right seat up against the right instrument panel (Figure 14 above).

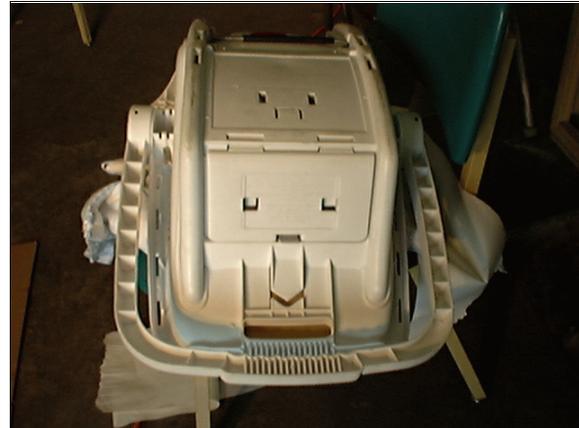
Figure 15: Undamaged back and carrying handle of case vehicle’s rear facing child safety seat which was toward front right air bag module’s cover flap (case photo #43)

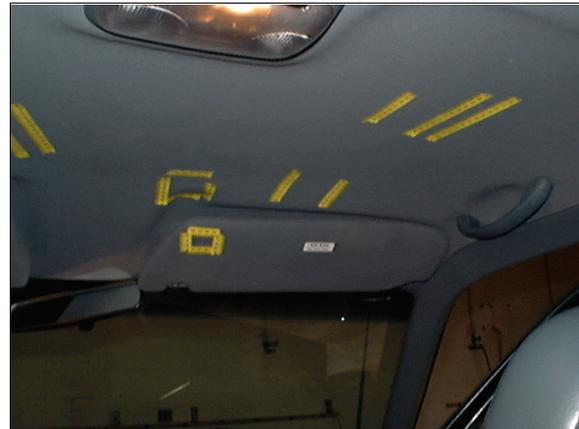
Figure 16: Case vehicle’s right sun visor and roof contacts from child safety seat and seat’s infant (case photo #26)

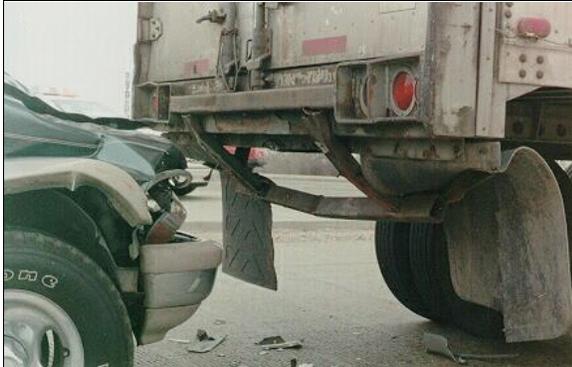
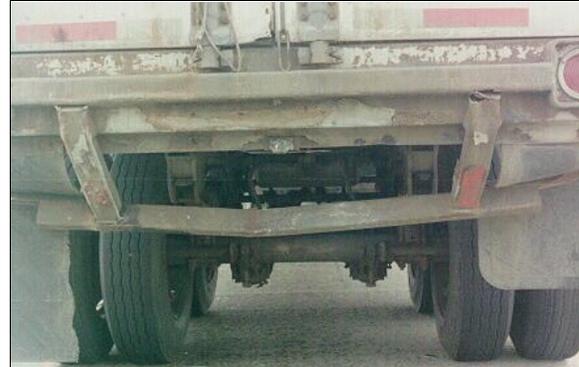
Figure 17: On-scene view from right of back showing Great Dane trailer's deformed underride guard and underride damage to case vehicle's front (case photo #51)

Figure 18: On-scene view from back showing Great Dane's deformed underride guard; Note: broken welds on underride guard (case photo #53)

Based on the available photographs (**Figures 17 and 18**), the direct damage to the trailer involved the back underride guard which was pushed underneath the bed of the trailer. The TDC for tractor-trailer was determined to be: **06-BDLW-A (180)**—maximum crush is unknown. No reconstruction program was used on this crash because this tractor-trailer combination is out-of-scope. The International truck-tractor was driven from the scene.
