**TRANSPORTATION SCIENCES
CRASH RESEARCH SECTION**

CALSPAN ON-SITE DEPOWERED AIR BAG DEPLOYMENT INVESTIGATION

CALSPAN CASE NO. CA98-017

VEHICLE - 1998 TOYOTA CAMRY

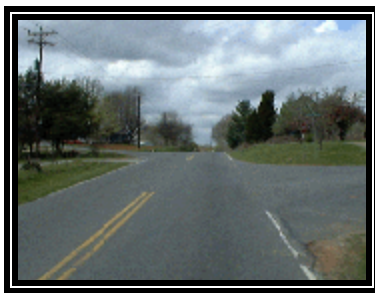
Figure 1: Westbound trajectory view 30 m (100 ft) from the POI.

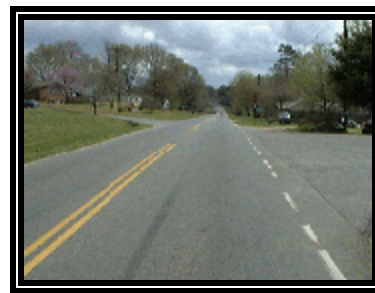
Figure 2: Eastbound trajectory view 30 m (100 ft) from the POI.

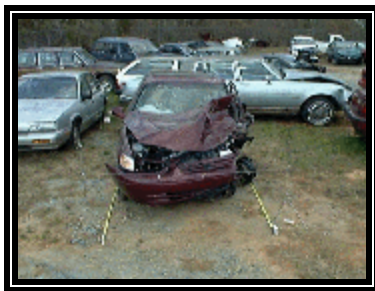
The Toyota Camry sustained 67.3 cm (26.5 in) of direct contact damage to the center and left portions of the front plane (**Figures 3 and 4** below). The direct damage began 21.6 cm (8.5 in) left of center and extended to the left front bumper corner. The measured crush profile was as follows: C1=55.9 cm (22.0 in), C2=55.9 cm (22.0 in), C3=38.1 cm (15.0 in), C4=25.4 cm (10.0 in), C5=17.8 cm (7.0 in), C6=0. The right front corner of the vehicle was displaced laterally to the left 17.8 cm (7.0 in). The windshield was fractured and the left front window glazing shattered in the impact. The left front suspension deformed rearward foreshortening the left side wheelbase 21.6 cm (8.5 in). Rearward deformation of the left A-pillar buckled the roof. The left side doors were jammed shut and buckled. The Collision Deformation Classification (CDC) of the Toyota was 12-FYEW-3. The barrier model of the SMASH program calculated the delta V of the Toyota to be approximately 29.1 km/h (18.1 mph). This calculated value appears low. The nature and extent of the vehicular damage is more consistent with a delta V of 32-39 km/h (20-24 mph) based on SCI experience.

Figure 3: Front view of the Toyota Camry.

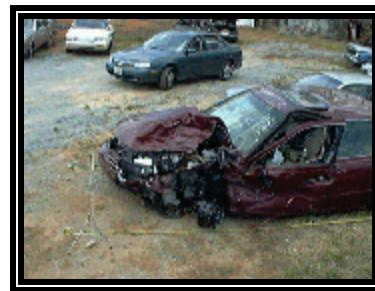
Figure 4: Left lateral view across the front plane.

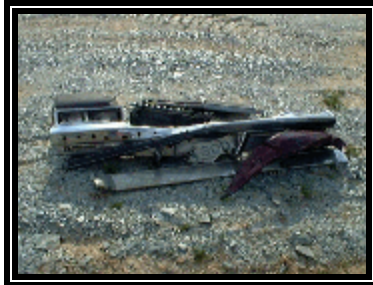
The owner of the 1983 Buick Regal was uncooperative and the vehicle was unavailable for inspection. At the inspection of the Toyota, the Buick's front bumper was located in the occupant compartment of the vehicle. The displaced bumper exhibited 109 cm (43 in) of deformation and maroon paint transfer along 163 cm (64 in) of the bumper's width (Figure 5). The damage began 28 cm (11 in) right of center and extended to the left bumper corner.

Figure 5: View of the Buick Regal's front bumper.

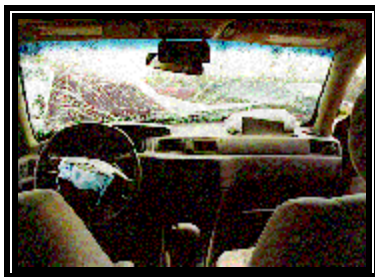
Figure 6: Front interior view.

The passenger air bag was configured as a top-mount design located in the right instrument panel. The air bag module cover flap was a single vinyl flap that hinged on the aft aspect of the top of the instrument panel (refer to Figure 6). The flap was trapezoidal in shape and measured 21.6 cm (8.5 in) in width. The inboard and outboard heights of the flap were 8.6 cm (3.4 in) and 5.8 cm (2.3 in) respectively. The passenger air bag was tethered by a single wide strap sewn to the face of the bag. The bag vented internally back through the air bag module. The air bag extended approximately 61 cm (24 in) from the instrument panel in its deflated state. The face of the deflated bag measured 51 cm (20 in) by 51 cm (20 in) width by height. There was no contact evidence on the air bag.

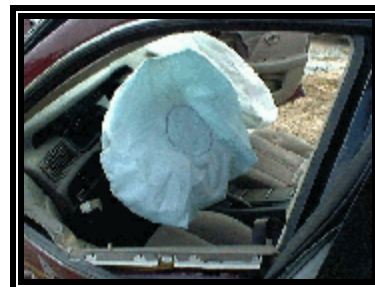
Figure 7: Driver air bag.

There was no contact evidence on the driver air bag. The driver air bag measured 63.5 cm (25.0 in)

in diameter in its deflated state. The bag was tethered by two 9.7 cm (3.8 in) wide straps. The bag was vented by two 2.5 cm (1.0 in) diameter ports located on the back side in 11 and 1 o'clock sectors. The back side of the air bag was stamped with the following nomenclature in the 12 o'clock sector:
