On-scene Investigation / Vehicle to Vehicle  
Dynamic Science, Inc. / Case Number: DS98018  
1995 Hyundai Accent L 3-door Hatchback  
Arizona  
May 1998

| 4. Title and Subtitle<br><b>In-Depth Accident Investigation</b> | | 5. Report Date<br>March 29, 2000 | | 6. Performing Organization Report No. | |

**Dynamic Science, Inc.**  
**Accident Investigation**  
**Case Number: DS98018**

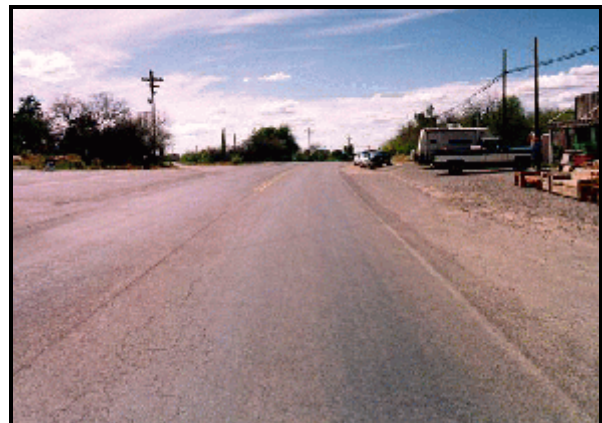
The collision occurred in May, 1998 around 1215 hours in Arizona. This was a two-vehicle rear end type collision. At the point of impact, the roadway is a two way, two lane, undivided asphalt roadway with a positive 3.3% slope (see Figure 1). The weather was clear, and the roadway was dry and free of defects. There were no traffic controls and the posted speed limit is 56 km/h (35 mph).

**Figure 1.** Roadway and impact area.

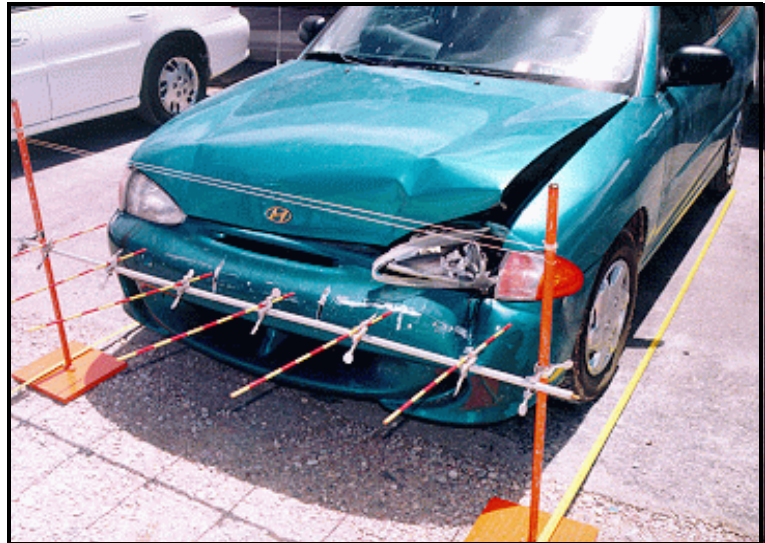
| Damage Description: | Moderate damage to the front bumper, hood, grille area, front left fender and windshield. The hood was displaced rearward and buckled upward at the left corner. There was contact damage and white paint transfers beginning at the front left bumper corner and extending laterally towards the front right bumper corner. The windshield was cracked by the front right passenger's air bag module cover. The vehicle was towed from the scene but not due to damage since the vehicle was driveable; it was driven to where it was inspected. | |

**Figure 2.** Damage to Vehicle 1.

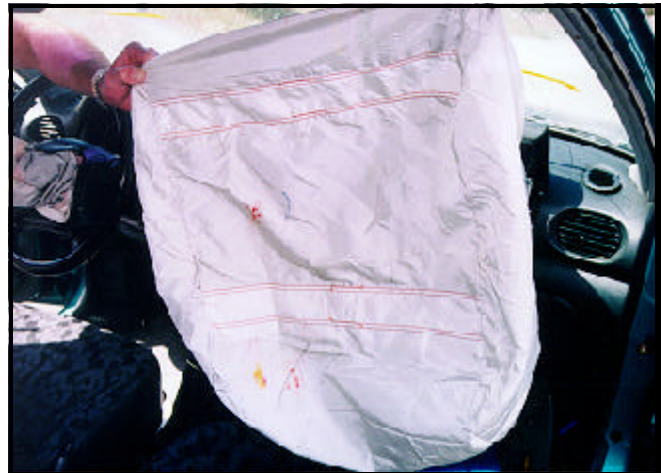
Vehicle 1 was equipped with a driver's air bag and mid-mounted front right passenger's air bag. The steering wheel hub mounted driver's air bag is circular and is 54.5 cm (21.5 in) in diameter; it has two vent holes, two tethers, and ten horizontal folds. There were black smudges on the upper right quadrant of the face of the air bag from either contact with the interior module covers or possibly make-up transfer from the driver. The module cover has an "H" configuration; there were no indications of any damage or occupant contact. The passenger side air bag is rectangular in shape and measures 54 cm (21.3 in) high by 42.5 cm (16.7 in) wide; it has two tethers and two vent holes. There is 58 cm (22.8 in) of air bag excursion. The distance from mid-instrument panel to the back of the front right seat is 76 cm (29.9 in). There were no occupant contacts found on the air bag, but there were crayon smearing about the entire face of the air bag (see Figure 3). The module cover is rectangular in shape and there were no indications of damage or occupant contact.

**Figure 3.** Crayon smearing to front right air bag.

The windshield on the right side was cracked by the front right passenger's air bag module cover. There was an air bag imprint on the windshield directly above the steering wheel. There was also an air bag imprint on the right side, on the upper front right quadrant of the windshield. There was also powder residue from the front right passenger's air bag on the front right side window.

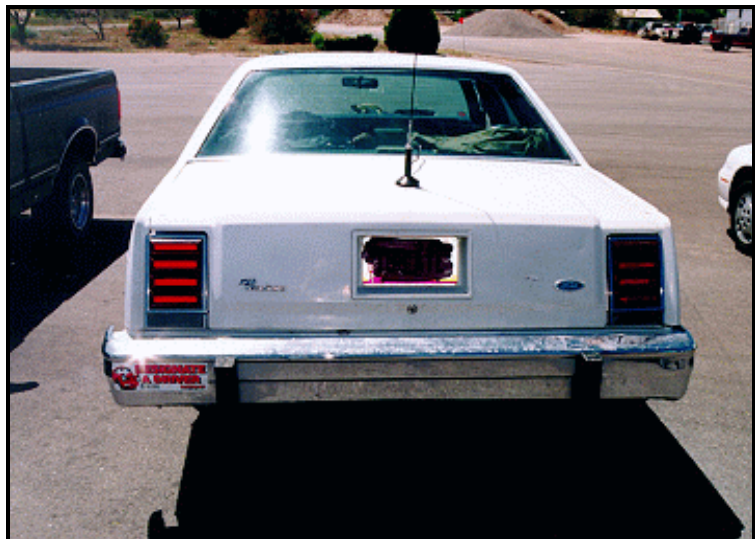
| Damage Description: | Minor damage to the rear bumper consisting of paint transfer. | |

**Figure 4.** Damage to Vehicle 2.
