**CALSPAN ON-SITE AIR BAG DEPLOYMENT INVESTIGATION**

**CALSPAN CASE NO. CA98-19**

**VEHICLE #1 - 1996 ACURA TL 2.5**

**VEHICLE #2 - 1979 FORD ECONOLINE E-150 CARGO VAN**

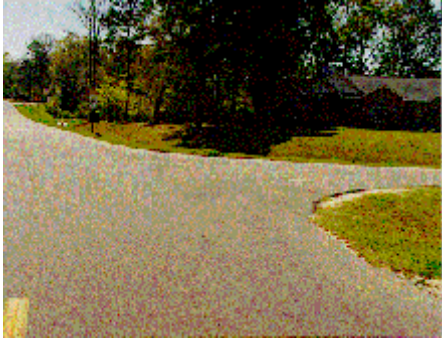
**Figure 1**- Approach of Vehicle #2, 30 m prior POI

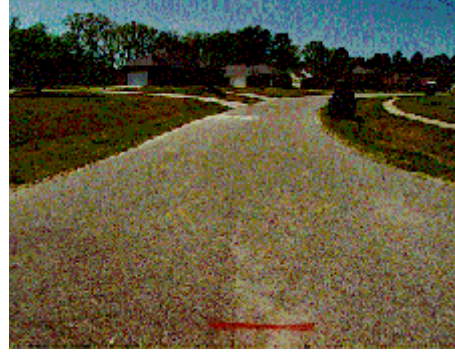
**Figure 2**- Approach of Vehicle #2, 15 m prior POI

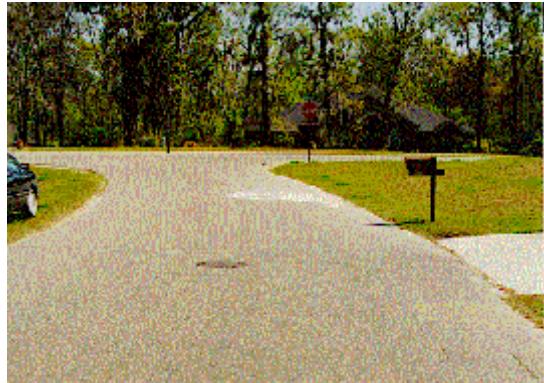
As Driver #1 proceeded eastbound (**refer to Figure #3**), she observed the approach of Vehicle #2 in her travel lane and applied the brakes in an attempted avoidance maneuver. The crash occurred approximately 21 m (70') south of the intersection.

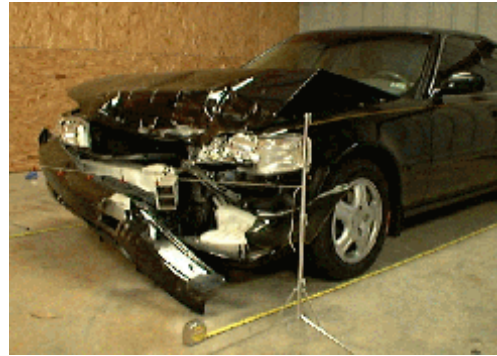
The 1996 Acura TL 2.5 was equipped with a dual front Supplemental Restraint System (SRS) which deployed as the result of the impact with Vehicle #2. The vehicle was equipped with a four wheel disc ABS braking system. Exterior damage to the vehicle involved the front bumper, the grille, the hood, both front fenders, and radiator (**refer to Figure 5**). The maximum crush of 29.2 cm (11.5") was located 54.6 cm (21.5") right of the left bumper corner. A square type deformation pattern located 27.9 cm (11.0") left of the Acura's centerline was attributed to contact with Vehicle #2's right frame rail end. The frontal crush profile is listed in the following table:

**Figure 5-** Left front corner view of the 1996 Acura TL 2.5

Frontal Crush Profile	$C_1 = 0$	$C_2 = 8.6 \text{ cm (3.4")}$	$C_3 = 20.7 \text{ (8.2")}$
	$C_4 = 10.9 \text{ cm (4.3")}$	$C_5 = 2.3 \text{ cm (0.9")}$	$C_6 = 4.8 \text{ cm (1.9")}$

### **CDC: 12-FDEW-2**

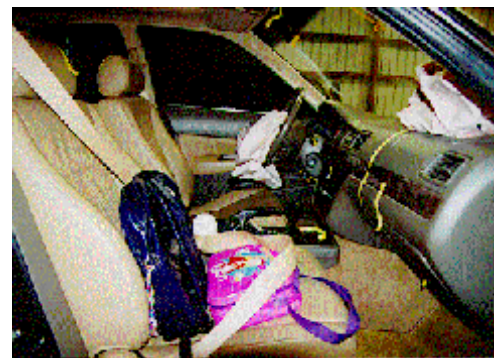
**Figure 6-** Lateral view of the right front seat in the 1996 Acura

The right front seat was adjusted 2.2 cm (0.875") rear of the full forward position (**refer to Figure 6**). This placed the leading edge of the seat cushion 6.0 cm (2.375") rearward from the vertical surface of the instrument panel and 27.3 cm (10.75") above the floor pan. The longitudinal dimension of the seat cushion measured 51.4 cm (20.25") with a measured designed incline of 20 degrees.

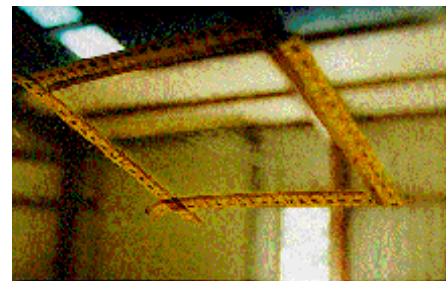
The windshield had a highly visible transfer mark which was located 29.2 cm (11.5") right of the vehicle centerline and 17.1 cm (6.75") below the windshield header (**refer to Figure 7**). The transfer measured 8.9 cm (3.5") vertically and 13.3 cm (5.25") laterally which appeared to be of an oil/grease texture with a striated pattern. This transfer was attributed to contact by the child's head during the crash sequence. Directly above this area was a 22.2 cm (8.75") wide particulate field that extended upper to the windshield header. This was attributed to bodily tissue dispersed from the air bag fabric during the air bag expansion.

**Figure 7**- View of the oil/grease transfer mark on the windshield of the Acura

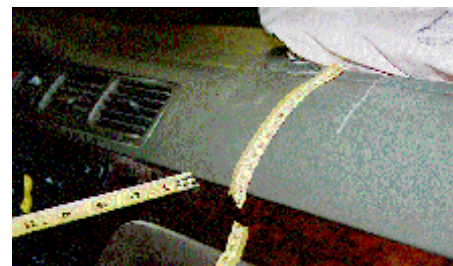
A faint imprint of a hand was noted along the surface of the instrument panel located left of the front right air bag module cover and 26.7 cm (10.5") right of the vehicle centerline (**refer to Figure 8**). This was attributed to contact by the right front occupant's left hand due to bracing prior to the crash.

**Figure 8**- Left hand imprint on the instrument panel by the right front occupant in the Acura

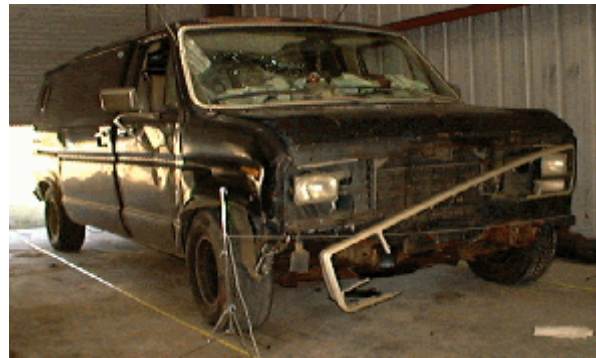
The 1979 Ford Econoline cargo van which was used for commercial enterprise was in poor overall condition prior to the crash (refer to Figure 9). The front bumper had been removed from the vehicle prior to the crash which left the two frame rail ends exposed. During the crash, the right frame rail contacted the left front bumper of the Acura resulting in a battering ram box type damage pattern.

**Figure 9**- Left corner view of the 1979 Ford Econoline cargo van

The right frame rail end was deformed rearward 2.2 cm (0.875") while the left frame rail was deformed 3.8 cm (1.5"). Given the poor condition of the vehicle, it was not determinable whether these displacement values were entirely the result of this crash.

The grille panel was fractured and displaced rearward during the crash. The maximum crush measured 31.8 cm (12.5") and was located 5.1 cm (2.0") left of the vehicle centerline. Crush measurements were obtained along the lower area of the grille panel which are contained in the following table:

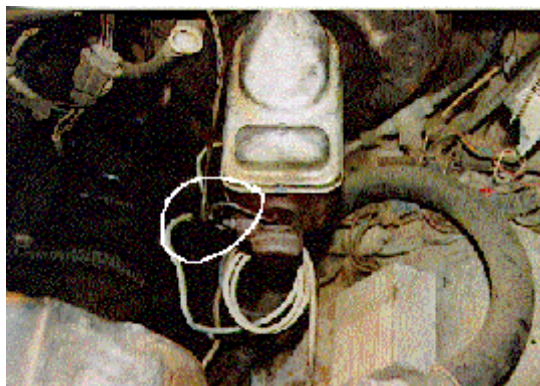
The braking system had been compromised prior to the crash where the rear brakes had been rendered inoperable. The metallic hydraulic brake line for the rear brakes had been cut near the tandem master cylinder (**refer to Figure 10**). Road dirt build-up at the site of the cut indicated that the line had been cut previous to the crash and that it was not severed during the crash. There was no hydraulic fluid in the front chamber of the tandem master cylinder which was consistent with the severed rear brake line (**refer to Figure 11**). The front brakes were operable, but the brake pedal had a long throw with an infirm feel. Reportedly a mechanic assessed the brake system at the request of the police department and reported that the rear brake shoes were missing and the front brake pads were defective.

**Figure 10-** View of the master cylinder and the severed rear brake line looking from the front of the vehicle rearward

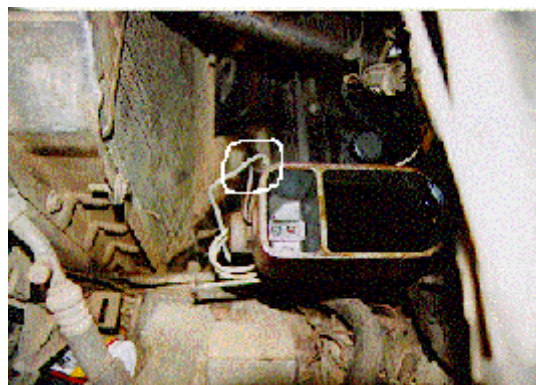
**Figure 11-** View of the master cylinder from the left side of the vehicle showing the empty forward brake chamber (designated for the rear brakes) and the severed brake line highlighted by the white circle

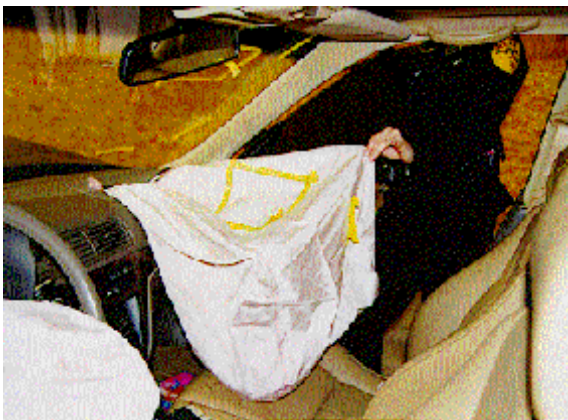
**Figure 12-** Excursion of the front right air bag in the Acura

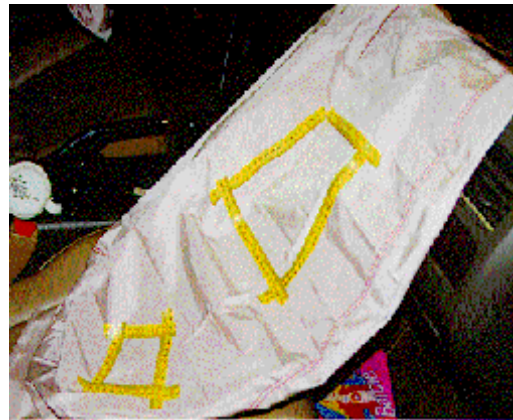
The front right air bag exhibited a heavy tissue transfer near the center of the front surface which was attributed to contact with the right front occupant's neck and facial area during the SRS deployment cycle. The largest area of transfer which measured 15.2 cm (6.0") in length and 10.8 cm (4.25") in width was located 33.0 cm (13.0") from the inflator unit. A second tissue transfer area was noted 19.1 cm (7.5") below the first transfer and measured 5.0 x 3.8 cm (2.0 x 1.5"). It appeared to be consistent in texture and alignment with the first transfer and indicated that the air bag was in an unfolding motion when it contacted the child's neck facial area.

**Figure 13-** Areas of tissue transfer on the front right air bag of the Acura

The face of the passenger side air bag exhibited two linear artifact fields of tan color deposits (**refer to Figure 13**) which were associated with tissue transfer from the right front occupant's neck and facial areas. The first area measured 15.2 cm (6.0") in length and 10.8 cm (4.25") in width. It began 33.0 cm (13.0") below the inflator unit and located in the center of the air bag. The second area of tissue transfer was located 67.3 cm (26.5") below the inflator unit which measured 5.1 cm (2.0") by 3.8 cm (1.5"). When the air bag was refolded along the predeployment fold lines during the vehicle inspection, these two areas aligned to form a continuous tissue transfer field. This indicated that the child's upper body was well forward and located within the expansion zone of the air bag at the time of SRS actuation.
