**CALSPAN ON-SITE AIR BAG/CHILD FATALITY INVESTIGATION
CALSPAN CASE NO. CA98-024
VEHICLE: 1997 FORD EXPLORER
LOCATION: VIRGINIA
CRASH DATE: APRIL, 1998**

<p>14. <i>Sponsoring Agency Code</i></p>	
<p>15. <i>Supplementary Notes</i> On-site investigation of an air bag deployment death of a 3 year old front right passenger in a 1997 Ford Explorer.</p>			
<p>16. <i>Abstract</i> This on-site investigation focused on the injury mechanisms and cause of death of a 3 year old child front right passenger of a 1997 Ford Explorer that was involved in a single vehicle, run-off-road crash. The Ford Explorer was equipped with frontal air bags for the driver and right front passenger positions. The air bag system deployed as a result of a front left impact sequence with a 22.9 cm (9.0") diameter tree. The child passenger was out of position forward, against the mid mount front right passenger air bag module cover at the time of deployment. Cover flap contact and subsequent bag expansion resulted in a fracture/dislocation of C1/C2 with approximately 5.1 cm (2.0") of separation and complete spinal cord transection. In addition, the child passenger sustained a band-like abrasion pattern that extended

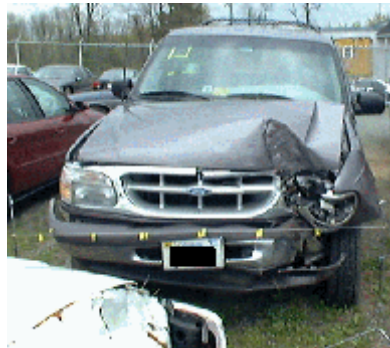
Figure 1. Frontal view of the Ford Explorer.

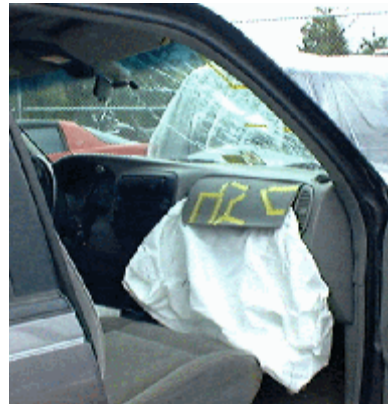
Figure 2. Interior contacts of the child passenger.

As the air bag membrane expanded, the child was accelerated in a rearward direction between the front bucket seat backs. A 5.7 cm (2.25") scuff mark was noted to the top surface of the center console. Abrasive type marks were noted to both integral head restraints of the front seat back supports. Similar type abrasions were noted to the headliner at the rear edge of the sun roof. The left side mark was located 6.4-11.4 cm (2.5-4.5") left of center and the right side abrasion was located 6.4-12.7 cm (2.5-5.0") right of the vehicle's centerline. Both abrasions extended 5.1 cm (2.0") rearward of the sunroof opening.

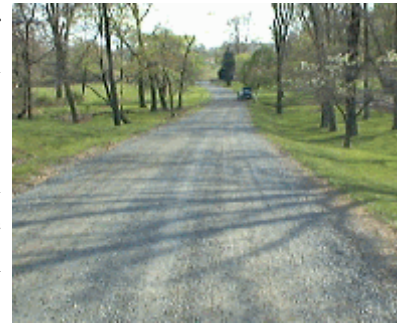
The crash occurred on a private roadway of an estate/equestrian center in Virginia (**Figure 3**). The stone road surface was 4.4 m (14'6") in width and was bordered by grassy shoulders with negative embankments and shallow drainage ditches located outboard of the shoulders. Large diameter trees (hardwoods) were scattered in the lawn area that extended along both sides of the roadway. The private roadway allowed for traffic flow in both the north and southbound directions of travel, however, it was basically designed as a one-lane access road to the facility. In the vicinity of the crash site, the roadway curved slightly to the right and had a negative grade of approximately 2 percent. At the time of the crash, the conditions were daylight, clear, and dry. There was no posted speed limit on the property.

Figure 3. Trajectory of the Ford Explorer.

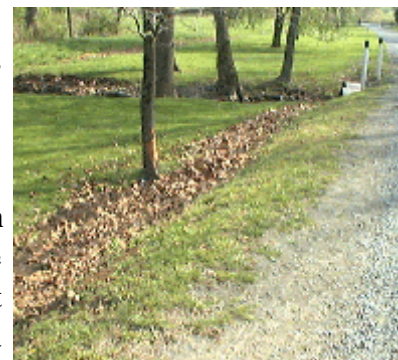
The left headlamp area of the Ford Explorer impacted a 22.9 cm (9.0") diameter tree that was located at the base of the negative embankment, 3 m (10.0') outboard of the left edge of the stone roadway (**Figure 4**). Initial contact involved the front bumper of the vehicle, however, as the bumper crushed, the grille and hood areas engaged against the tree. The resultant direction of force was within the 12 o'clock sector which produced a maximum crush value of 40.6 cm (16.0") located at the front left bumper corner. The total velocity change was computed at 19.8 km/h (12.3 mph) by the WinSMASH program (**Figure 5**). As a result of the tree impact, the Ford Explorer's frontal air bag system deployed.

Figure 4. Struck tree and its relationship to the private roadway.

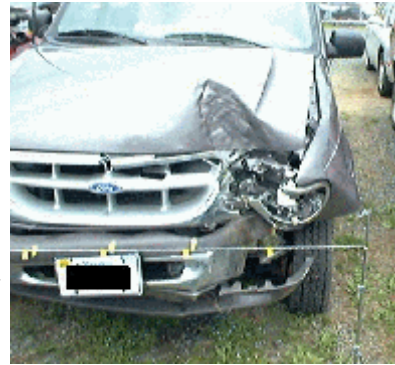
Figure 5. Frontal damage to the Ford Explorer.

The Ford Explorer sustained moderate damage to the front left area from its run-off-road impact sequence with the 22.9 cm (9.0") diameter tree. Maximum crush was cm 40.6 cm (16.0") located at the left front bumper corner (**Figure 6**). The direct contact damage on the bumper fascia began 55.9 cm (22.0") left

of the vehicle's centerline and extended 24.1 cm (9.5") to the left corner. The damage on the hood face began cm 20.0 cm (7.9") left of center and extended 22.2 cm (8.75") to the right. The narrow impact deformed the full length of the bumper which resulted in a combined direct and induced damage length (Field L) of 138.4 cm (54.5"). The primary damage, however, was focused outboard of the left frame rail. The damage profile at bumper level was as follows: C1 = 40.6 cm (16.0"), C2 = 12.1 cm (4.75"), C3 = 7.4 cm (2.9"), C4 = 3.8 cm (1.5"), C5 = 1.9 cm (0.75), C6 = 0 cm . The Collision Deformation Classification (CDC) was 12-FYEN-2.

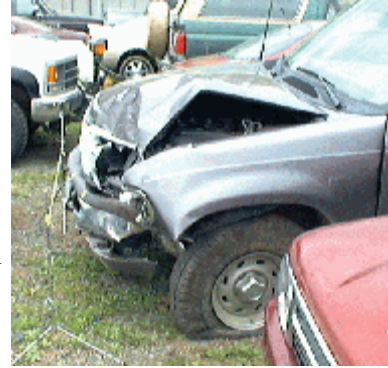
Figure 6. Maximum crush at front left bumper corner.

The frontal impact deformed the left front bumper corner rearward into the inboard sidewall area of the left front tire. The tire was aired out, however, there was no visible damage to the sidewall area. The left wheelbase was reduced in length by 1.5 cm (0.6"). Both front fenders were displaced rearward against the leading edge of the front doors. All four doors remained operational, however, the front doors were bound against the fenders.

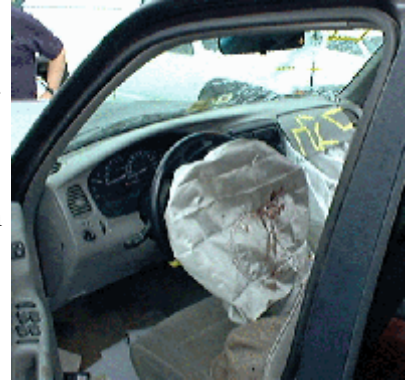
Although no direct driver contact evidence was visible on the bag, a blood stain was noted to the upper right quadrant of the bag. This stain resulted post-crash as the driver slumped over the deployed bag. Several black vinyl transfers were noted to the forward panel of the bag which resulted from bag expansion against the inside surface of the module assembly.

Figure 7. Deployed front left air bag.

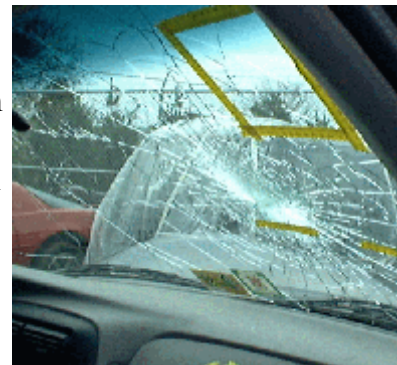
The child passenger initially moved on a forward trajectory and impacted the laminated windshield with her frontal/superior scalp area. The contact fractured the glazing in a star-like pattern located 34.9 cm (13.75") right of the vehicle's centerline and 17.1 cm (6.75") above the top of the instrument panel (**Figure 8**). This contact was located directly forward of the front right passenger air bag module cover flap. Several strands of fine blond hair, approximately 2.5 cm (1.0") in length, were embedded into the glazing at the fracture site. In addition, two small fragments (possible tissue) were embedded into the glazing at the location of the contact. A long single hair strand was embedded into a glazing crack 49.5 cm (19.5") right of center and 12.1 cm (4.75") above the instrument panel. There was no supporting contact evidence surrounding this hair stand. There was no reported injury from this head contact point.

Figure 8. Child passenger head impact to windshield.

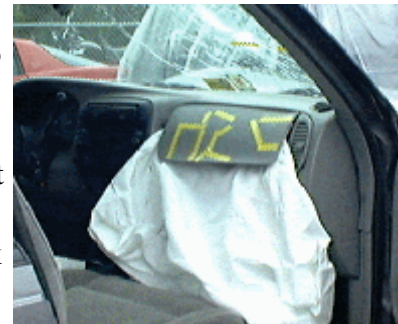
The front right passenger air bag was concealed within the right instrument panel in a mid mount configuration. The module assembly consisted of a single cover flap design that opened at the lower and side surfaces, while remaining hinged at the top edge. The cover flap was rectangular in shape with a vertical height of 17.1 cm (6.75") and a horizontal width of 37.1 cm (14.6"). The child passenger was out-of-position in a forward direction and was in a close proximity to the cover flap as it opened in an upward direction, contacting the underside of the child's chin. A large tissue transfer was noted to the left side of the cover flap, located 7.6-12.7 cm (3.0-5.0") left of the centerline of the flap and 1.9-8.3 cm (0.75-3.25") above the lower (leading) edge. A pinkish fabric transfer was located on the leading edge of the flap. The transfer began 12.7 cm (5.0") left of the flap's centerline and extended 14.6 cm (5.75") to the right. At a point 2.5 cm (1.0") left of center, the fabric transfer extended 1.9 cm (0.75") onto the face of the flap.

Directly above the pink fabric transfer, a whitish scuff mark extended 0-5.3 cm (0-2.1") left of center and 5.1-12.7 cm (2.0-5.0") above the leading edge of the flap. The whitish transfer probably resulted from contact with the collar area of the child passenger's shirt. On the right side of the mid mount module cover flap, a dark stain was noted, located 11.4-14.2 cm (4.5-5.6") right of the centerline of the flap and 7.0-9.5 cm (2.75-3.75") above the leading edge. The stain was similar to a windshield transfer that possibly resulted from nasal expulsion.

The continued upward rotation of the cover flap resulted in contact of the face of the flap against the underside of the child's chin which rotated the head in an upward and rearward (hyperextension) direction. The contact was evidenced by a large circular tissue transfer that was located 7.6-12.7 cm (3.0-5.0") left of the centerline of the flap and 1.9-8.3 cm (0.75-3.25") above the leading edge (**Figure 9**). Adjacent to the tissue transfer was a whitish scuff that extended 0-5.3 cm (0-2.1") left of center and 5.1-12.7 cm (2.0-5.0") above the leading edge. This scuff mark possibly resulted from the collar area of the child's shirt following the contact with her thoracic area. A third area of possible contact was noted to the upper right quadrant of the cover flap. A dark stain was located 11.4-14.2 cm (4.5-5.6") right of the centerline and 7.0-9.5 cm (2.75-3.75") above the leading edge of the flap. This stain appeared to be a mucous transfer, possibly a nasal expulsion. A similar

Figure 9. Contact evidence on the mid mount cover flap.

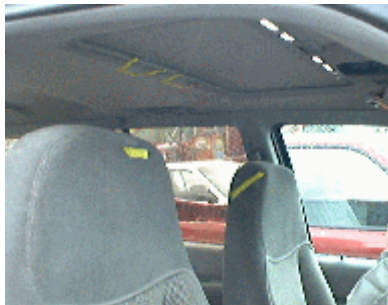
The trajectory of the child was evidenced by contact points on the center console, both integral head restraints, and the headliner at the trailing edge of the sunroof. In addition to the cervical injuries, the child sustained abrasions of the dorsal aspect of the right forearm and of the dorsal left hand. Both injuries possibly resulted from the rebound trajectory into the rear of the vehicle.

Figure 10. Trajectory of child passenger between seat backs.

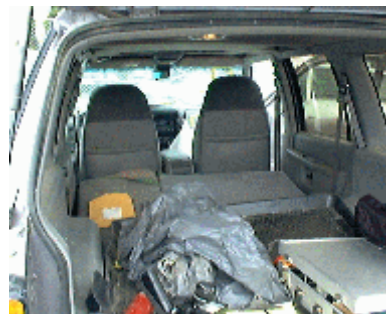
The continued expansion of the non-tethered front right air bag accelerated the child's rearward motion which was initiated by her rebound from the laminated windshield contact sequence. The child was displaced between the front seat back supports (**Figure 10**), into the rear cargo area of the vehicle where she came to rest. The rear seat back was folded down onto the seat cushion which allowed the child to continue rearward with her head coming to rest against the tailgate of the Ford Explorer and her feet adjacent to the left C-pillar. At rest the child was covered with plastic sheet which was lying in the cargo area of the truck (**Figure 11**).

Figure 11. Final rest position of the child passenger.
