REMOTE AIR BAG DEPLOYMENT REPORT

CASE NUMBER - IN98-024

VEHICLE - 1994 PONTIAC FIREBIRD

CRASH DATE - December 1994

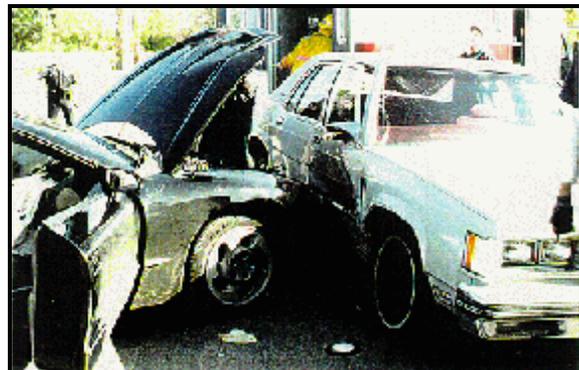
The front of the case vehicle impacted the right front door panel of the other vehicle, causing the case vehicle's driver and front right passenger air bags to deploy. Both vehicles came to rest near the point of impact (**Figure 1**). The other vehicle was partially blocking both southbound travel lanes. Both vehicles were towed due to disabling damage.

Figure 1: On-scene view of the two vehicles at final rest (case photo #05)

The other vehicle's CDC was estimated from photographs (see **Figure 1**) as **02-RPEW-2 (60)**. The WinSMASH reconstruction program, CDC-only algorithm based on visually estimated CDCs for both vehicles, was used. The preliminary Total, Longitudinal, and Lateral Delta Vs are respectively: 20 km.p.h. [12.4 m.p.h.], -10 km.p.h.[-6.2 m.p.h.], and -17 km.p.h. [-10.6 m.p.h.]. These results should be regarded as borderline but reasonable. The Mercury was towed due to damage.

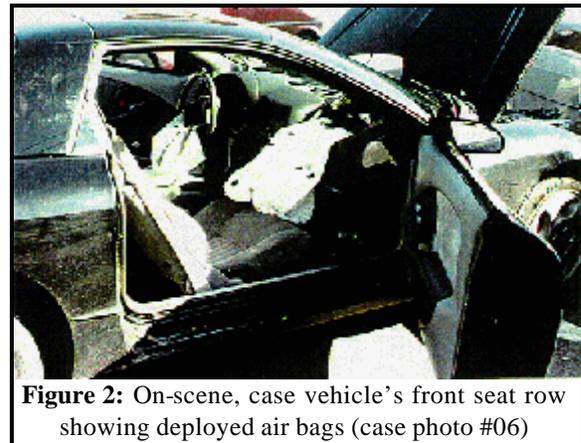
The front right passenger's air bag was located in the top of the instrument panel. The video tape shows that the air bag module's single cover flap opened at the designated tear points and there was no obvious damage to the air bag or the instrument panel structures surrounding the module (**Figure 2**). This module was of the type where the cover flap is entirely separate from the rest of the module, with the cover flap attached by a single wide mesh tether. (An example of this type of cover flap, taken from a different vehicle, is shown in **Figure 3**.) The video does not provide good views of the module's cover flap, but it appears that the cover flap was entirely separated from the mesh tether and stuffed back into the module area. The cover flap appears to be bent, approximately at the middle. It is not known whether the apparent damage was a result of the deployment or post-crash handling.

Figure 2: On-scene, case vehicle's front seat row showing deployed air bags (case photo #06)

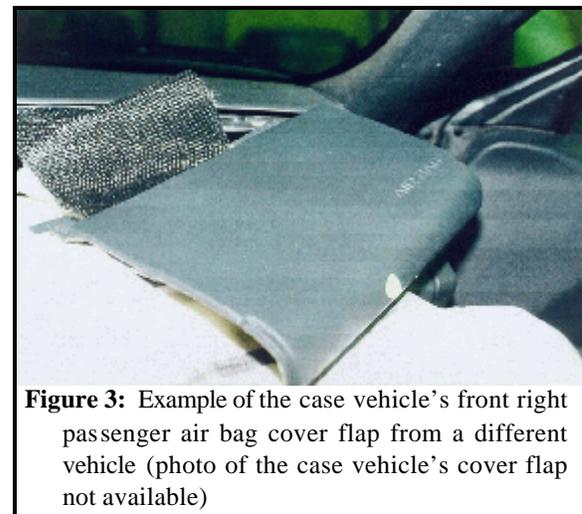
Figure 3: Example of the case vehicle's front right passenger air bag cover flap from a different vehicle (photo of the case vehicle's cover flap not available)

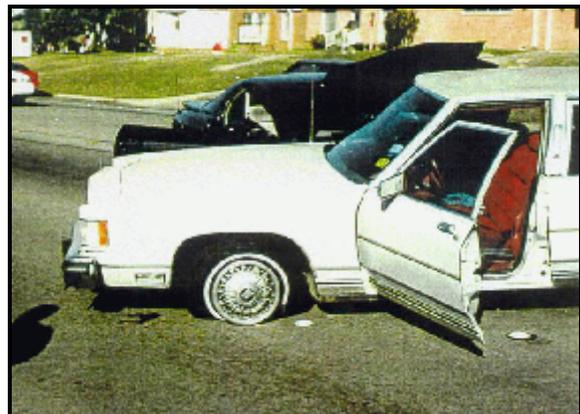
Figure 4: On-scene, left side of the other vehicle at final rest (case photo #08); see also **Figure 1**
