ON-SITE CHILD AIR BAG-RELATED FATALITY INVESTIGATION

CASE NUMBER - IN98-027
LOCATION - ARKANSAS
VEHICLE - 1995 TOYOTA COROLLA DX
CRASH DATE - September, 1998

1. <i>Report No.</i> IN98-027		2. <i>Government Accession No.</i>		3. <i>Recipient's Catalog No.</i>	
4. <i>Title and Subtitle</i> On-Site Child Air Bag-Related Fatality Investigation Vehicle - 1995 Toyota Corolla DX Location - Arkansas			5. <i>Report Date:</i> March 17, 2003

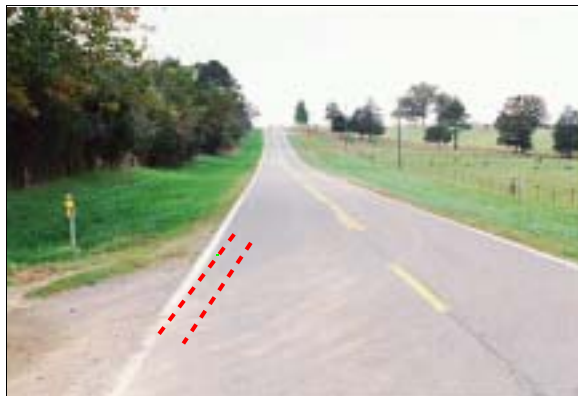
Figure 1: Southwestward view of case vehicle's northeastbound travel path to impact; Note: highlighted right front tire mark (case photo #03a)

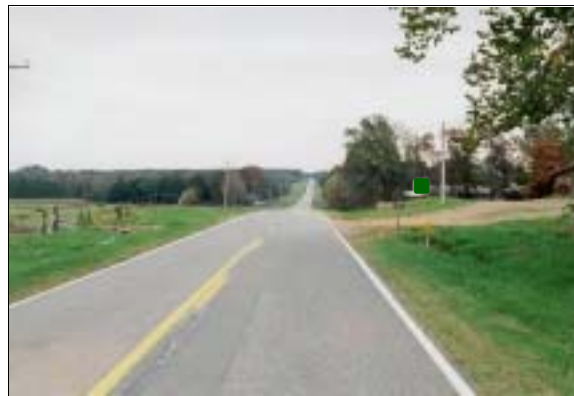
Figure 2: Case vehicle's northeastward travel path just prior to impact with Freightliner's Fruehauf trailer backing into driveway (case photo #01)

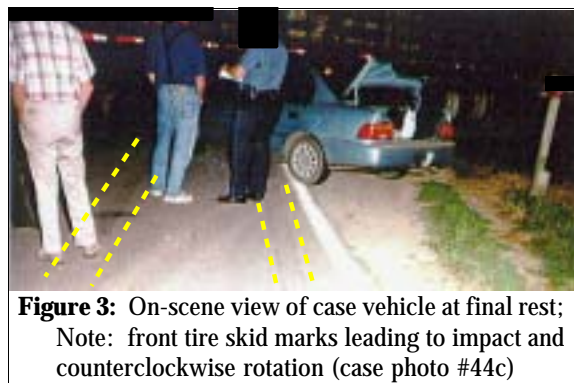
Figure 3: On-scene view of case vehicle at final rest; Note: front tire skid marks leading to impact and counterclockwise rotation (case photo #44c)

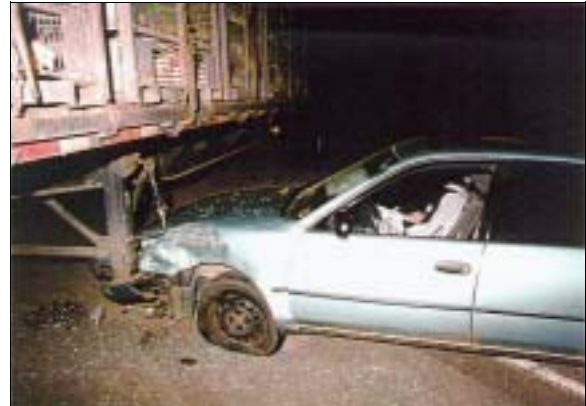
The front left corner (**Figure 4** and **Figure 5**) of the case vehicle impacted the left dolly wheel attached to the undercarriage of the truck-tractor's semi-trailer. The case vehicle’s front left narrow end engagement extended down the left side before snagging on the left front wheel rim. The case vehicle’s initial engagement with the flat base of the trailer's left dolly wheel resulted in slicing damage to the front left bumper corner at the turn signal housing (**Figure 6**). The snagging action to the left front wheel (**Figure 7** below) caused the case vehicle to achieve the deployment threshold and resulted in the deployment of the case vehicle's driver and front right passenger supplemental restraints (air bags). The case vehicle rotated approximately 45 degrees counterclockwise post-impact and came to rest in contact with the tractor-trailer, heading northward (**Figure 4** and **Figure 8** below).

Figure 4: On-scene view of case vehicle at final rest against trailer’s dolly wheels; Note: case vehicle rotated approximately 45 degrees counterclockwise after impact (case photo #45)

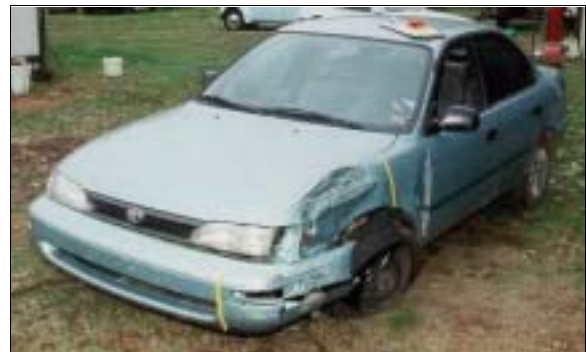
Figure 5: Case vehicle’s very narrow frontal impact with Fruehauf trailer; Note: yellow tape marks beginning (front bumper) and ending (left fender) of direct damage (case photo #08)

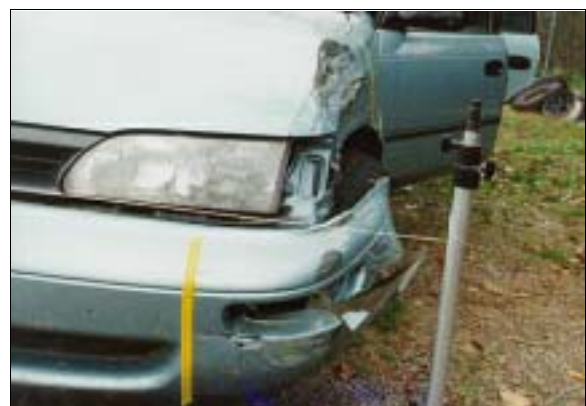
Figure 6: Reference line view down case vehicle’s left side showing narrow direct damage to front left corner (case photo #11)

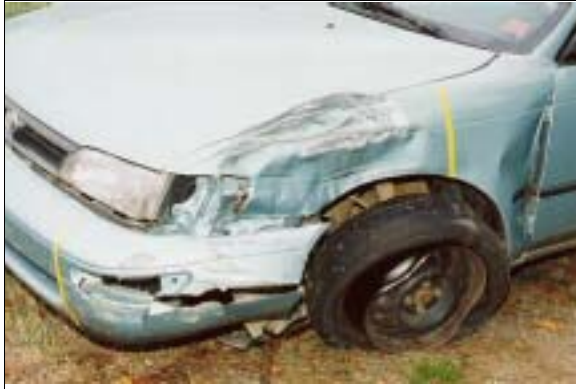
Figure 7: Case vehicle's front left damage viewed from left of front; Note: left front wheel rim snagged during narrow corner engagement (case photo #12)

(37.4 inches) down the left side (**Figure 7** above). The wheelbase on the case vehicle's left side was shortened 14 centimeters (5.5 inches) while the right side was shortened approximately 1 centimeters (0.4 inches). The case vehicle's front bumper fascia, front left turn signal assembly, hood, left front side marker, and left fender were directly damaged and crushed rearward. The case vehicle's left front tire was damaged, deflated, and physically restricted (**Figure 7** above). The left fender and left front door also sustained induced damage. The windshield's glazing sustained a stress crack laterally across the top of the windshield and a stress fracture near the right "A"-pillar. In addition, the left front window glazing was disintegrated from the impact (**Figure 5** above).

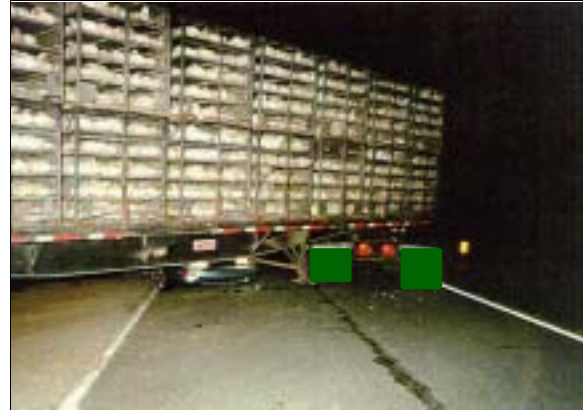
Figure 8: On-scene view looking southwestward in northeastbound lane at final rest positions of case vehicle and Fruehauf trailer (case photo #46)

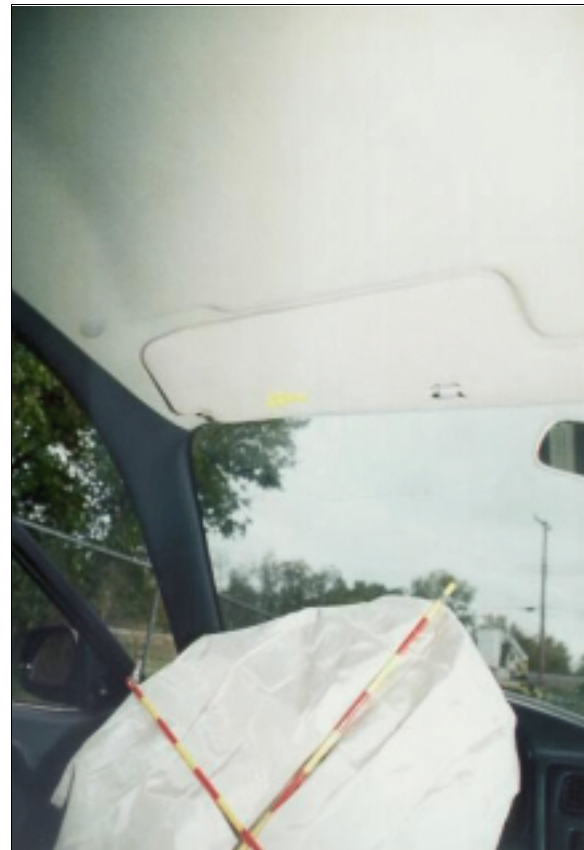
Inspection of the case vehicle's interior revealed a skin transfer and indentation on the driver's sun visor (**Figure 10**) and scuffs to the glove box door and front right passenger's knee bolster. In addition the rearview mirror was askew from contact with the deploying front right passenger air bag, and there was a contact to the right "A"-pillar from the child safety seat (**Figure 11**). Finally, the energy absorbing steering column showed no evidence of compression.

Figure 10: Case vehicle's deployed driver air bag and greenhouse area showing indentation and skin evidence on driver's sun visor (case photo #19)

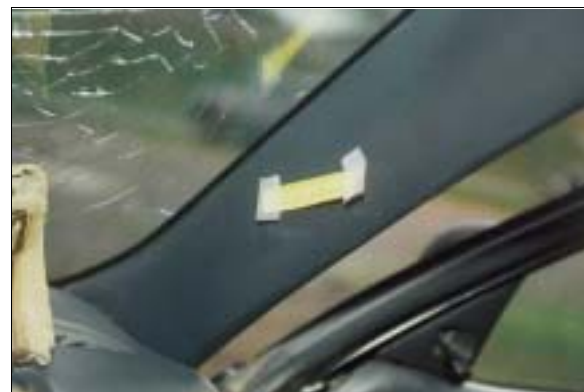
Figure 11: Close-up of scuffing to case vehicle's right "A"-pillar from contact by child safety seat and stress fracture to right side of windshield's glazing (case photo #23)

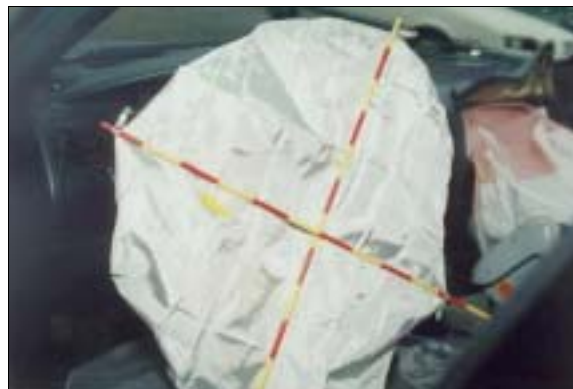
cover flaps made of thick vinyl with overall dimensions of 15 centimeters (5.9 inches) at the horizontal seam and 7 centimeters (2.8 inches) vertically for both the upper and lower flaps. An inspection of the air bag module's cover flaps and air bag revealed that the cover flaps opened at the designated tear points, and there was no evidence of damage during the deployment to the air bag or the cover flaps. The driver's air bag was designed without any tethers. The driver's air bag had two vent ports, approximately 3 centimeters (1.2 inches) in diameter, located at the 11 and 1 o'clock positions. The deployed driver's air bag was round with a diameter of 63 centimeters (24.8 inches). Inspection of the driver's air bag revealed a small blood drop and either a tiny clump of skin or mucous, not readily apparent, to the lower right quadrant just below the center and toward the 6 o'clock position (**Figure 12**).

Figure 12: Case vehicle's deployed driver air bag showing contact evidence in right lower quadrant; Note: steering wheel has been rotated clockwise (case photo #25)

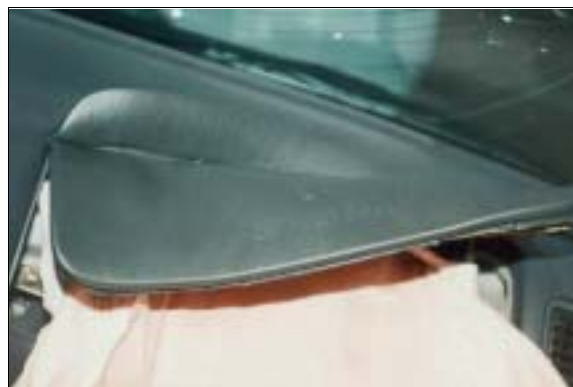
Figure 13: Close-up of evidence on left side of case vehicle's front right passenger air bag module's cover flap from contact with top of forward facing child safety seat (case photo #29)

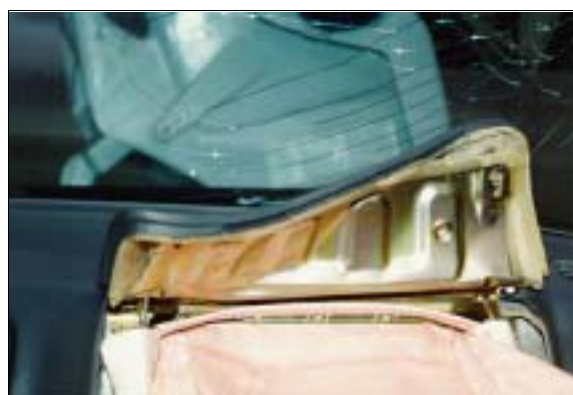
Figure 14: Case vehicle's deformed front right passenger air bag module's cover flap; Note: flap deformed from contact with forward facing child safety seat seen in background (case photo #31)

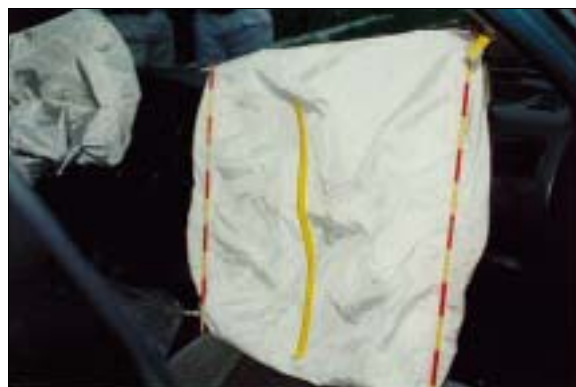
Figure 15: Case vehicle's deployed front right passenger air bag showing skin and grease smears down left side of front portion (case photo #27)

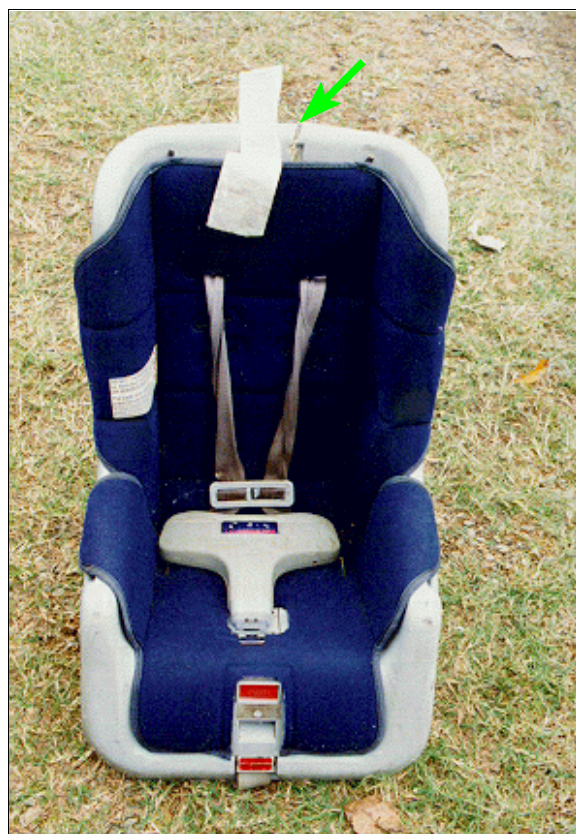
The child safety seat used by the case vehicle's front right passenger was manufactured by Century on May 27, 1997 and was identified by Model number 4263NZF (**Figure 16**). The involved convertible child safety seat was improperly used at the time of the crash (i.e., the CSS was not secured by the available three-point, lap-and-shoulder, safety belt system). The convertible safety seat was designed to be used as either a rearward facing infant restraint for infants under 69 centimeters and 9 kilograms (27 inches, 20 pounds) or as a forward facing safety seat for infants between 69-102 centimeters and 9-18 kilograms (27-40 inches, 20-40 pounds). The child safety seat consisted of plastic one-piece shell with a pivoting carrying handle attached to the sides which had been removed. The seat was equipped with a shoulder harness and "T"-shield which was attached to the shell and correctly threaded through the upper most slots of the shell back. There were three different height levels that the webbing could be adjusted to, depending on the child's height. The shell had a foam pad on the back support portion, providing a soft surface for the infants back. The seat was also designed

Figure 16: Front of forward facing child safety seat that was secured in case vehicle's front right seating position; Note: crack (arrow) to top of seat (case photo #32)

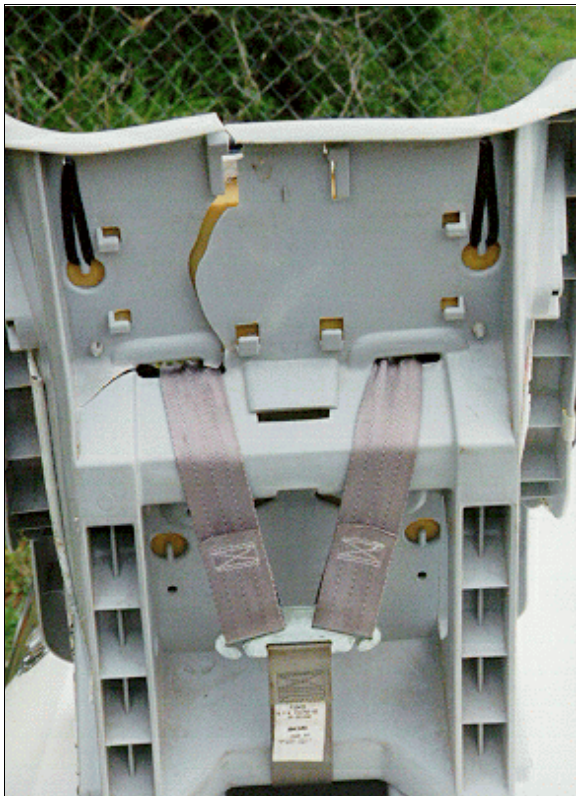
Figure 17: Close-up of backside of forward facing child safety seat secured in case vehicle's front right seating position; Note: seat cracked from impact with front right air bag module's cover flap (case photo #37)

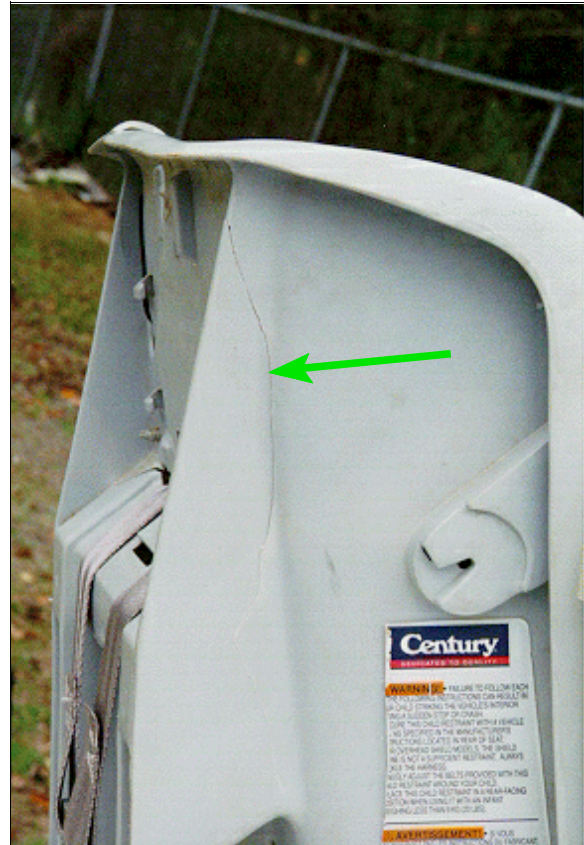
Figure 18: Close-up of right side of forward facing child safety seat secured in case vehicle's front right seating position; Note: crack radiating down side of rear back support bar (case photo #35)

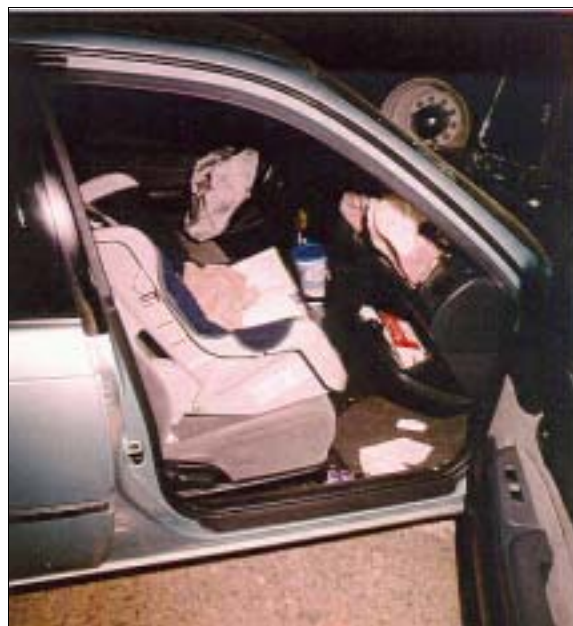
The case vehicle's front right passenger was restrained in a forward facing child seat by a shoulder harness and "T"-shield, but the child safety seat was not secured by the available, active, three-point, lap-and-shoulder, safety belt system. At the time of the crash the child restraint was positioned in the front right seat in a forward facing position with the shell's back flush against the seat back. Furthermore, the inspection of the front right passenger's seat belt webbing, "D"-ring, and latch plate showed no evidence of loading. In addition, photographs taken on-scene by a freelance photographer showed the child safety seat unrestrained (**Figure 19**). It should be noted that if the case vehicle's seat belt system had been secured to the safety seat as required it still would not have prevented the seat from flipping forward at impact since the system's webbing retractor was not in the automatic locking mode (ALR).

Figure 19: On-scene photo of case vehicle's interior from outside front right door; Note: child safety seat not secured by belt system (case photo #48)
