CALSPAN ON-SITE DRIVER AIR BAG DEPLOYMENT/FATALITY INVESTIGATION

CALSPAN CASE NO. CA98-30

VEHICLE - 1995 MITSUBISHI MIRAGE

LOCATION - DELAWARE

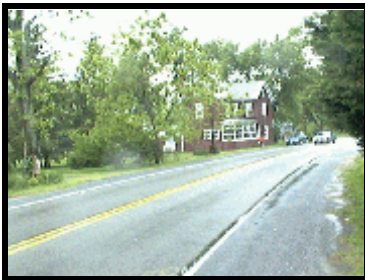
Figure 1: Northbound trajectory view 30 m (100 ft) from the POI.

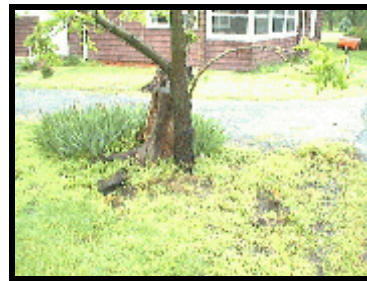
Figure 2: View of the POI and final rest of the vehicle.

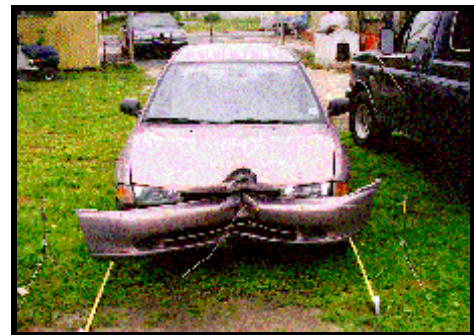
The damage to the Mitsubishi Mirage was localized to the front center section of the vehicle. The Mitsubishi sustained 21.6 cm (8.5 in) of direct contact damage to the center aspect of the vehicle's front bumper structure. The direct contact damage began 10.2 cm (4.0 in) left of center and ended 11.4 cm (4.5 in) right of center. The crush profile measured across the width of the bumper reinforcement was: $C_1=0$, $C_2=8.1$ cm (3.2 in), $C_3=22.9$ cm (9.0 in), $C_4=15.2$ cm (6.0 in), $C_5=0$, $C_6=0$. The field $L=137$ cm (54 in). The maximum crush of

Figure 3: Front view of the Mitsubishi.

33.0 cm (13.0 in) was located 6.4 cm (2.5 in) left of centerline. The impact damage extended rearward into the engine compartment deforming the upper and lower radiator supports. The hood was buckled and

deformed in the typical pattern. There was no measurable change in the wheelbase dimensions. The Collision Deformation Classification (CDC) of the vehicle was 12-FCEN-2. The delta V of the vehicle calculated by the barrier model of WINSMASH algorithm was 21.6 km/h (13.4 mph). **Figures 3 and 4** are front and right lateral views of the Mitsubishi respectively.

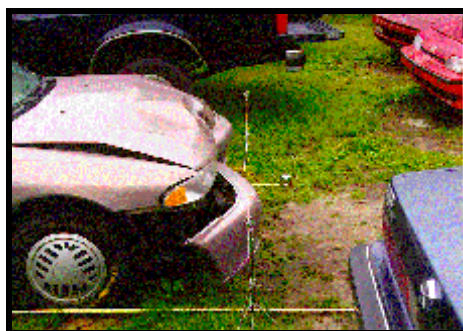
Figure 4: Right lateral view of the Mitsubishi.

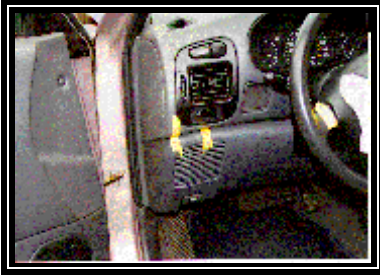
The left aspect of the driver's knee bolster, near the heater vent, exhibited contact from the driver's left knee. The bolster was displaced forward and cracked above the impact sight, **Figure 5**. There was no deformation to the steering wheel rim. However, the steering column exhibited indications of having been loaded. The trim panels forward of the steering wheel were displaced, **Figure 6**. The displacement of the steering column's shear plate measured approximately 5 mm (0.2 in) and 10 mm (0.5 in) on its outboard and inboard sides, respectively, **Figure 7**.

Figure 5: View of the driver's left knee contact.

Upon impact with the tree, the driver initiated a forward trajectory in response to the 12 o'clock direction of the impact. The driver's left knee contacted and cracked the knee bolster (**Figure 5**). The forward kinematic pattern positioned the driver within the deployment zone of the driver air bag. The deploying air bag contacted the driver's chest resulting in the right ventricle perforation, left pulmonary laceration, contusion and hemothorax and the thoracic contusions. The probable cause of the right 1st rib fracture was a rebound contact from the left arm of the right front passenger. The passenger's left arm was extended across the driver air bag module and fractured during the deployment. The arm then rebounded impacting the driver.

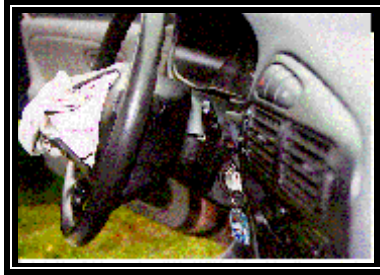
Figure 6: Right lateral view of the steering wheel.

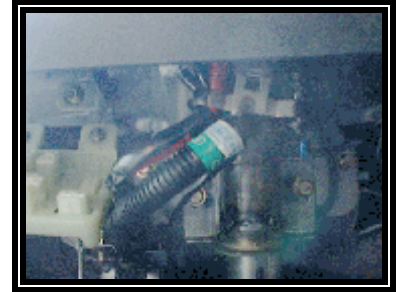
Figure 7: View of the steering column's shear plate.

The driver's forward trajectory and interaction with the deploying air bag loaded the steering column evidenced by the displacement of the shear capsules and deformation to the interior trim panels forward of the steering wheel rim. The displacement of the steering column's shear plate measured approximately 5 mm (0.2 in) and 10 mm (0.5 in) on its outboard and inboard sides, respectively, refer to **Figure 7**.

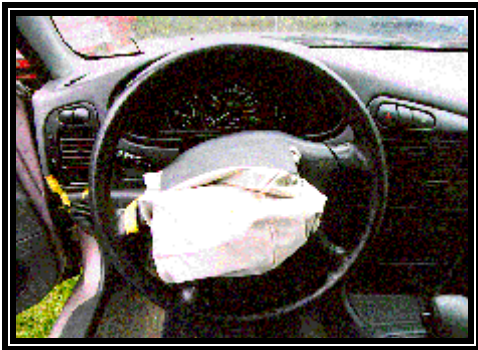
The driver air bag deployed as designed from the H-configuration module, **Figure 8**. The width of the vinyl cover flaps measured 16.0 cm (6.3 in) at the center seam. The height of the upper and lower flaps were 6.4 cm (2.5 in) and 5.8 cm (2.3 in), respectively. There was no contact evidence on the interior or exterior surfaces of the cover flaps.

Figure 8: View of the driver air bag module.

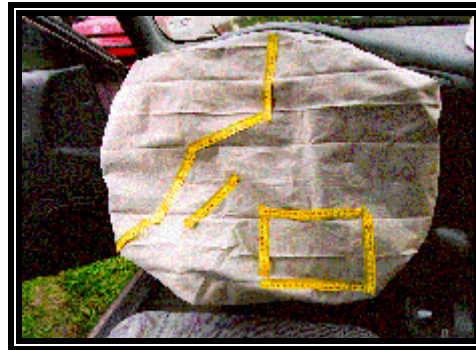
The driver air bag measured 66 cm (26 in) in its deflated state. The air bag was not tethered. The bag was vented by two 3.3 cm (1.3 in) diameter ports located in the 11/1 o'clock sectors on the back side of the bag. There were two distinct areas of occupant contact on the face of the air bag, **Figure 9**. The contact evidence consisted of cross-hatch abrasions caused by contact with the driver's prescription glasses. An area approximately 48 cm (19 in) by 23 cm (9 in) extended over the 8 to 12 o'clock sectors and a 15 cm x 10 cm (6 in x 4 in) area was noted in the right lower quadrant. The large abraded area in the upper left quadrant extended onto the back side of the bag. At inspection, the glasses were found on the left side of the instrument panel. It was noted that the metal frames of the glasses were bent and distorted. The lenses were intact. A bar code label was located in the 12 o'clock sector on the back side of the with the following designation:

Figure 9: View of the contact evidence on the air bag face.

The sudden deceleration of the chest caused the driver's head to rotate forward and into contact with the deploying air bag. The abrasions on the face of the air bag are indicative of the direct contact between the driver's glasses and the expanding air bag. The interaction between the expanding air bag and the driver's glasses coupled with the driver's forward kinematic pattern caused the periorbital ecchymosis and facial and head trauma.

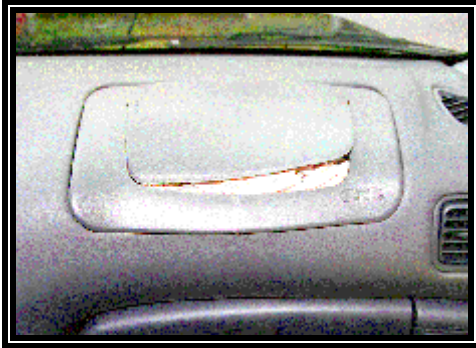
Figure 10 is a view of the top-mount front passenger air bag module. The exterior dimensions of the module measured 32.5 cm x 19.1 cm (12.8 in x 7.5 in) width by height. The single vinyl cover flap was hinged on the forward aspect of the module and measured 22.9 cm x 10.2 cm (9.0 in x 4.0 in). The front passenger air bag extended from the inflator 64 cm (25 in). The face of the air bag measured 58 cm x 51 cm (23 in x 20 in) width by height in its deflated state. The air bag was not tethered and was vented by two 6.4 cm (2.5 in) diameter vent ports located on the bag's side panels. A 20 square cm (8 sq in) area of fabric abrasion was noted on the face of the bag, **Figure 11**. This abrasion was probably caused by

Figure 10: View of the front passenger air bag module.

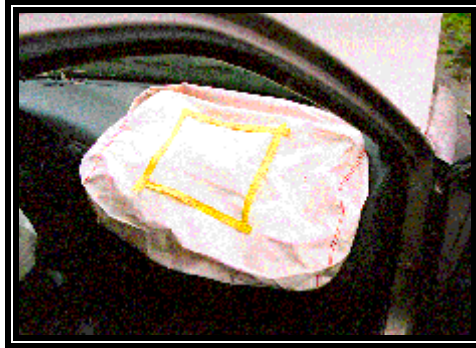
an interaction between the right front occupant and the fully expanded air bag. The following manufacturer's designation was located in the 12 o'clock sector of the bag:

Figure 11: Front passenger air bag.
