ON-SITE CHILD AIR BAG-RELATED FATALITY INVESTIGATION

CASE NUMBER - IN98-030
LOCATION - ARKANSAS
VEHICLE - 1998 DODGE RAM 1500
CRASH DATE - November, 1998

1. <i>Report No.</i> IN98-030		2. <i>Government Accession No.</i>		3. <i>Recipient's Catalog No.</i>	
4. <i>Title and Subtitle</i> On-Site Child Air Bag-Related Fatality Investigation Vehicle - 1998 Dodge Ram 1500 Location - Arkansas			5. <i>Report Date:</i> January 30, 2003

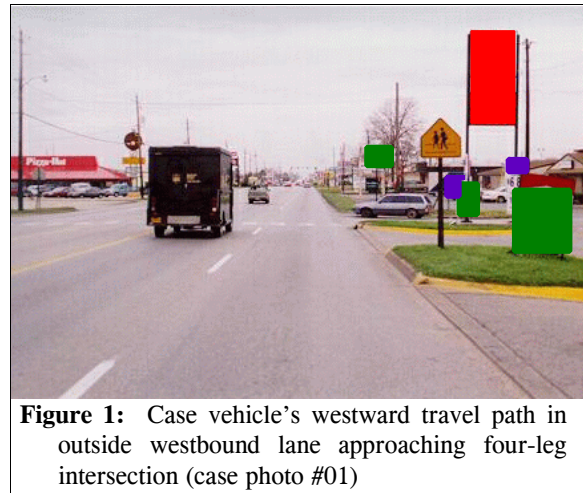
Figure 1: Case vehicle's westward travel path in outside westbound lane approaching four-leg intersection (case photo #01)

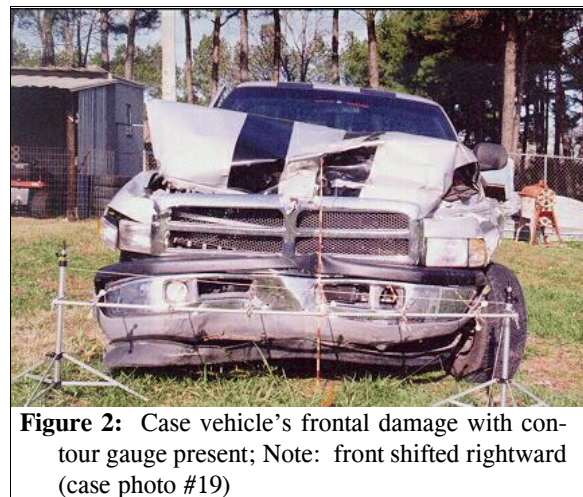
Figure 2: Case vehicle's frontal damage with contour gauge present; Note: front shifted rightward (case photo #19)

The case vehicle's initial contact with the Dodge minivan involved the entire front (**Figure 2** above and **Figure 9** below). Direct damage extended from bumper corner to bumper corner, a measured distance of 161 centimeters (63.4 inches). Residual maximum crush was measured

as 41 centimeters (16.1 inches) at C₃. The front bumper fascia, grille, hood, and radiator were crushed rearward. The case vehicle's front end was shifted to the right approximately 10 centimeters (3.9 inches). The side slap contact was located at the crease of the driver's door just below the "A"-pillar. The direct damage width was 31 centimeters (12.2 inches) and the field L was 32 centimeters (12.6 inches). The case vehicle's third and final impact also involved the front bumper. Because the case vehicle's impact with the Ford was so minor, the exact location could not be distinguished along the front bumper (Figure 6 above). Based on the inspection of the Ford, there was no deformation to the case vehicle's front from its impact with the Ford. The case vehicle's wheelbase was unaltered from the crash. None of the case vehicle's tires were damaged, deflated, or physically restricted. Both the right and left headlight and turn signal assemblies sustained induced damage as well as both the right and left fenders.

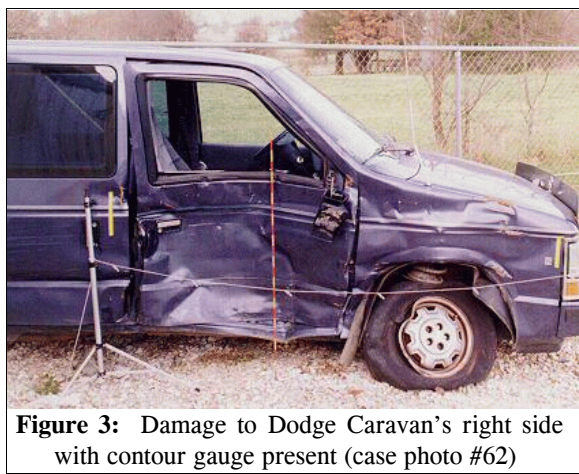
Figure 3: Damage to Dodge Caravan's right side with contour gauge present (case photo #62)

The front of the case vehicle (**Figure 2** above) impacted the right front of the Dodge minivan (**Figures 3** and **4**) causing the case vehicle's driver and front right passenger supplemental restraints (air bags) to deploy. After the initial impact the case vehicle and the Dodge minivan side slapped, with the right rear corner of the Dodge minivan impacting the case vehicle's driver door. Both vehicles were redirected in a northwesterly direction. The case vehicle subsequently traveled northwestward and impacted the front left bumper corner of the Ford with its front bumper (**Figure 5** and **Figures 6** and **7** below). The case vehicle came to rest heading north-northwest. The Dodge minivan was redirected in a westerly direction, traversed a curb, and came to rest approximately 22 meters (73 feet) from its initial impact with the case vehicle, heading west in a parking lot (**Figure 8** below). The Ford was nudged slightly westward and came to rest near its original pre-crash position.

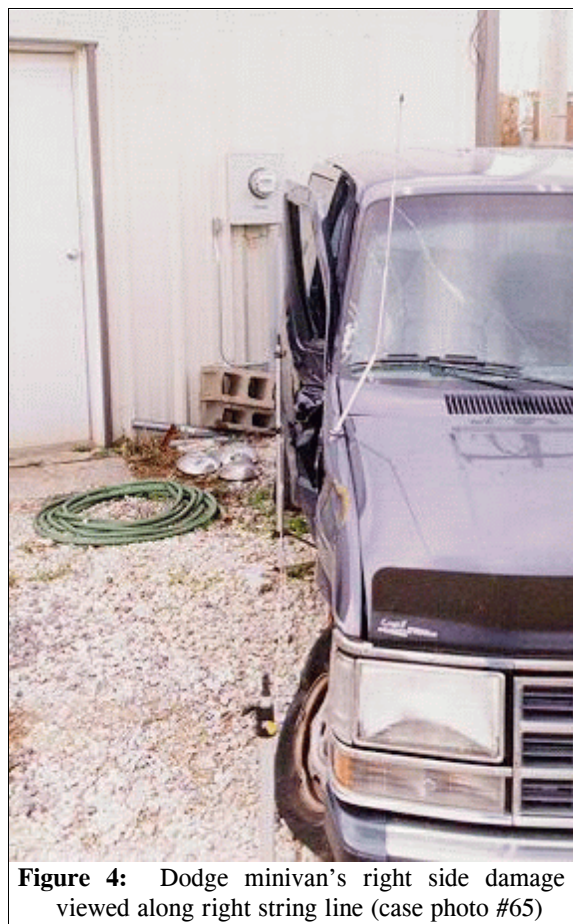
Figure 4: Dodge minivan's right side damage viewed along right string line (case photo #65)

The 1990 Dodge Caravan SE was a front wheel drive, seven-passenger, three-door minivan (VIN: 2B4FK4531LR-----) equipped with a 3.0L, V-6 engine. Based on the vehicle inspection, the CDC for the Dodge minivan was determined to be: **2-RYEW-3** [maximum crush was 27 centimeters (10.6 inches)]. The WinSMASH reconstruction program, damage only algorithm, was used on the Dodge’s highest severity impact. The Total, Longitudinal, and Lateral Delta Vs are, respectively: 31.4 km.p.h. (19.5 m.p.h.), -10.7 km.p.h. (-6.6 m.p.h.), and -29.5 km.p.h. (-18.3 m.p.h.). The Dodge minivan was towed due to damage.

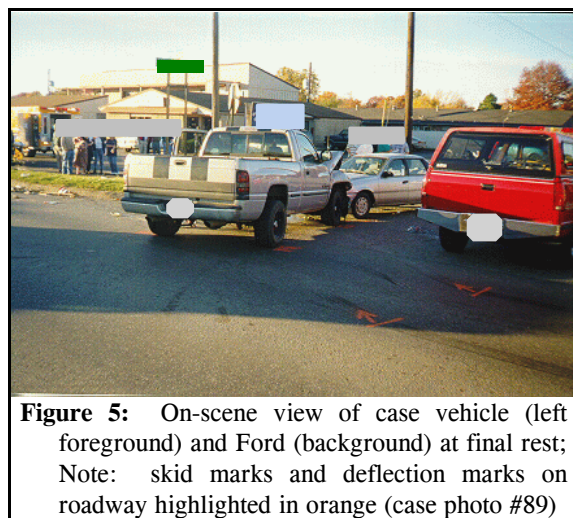
The case vehicle's driver locked up the brakes and then tried steering to the right, attempting to avoid the crash. The Police Crash Report recorded 17.7 meters (58 feet) of skid marks from the case vehicle's front right tire. The crash occurred in the four-leg intersection of the two roadways; see **CRASH DIAGRAM** below.

Figure 5: On-scene view of case vehicle (left foreground) and Ford (background) at final rest; Note: skid marks and deflection marks on roadway highlighted in orange (case photo #89)

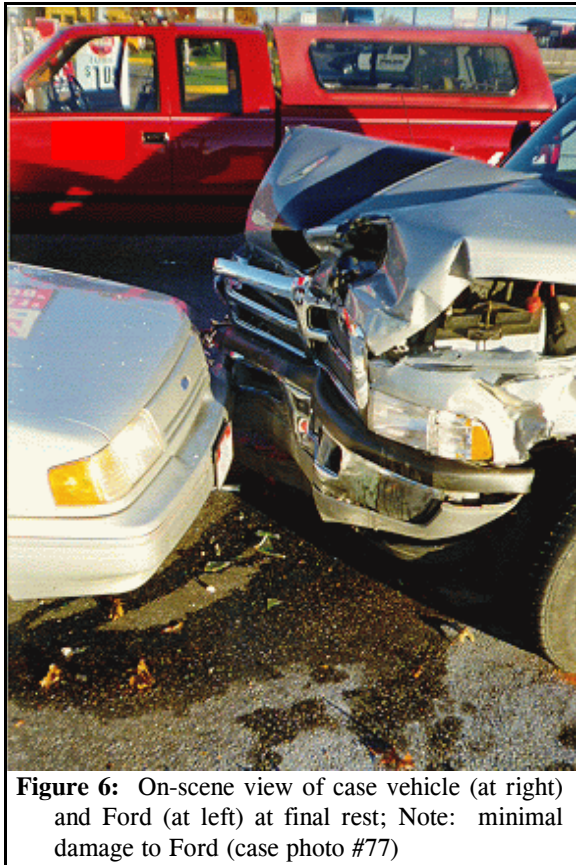
Figure 6: On-scene view of case vehicle (at right) and Ford (at left) at final rest; Note: minimal damage to Ford (case photo #77)

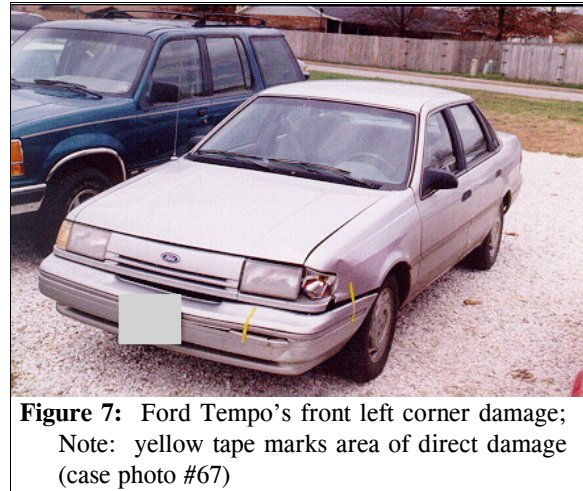
Figure 7: Ford Tempo's front left corner damage; Note: yellow tape marks area of direct damage (case photo #67)

The 1993 Ford Tempo GL is a front wheel drive, six-passenger, four-door sedan (VIN: 2FAPP36XXPB-----) equipped with a 2.3L, I-4 engine. Based on the vehicle inspection, the CDC for the Ford's sole impact was determined to be **11-FLEE-1** [maximum crush was 1 centimeter (0.4 inches)]. The Ford was driven from the scene.

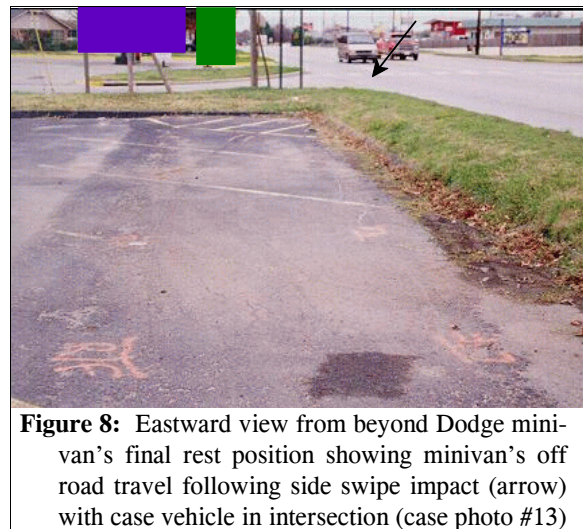
Figure 8: Eastward view from beyond Dodge minivan's final rest position showing minivan's off road travel following side swipe impact (arrow) with case vehicle in intersection (case photo #13)

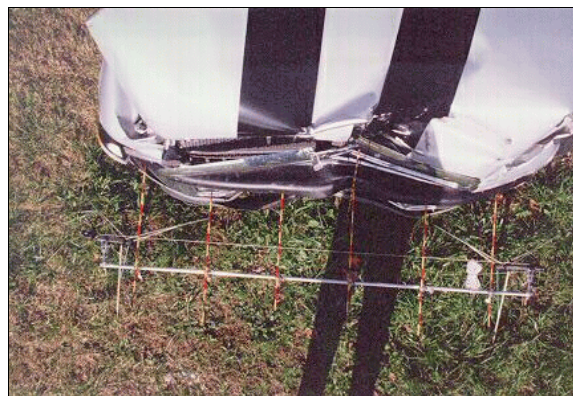
Based on the vehicle inspection, the CDC for the case vehicle's primary impact with the Dodge minivan was determined to be: **71-FDEW-2 (340)**. The CDC for the side slap impact was determined to be: **09-LPEN-1**. The WinSMASH reconstruction program, damage only algorithm, was used on the case vehicle's highest severity impact. The Total, Longitudinal, and Lateral Delta Vs are, respectively: 29.3 km.p.h. (18.2 m.p.h.), -27.5 km.p.h. (-17.1 m.p.h.), and +10.0 km.p.h. (+6.2 m.p.h.). The case vehicle was towed due to damage.

Figure 9: Overhead view of case vehicle's frontal deformation with contour gauge present (case photo #21)

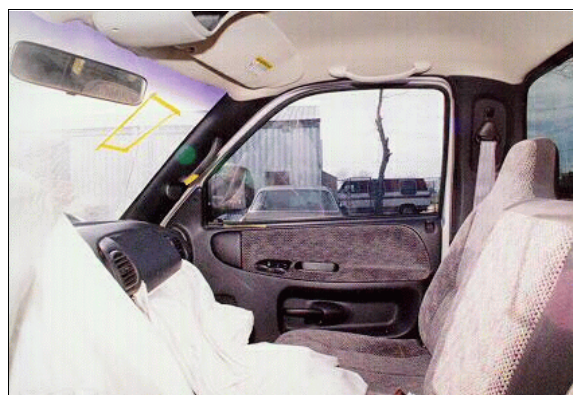
Inspection of the case vehicle's interior revealed evidence of occupant contact (i.e., a scuff) to the glove box door from contact with the front right passenger's knees, and there was a small hand imprint to the windshield's glazing possibly from the front right passenger contacting it before he was redirected backwards by the deploying air bag (Figure 10). Furthermore, there was a long scuff towards the bottom of the front right door panel and a brush abrasion to the right front door sill. Finally, there was no evidence of compression of the energy absorbing shear capsules in the base of the steering column and no deformation to the steering wheel rim.

Figure 10: Case vehicle's front seating area showing deployed front air bags and contact evidence on right windshield's glazing and right front door sill (case photo #44)

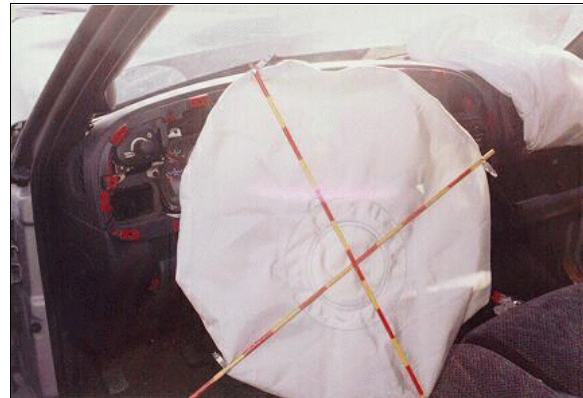
as a result of the frontal impact with the Dodge minivan. The case vehicle's driver air bag was located in the steering wheel hub. The module cover consisted of asymmetrical "H"-configuration cover flaps made of thick vinyl with overall dimensions of 14 centimeters (5.5 inches) at the horizontal seam and 10.5 centimeters (4.1 inches) vertically for the upper flap and 3 centimeters (1.2 inches) vertically for the lower flap. An inspection of the air bag module's cover flaps and air bag revealed that the cover flaps opened at the designated tear points, and there was no evidence of damage during the deployment to the air bag or the cover flaps. The driver's air bag was designed with three tethers, each approximately 8 centimeters (3.1 inches) in width. The driver's air bag had one vent port, approximately 3.5 centimeters (1.4 inches) in diameter, located at the 12 o'clock position. The deployed driver's air bag was round with a diameter of 59 centimeters (23.2 inches). An inspection of the driver's air bag fabric revealed no contact evidence readily apparent on the air bag's fabric (**Figure 11**).

Figure 11: Case vehicle's deployed driver air bag showing no obvious evidence of occupant contact (case photo #37)

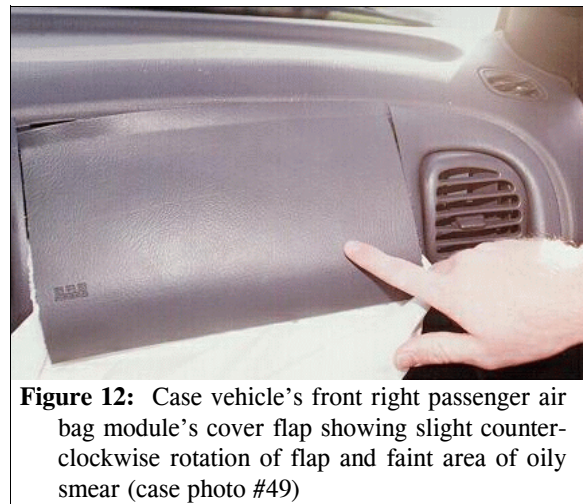
The front right passenger's air bag was located in the middle of the instrument panel. There was a single, essentially rectangular, modular cover flap. The cover flap was made of a thick vinyl over a thin cardboard type frame. The flap's dimensions were 28 centimeters (11.0 inches) at the lower horizontal seam and 19 centimeters (7.5 inches) along both vertical seams. The profile of the case vehicle's instrument panel was flush with the leading edge of the cover flap. An inspection of the front right air bag module's cover flap and air bag revealed that the cover flap opened at the designated tear points, and there was no evidence of damage during the deployment to the air bag's fabric. The top left corner of the cover flap was torn during the deployment causing the cover flap to be shifted slightly counterclockwise, and there was an unknown (i.e., source) area of oily transfer on the front right of the cover flap (**Figure 12**). The oily transfer was approximately 11 x 6 centimeters (4.3 x 2.4 inches) in size and started at the leading edge of the cover flap. The front right occupant's available medical records do not indicated that there was contact between this occupant and the cover flap. The front right passenger's air bag was designed without any tethers. The front right air bag had no vent ports. The deployed front right air bag was rectangular with a height of approximately 45 centimeters (17.7 inches) and a width of approximately 90 centimeters (35.4 inches). An inspection of the front right passenger's air bag fabric revealed skin evidence on the top and front surfaces along with a substantial amount of red/burgundy cloth transfer on the top, front, right side, and bottom surfaces of the air bag. The examination also revealed some black scuffs from the underside of the cover flap to the left of the

Figure 12: Case vehicle's front right passenger air bag module's cover flap showing slight counterclockwise rotation of flap and faint area of oily smear (case photo #49)

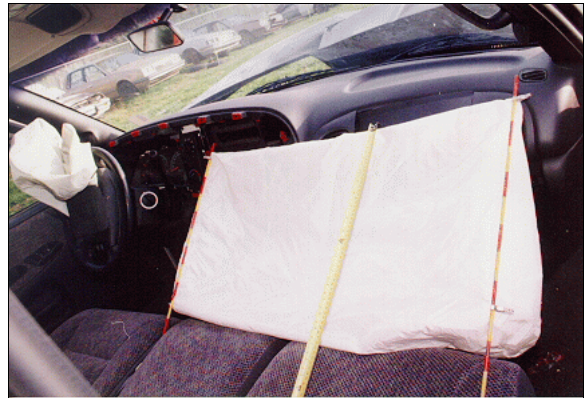
skin transfer on the top surface. The skin transfer to the top surface was approximately 26 centimeters (10.2 inches) wide and started approximately 9 centimeters (3.5 inches) down from the instrument panel and extended downwards onto the front surface an additional 38 centimeters (15.0 inches). The skin transfer on the front surface was 21 centimeters (8.3 inches) wide and started 8 centimeters (3.1 inches) in from the right edge (**Figure 13**).

Figure 13: Front surface of case vehicle's deployed front right passenger air bag; Note: a large area of faint skin transfer is present (but not visible) in the upper right portion (case photo #47)

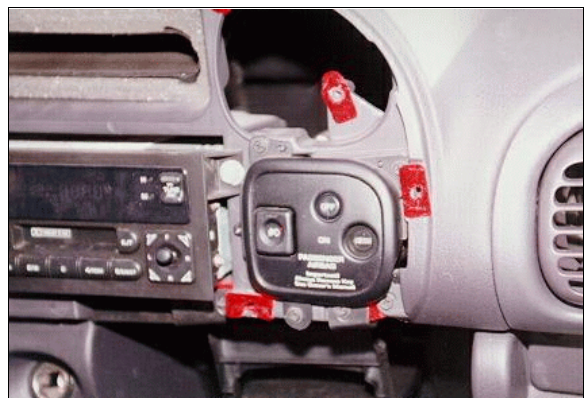
The case vehicle was equipped with an on/off switch for the front right passenger air bag. According to the owners manual when the key slot is turned to the vertical position (12–6 o'clock) the air bag is shut off and a circular light near the switch is illuminated. When the key slot is turned counterclockwise so it is in the lateral position (9–3 o'clock), the air bag is on and the light near the switch will be off. Based on this contractor's visual inspection, the key slot was turned to the lateral or **ON** position (**Figure 14**).

Figure 14: Case vehicle's "On/Off" switch controlling front right passenger's air bag; Note: switch was in **ON** position (case photo #42)

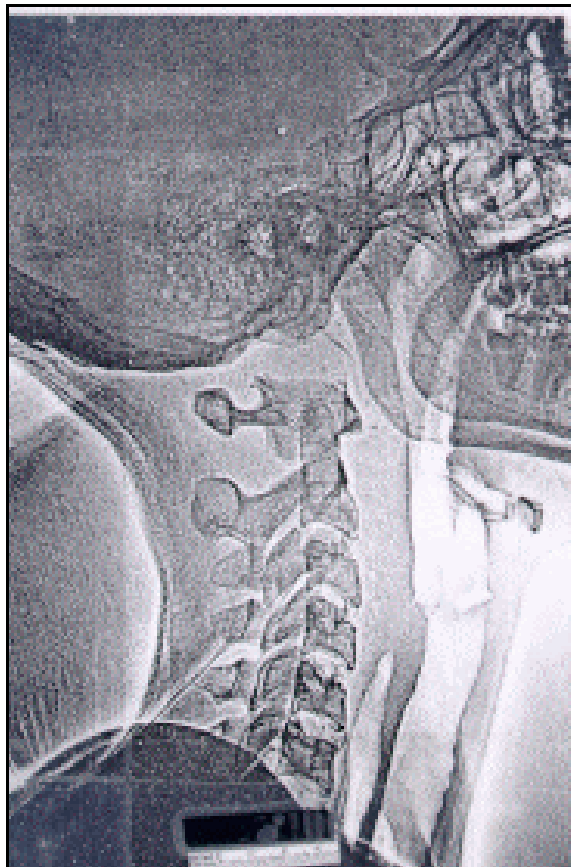
In neck injuries, the most common fatal injuries are upper cervical fractures or dislocation at the atlanto-occipital junction (Figure 9.4). This can result in either complete transection or crushing of the cord. In other instances, the cord is violently pulled down, with partial or complete avulsion of the brain stem, ventrally at the ponto-medullary junction.

Figure 9.4: Fracture-dislocation of neck at atlanto-occipital joint
