CALSPAN LIMITED ON-SITE REDESIGNED AIR BAG INVESTIGATION
CALSPAN CASE NO. CA98-031
VEHICLE: 1998 JEEP GRAND CHEROKEE
LOCATION: NEW YORK
CRASH DATE: MAY 1998

Contract No.
DTNH22-94-D-07058

CALSPAN LIMITED ON-SITE REDESIGNED AIR BAG INVESTIGATION
CALSPAN CASE NO. CA98-031
VEHICLE: 1998 JEEP GRAND CHEROKEE
LOCATION: STATE OF NEW YORK
CRASH DATE: MAY 1998

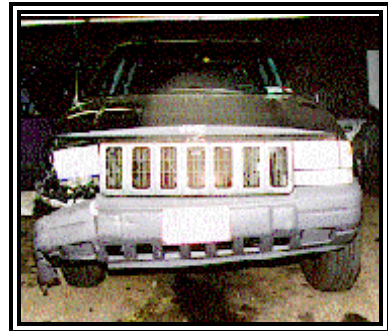
Figure 1. Front right damage to the Jeep Cherokee.

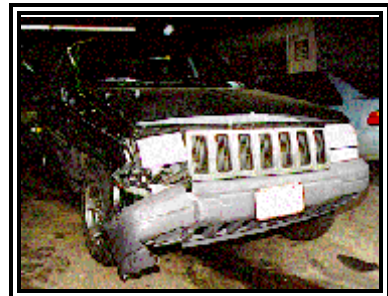
The left turn-across-path crash resulted in front right damage to the Cherokee. The direct contact damage began 27.9 cm (11.0 in) right of center on the bumper fascia and extended 43.2 cm (17.0 in) to the right corner. The vehicle was dismantled at the time of this SCI inspection, therefore maximum crush was estimated at 10 cm (4 in), located at the front right corner. Damaged components included the front bumper fascia, reinforcement bar, front right head lamp assembly, right front fender, and the right front frame rail. The damage profile is documented in **Figure 2**. The Collision Deformation Classification (CDC) for this impact sequence was 12-FZEW-1.

Figure 2. Front right three-quarter view of the damage to the Grand Cherokee.

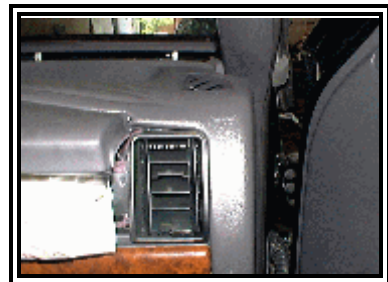
Figure 3. Displaced vent louver fins.

Both frontal air bags deployed as designed from the respective module assemblies. The front right air bag expanded against the right door panel which deposited membrane transfers onto the right door panel. Several areas of vinyl transfers were noted to the bag from expansion within the module assembly. The deployment of the front right passenger air bag resulted in deflection of the right mid instrument panel with displacement of the right vent louver fins (**Figure 3**). There were no tears or damage to the deployed air bag membranes.

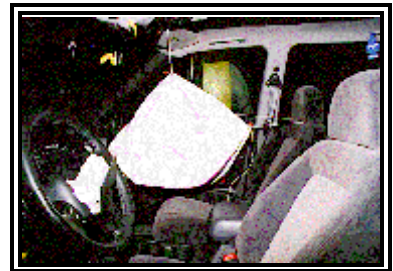
The 1998 Jeep Cherokee was equipped with a Supplemental Restraint System (SRS) that consisted of a single-point sensing system and frontal air bags for the driver and right passenger positions (**Figure 4**). The front left (driver) air bag was identified by Chrysler as a redesigned air bag while the front passenger air bag remained as a full power module. The driver module was housed in a conventional configuration in the steering assembly while the front right air bag was mounted in the mid right instrument panel. Both air bags deployed as a result of the vehicle's front right corner impact sequence with the Ford Escort. The front left (driver) air bag deployed from asymmetrical H-configuration module cover flaps. The upper flap had a maximum width of 15 cm (6 in) at the horizontal tear seam and a height of 3.6 cm (1.4 in). The lower aspect of the flap shared the same width as the upper flap with a height of 8.9 cm (3.5 in) in height. There was no contact evidence or damage to the cover flaps.

Figure 4. Left lateral view of the Cherokee's passenger compartment and deployment of the frontal air bag system.

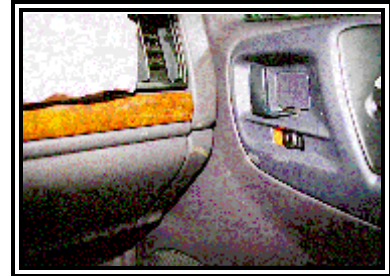
The front right module cover flap measured 36.5 cm (14.4 in) in width and 10.5 cm (4.1 in) in height. There was no damage to the module cover flap. The face of the front right air bag had a measured seam-to-seam width of 45.0 cm (17.7 in) and height of 57 cm (22.4 in). The top surface of the air bag exhibited a gray vinyl transfer that resulted from expansion within the module assembly and against the cover flap. Another gray vinyl transfer was located on the right side of the air bag and resulted from contact with the forward aspect of the front right door and the right most portion of the upper instrument panel area. The transfer began 18 cm (7 in) below the juncture of the top and right air bag seam and 9 cm (3.5 in) forward (with respect to the vehicle) of the right air bag seam. It measured 17.0 cm (6.7 in) in length and 2.5 cm (1.0 in) in width. Air bag fiber transfers were located on the forward most aspect of the right front door (Figure 5). Bag deployment displaced the fins of the right vent louver.

Figure 5. Air bag transfers located on the right front door and right instrument panel area.

The air bag was not tethered and had a maximum rearward excursion of 79 cm (31 in) from the inflator unit (Figure 5). Exhaust residue from the air bag gases was deposited on the right A-pillar.

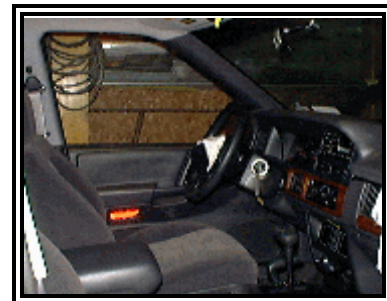
The 17 year old female driver of the rented Jeep Grand Cherokee was seated in a mid track position with the back rest slightly reclined (**Figure 7**). At the time of the SCI inspection of the Cherokee, the seat back angle was reclined to 30 degrees. Although there was no loading evidence on the manual belt system, the driver alleged she was properly restrained by the 3-point lap and shoulder belt system with the D-ring adjusted to the top (full-up) position.

Figure 7. Profile view of the driver's seated position with respect to the steering assembly and the deployed redesigned front left air bag.

At impact, she responded to the 1 o'clock impact force by moving forward and laterally to the right. She loaded the manual belt system which allowed her head to flex forward into the deployed redesigned front left air bag. The flexion motion of the head resulted in her complaint of cervical pain. The driver's left knee contacted the protruding aspect of the knee bolster at the base of the steering column. A scuff mark evidence the contact point. No injury occurred from the knee loading.
