**CALSPAN ON-SITE REAR FACING CHILD SAFETY SEAT/AIR BAG DEPLOYMENT
FATALITY INVESTIGATION**

CALSPAN CASE NO. CA98-34

VEHICLE - 1997 FORD F150 PICK-UP

LOCATION - OHIO

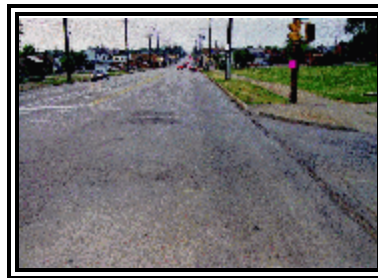
Figure 2: Northbound view of the area of impact.

The driver of the Ford F150 reacted to the Ford Ranger by steering counterclockwise and braking. The area of impact (**Figure 2**) was identified by a 4 m (13 ft) skid mark directed northwestward. The skid mark began at the point of impact. The skid mark was attributed the right front tire of the F150 and defined its post-impact trajectory. Two 1.5 m (5 ft) long gouge marks directed northeastward were also identified at the scene. The gouge marks were attributed to contact from the left front suspension of the Ford Ranger during its post-impact travel.

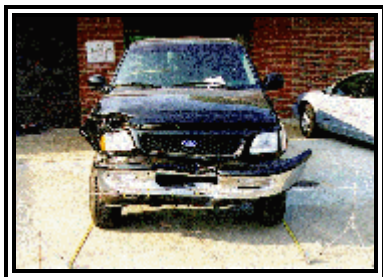
The Ford F150 sustained 114.3 cm (45.0 in) of direct contact damage to the center and right portions of the front plane (**Figures 3 and 4**). The direct contact began 24.1 cm (9.5 in) left of center and continued to the front right bumper corner. The measured crush profile at the elevation of the front bumper, across the 114.3 cm (45.0 in) field L, was as follows: C1=10.2 cm (4.0 in), C2=19.8 cm (7.8 in), C3=10.2 cm (4.0 in), C4=5.1 cm (2.0 in), C5=3.8 cm (1.5 in), C6=7.6 cm (3.0 in). The right front fender was buckled restricting the operation of the right door. There was no measurable change in the wheelbase dimensions. The Ford sustained disabling damage and was towed to the police impound post-crash. However, the vehicle was still operational, as it was started and driven out of the garage bay at the SCI inspection. The Collision Deformation Classification (CDC) of the vehicle was 12-FZEW-01. The barrier equivalent delta V calculated by the WINSMASH model was 16.1 km/h (10.0 mph)

Figure 3: Front view of the Ford F150.

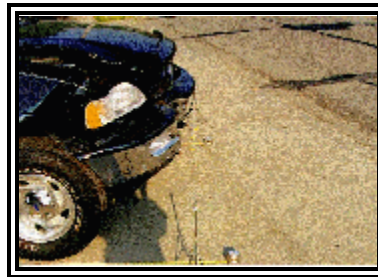
Figure 4: Right lateral view across the front plane.

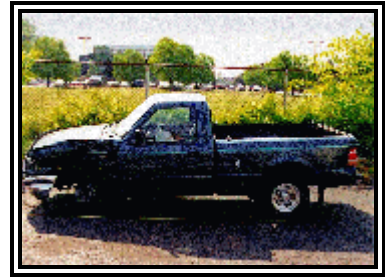
The Ford Ranger sustained 127.5 cm (49.5 in) of direct contact damage to the forward portion of the left side plane (**Figure 5**). The direct contact damage began 221 cm (87 in) forward of the left rear axle and continued to the left front bumper corner. The impact was approximately centered on the left front suspension and displaced the tire and rim from the axle. The measured crush profile at the trim elevation was as follows: C1=0, C2=12.7 cm (5.0 in), C3=22.9 cm (9.0 in), C4=20.9 cm (8.2 in), C5=17.5 cm (6.9 in), C6=5.1 cm (2.0 in). The Ranger's entire front structure was displaced laterally (slightly) to the right restricting the operation of the right door. The CDC of the Ranger was 09-LFEW-03.

Figure 5: Left side view of the Ford Ranger.

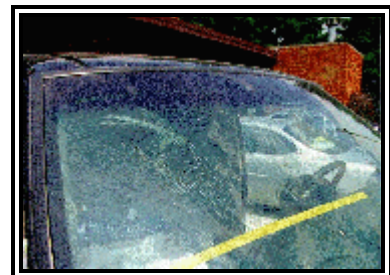
A fracture of the right aspect of the windshield was located 16.5 cm (6.5 in) left of the A pillar and 28 cm (11 in) below the header (**Figure 6**). Surrounding the fracture site was an area of air bag fabric transfers that measured approximately 48 cm x 38 cm (19 in x 15 in), width by height. The windshield fracture resulted from the altered deployment path of the front passenger air bag due to the placement of the rear facing child seat in the front right of the vehicle.

Figure 6: View of the windshield fracture and air bag fabric transfers.

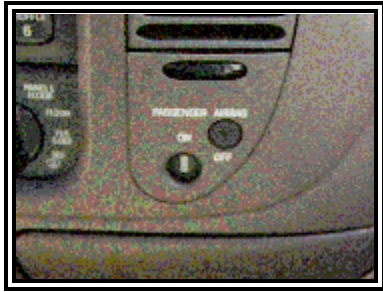
The Ford F150 was equipped with a Supplemental Restraint System that consisted of driver and front passenger air bags that deployed as a result of the crash. The SRS utilized a cut-off switch that could disable deployment of the front passenger air bag. The switch was in the ON position at the time of the crash documented by the on-scene police photographs (**Figure 8**). The front passenger air bag is active with the switch in this position and the indicator light is dark. During the course of the SCI inspection, the ignition key was used to place the cut-off switch in the OFF position (**Figure 9**). In this position the front passenger air bag is disabled and the indicator is illuminated. Visual inspection of the illuminated light indicated the switch functioned properly.

Figure 8: View of the air bag cut-off switch in the ON position.

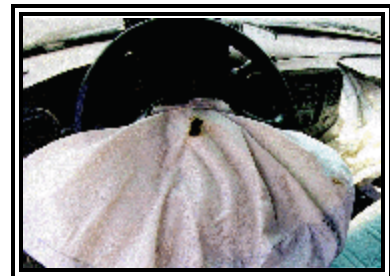
The back side of the driver's air bag was scuffed in all four quadrants indicative of an impeded deployment due to the forward position of the unrestrained driver. The shape of the scuff marks matched to the configuration of the flaps. A 3.8 cm (1.5 in) diameter burn hole was noted in the 12 o'clock sector on the back side of the bag, **Figure 10**. This hole was caused due to post-crash contact between the hot inflator and the deflating air bag membrane.

Figure 10: View of a hole in the driver air bag 12 o'clock sector.

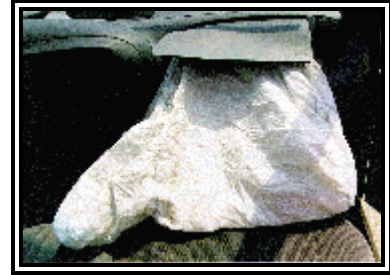
The front passenger air bag was configured in a mid-mount module on the right side of the instrument panel. The air bag module cover consisted of a single top hinged flap that measured 39.4 cm x 16.5 cm (15.5 in x 6.5 in), width by height. The front passenger air bag (**Figure 11**) was L shaped. The extension of the air bag membrane toward the center of the vehicle would provide protection for a center occupant. The

Figure 11: View of the front passenger air bag.

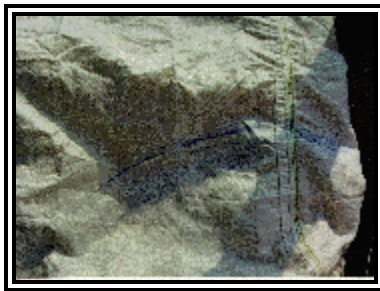
Contact evidence of the face of the air bag consisted of a large blue fabric transfer (**Figure 12**). The transfer was attributed to contact with the restraint harness that extended from the back of the child seat. The blue transfer measured approximately 5 cm (2 in) in width and 38 cm (15 in) in length on the face of the air bag. The transfer extended 23 cm (9 in) further onto the outboard surface of the bag and tapered to 10 cm (4 in) in width. On the bottom surface of the bag were 3 holes in the bag fabric (**Figure 13**). The holes measured 8.9 cm x 3.8 cm (3.5 in x 1.5 in), 8.9 cm x 1.3 cm (3.5 in x 0.5 in) and 1.3 cm (0.5 in) in diameter, inboard to outboard respectively. There was also a 8.9 cm x 3.8 cm (3.5 in x 1.5 in) hole on the lower aspect of the outboard side panel. The air bag fabric was holed when it became snagged on the fractured carrier handle and back of the child seat, in the deployment sequence.

Figure 12: View of blue fabric transfers on the face of the PAB.

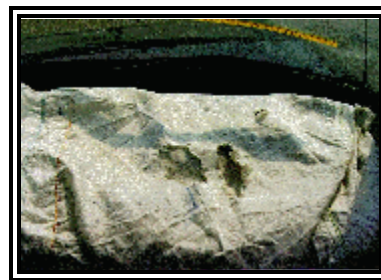
Figure 13: View of holes in the bottom surface of the PAB.

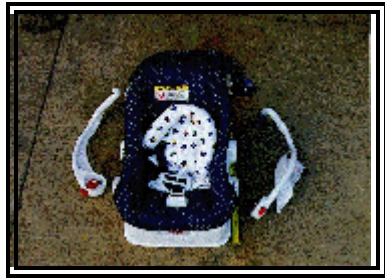
The deployment of the front passenger air bag fractured the U-shaped carrier handle (**Figure 14**). The left section of the fractured handle was then displaced into the right side interior evidenced by the aforementioned interior contacts. Gray vinyl transfers on the mid and lower aspects of the carrier handle related to these contacts. A 16.5 cm x 21.6 cm (6.5 in x 8.5 in) area of the upper left aspect

Figure 14: View of the Evenflo rear facing child seat.

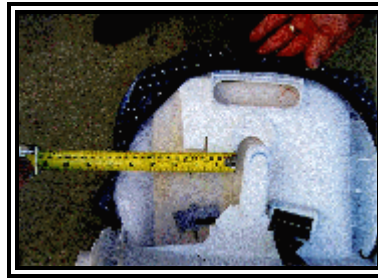
of the car seat's seat back was also fractured in the deployment (**Figure 15**). The location of the seat back fractured corresponded to the location of the child's head injury.

Figure 15: View of the fractured back of the child seat.

At impact and deployment of the air bag, the infant's head was positioned adjacent to the location of the RFCSS's fractured shell. The fractured shell and expanding air bag impacted the left posterior aspect of the infant's skull. This impact coupled with the rapid acceleration of the infant's head resulted in skull fracture and massive brain injuries. As the RFCSS rotated rearward, the infant was then displaced rearward with respect to the vehicle and contacted the vehicle's right front seat back. The abrasions and contusions to the forehead and scalp were a result of this kinematic pattern. The child then rebounded back into the RFCSS where he was found.

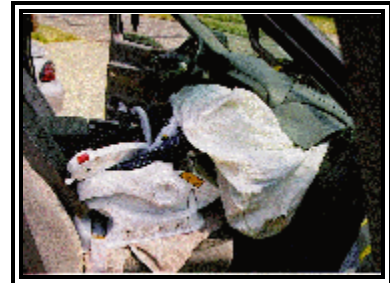
During the course of the SCI inspection, the approximate position of the restraint within the vehicle at the time of the crash was reconstructed. The position of the vehicle's seat and the rear facing restraint was determined through the use of the on-scene police photographs. The horizontal distance between the back of the car seat and the lower edge of the front passenger air bag module measured 30 cm (12 in). **Figure 16** is a view of the car seat with the front passenger air bag extended rearward.

Figure 16: View of the reconstructed at-crash position of the child seat.
