ON-SITE REDESIGNED AIR BAG CHILD FATALITY INVESTIGATION

CALSPAN CASE NO: CA98-038

VEHICLE: 1998 PLYMOUTH NEON

CRASH DATE: JULY, 1998

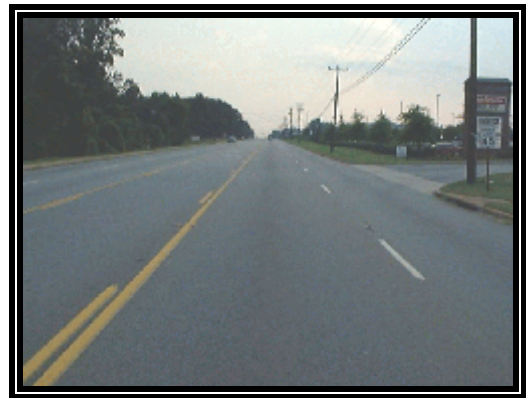
Figure 1: Westbound trajectory view of the crash scene.

intersection. **Figure 1** is a westbound trajectory view approximately 30 m (100 ft) east of the point of impact. The speed limit in the area of the crash was 72 km/h (45 mph).

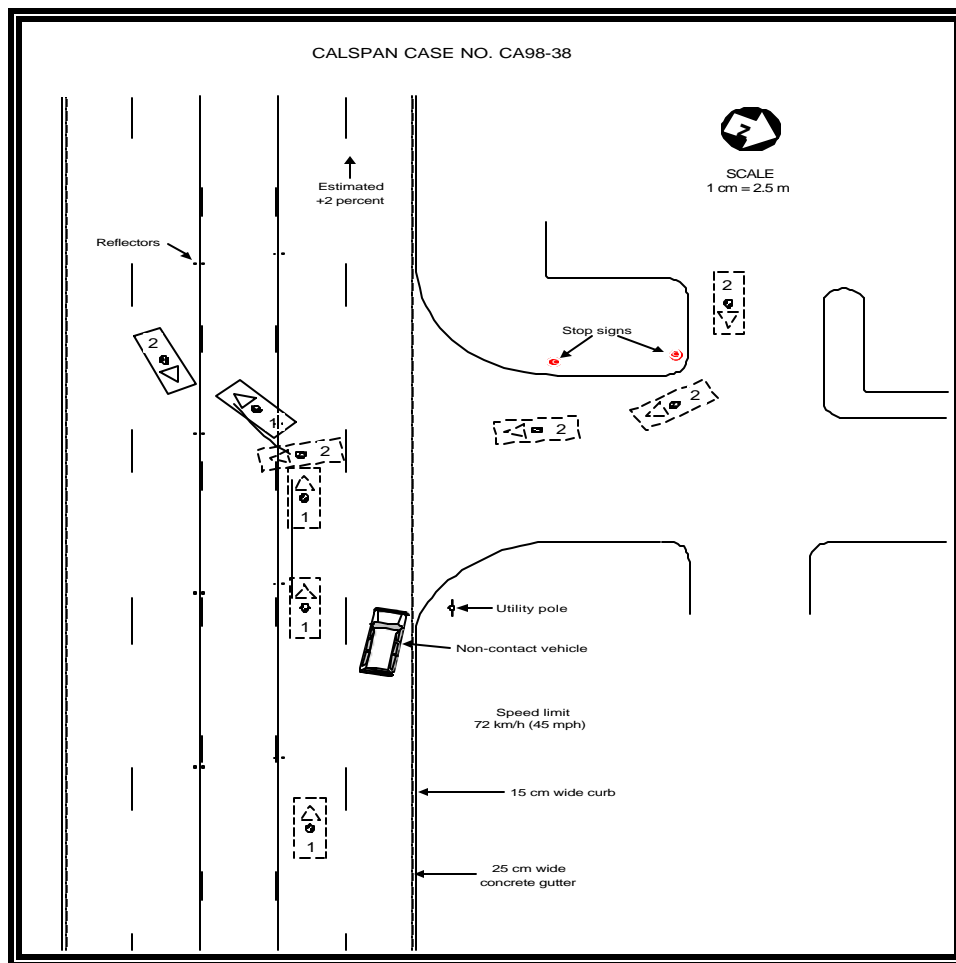
The 1998 Plymouth Neon was a rental vehicle driven by a 22 year old female. The Plymouth was traveling west in the in-board lane of the roadway, passing in front of a shopping center/restaurant and was occupied by 10 unrestrained individuals (driver included). **Figure 2** is a view of the crash schematic. The 1988 Chevrolet S-10 pick-up, driven by a 16 year old male, exited south from the private road's center lane, directly into the path of the Plymouth. The driver of the Plymouth Neon braked prior to the crash evidenced by a 8.6 m (28.2 ft) skid mark. The skid mark was identified during the inspection of the crash scene and was attributed to the left front tire of the Neon. The skid mark was located in the inboard westbound lane and ended at the point of impact.

Figure 2: View of the crash schematic.

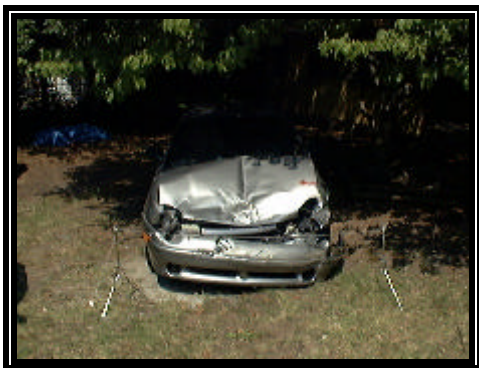
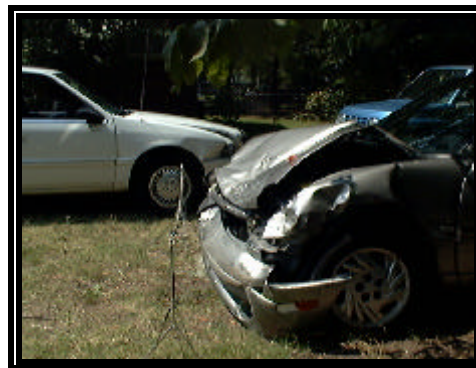
The Plymouth Neon sustained direct contact damage across the full 145 cm (57 in) frontal width of the vehicle. The damage was weighted more heavily to the vehicle's left side due to the lateral momentum of the pick-up. The measured crush profile was as follows: C1=21.1 cm (8.3 in), C2=21.6 cm (8.5 in), C3=14.5 cm (5.7 in), C4=9.4 cm (3.7 in), C5=6.9 cm (2.7 in), C6=3.8 cm (1.5 in). The Collision Deformation Classification (CDC) was 01-FDEW-1. The left front fender buckled rearward and slightly restricted the opening of the left front door. The forward aspect of the damaged left front inner fender was in contact with the left front tire. The left side wheelbase was foreshortened approximately 2.5 cm (1.0 in). The right side wheelbase dimension was unchanged. The hood buckled in the typical manner. All the doors were operational upon inspection and all window glazings were in-tact. A single fracture was located on the right side of the windshield. The fracture was linked to the altered deployment of the front right passenger air bag. The total Delta V calculated by the Damage Only Algorithm of the WINSMASH program was 28.3 km/h (17.6 mph). The longitudinal and lateral components were -27.3 km/h (-17.0 mph) and -7.3 km/h (-4.5 mph), respectively. The barrier equivalent speed was 20.7 km/h (12.9 mph). **Figures 3 and 4** are front and left lateral views of the Plymouth Neon.

Figure 3: Front view of the 1998 Plymouth Neon.

Figure 4: Left lateral view across the front plane of the Neon.

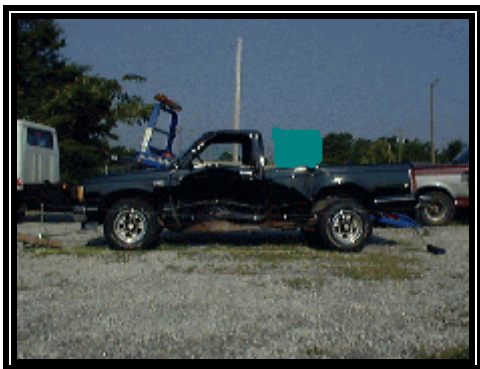
The Chevrolet S-10 pick-up sustained 186.7 cm (73.5 in) of direct contact damage to the vehicle's left plane, **Figure 5**. The damage began 35.8 cm (14.1 in) forward of the left rear axle and extended forward to the leading edge of the left door. The measured crush profile of the vehicle was as follows: C1=24.1 cm (9.5 in), C2=27.3 cm (10.8 in), C3=33.0 cm (13.0 in), C4=43.2 cm (17.0 in), C5=32.4 cm (12.8 in), C6=10.4 cm (4.1 in). The maximum lateral deformation, located 11.4 cm (4.5 in) forward of C4 (166.9 cm (65.7 in) forward of the left rear axle), measured 48.3 cm (19.0 in). The impact bent the left frame rail of the pick-up, **Figure 6**. The left wheelbase was foreshortened 3.0 cm (1.2 in). Both doors were jammed shut. The left window glazing was shattered. The cab was shifted laterally to the right 8.4 cm (3.3

in) relative to the pick-up box. The CDC of the vehicle was 10-LPEW-3. The total Delta V calculated by the Damage Only Algorithm of the WINSMASH program was 30.9 km/h (19.2 mph). The longitudinal and lateral components were -15.5 km/h (-9.6 mph) and 26.8 km/h (-16.6 mph), respectively. The barrier equivalent speed was 37.3 km/h (23.2 mph).

Figure 5: Left side view of the 1988 Chevrolet S-10 pick-up.

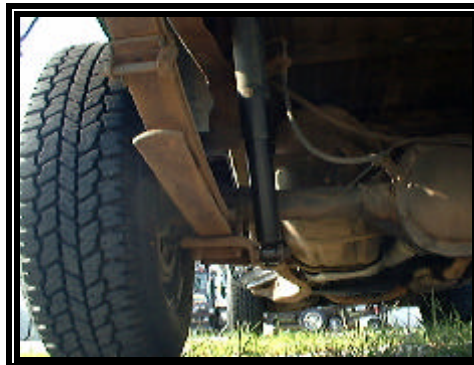
Figure 6: Rear undercarriage view along the left frame rail.

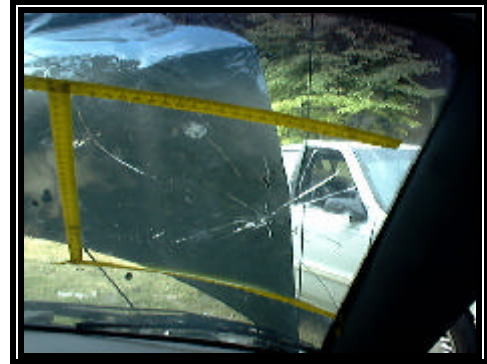
The right side of the windshield exhibited a fracture, **Figure 7**. The fracture site was located 30.5 cm (12.0 in) below the windshield header and 10.8 cm (4.3 in) left of the right A-pillar. An area of air bag fabric transfers surrounded the fracture site. The windshield fracture and surrounding transfers were resultant to the altered deployment path of the passenger air bag.

Figure 7: View of the windshield fracture.

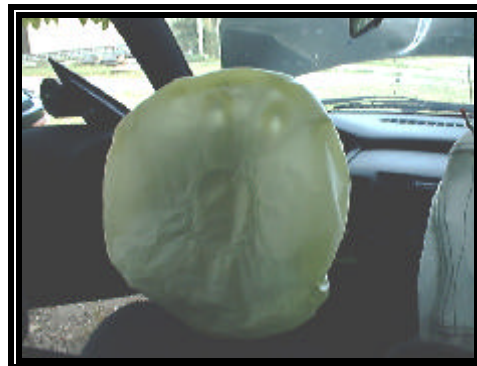
The driver air bag, **Figure 8**, measured 63.5 cm (25.0 in) in its deflated state. The air bag was vented by two 2.5 cm (1.0 in) diameter vent ports located in the 11/1 o'clock sectors on the back side of the bag. The air bag was tethered by two 14.0 cm (5.5 in) wide straps. The face of the driver air bag was smudged in the lower left and lower right quadrants probably as a result of an altered deployment. The forward position of the driver probably impeded the normal deployment of the air bag and the smudges are resultant to a friction heating between the air bag fabric and the interior surfaces of the driver air bag module.

Figure 8: Driver air bag.

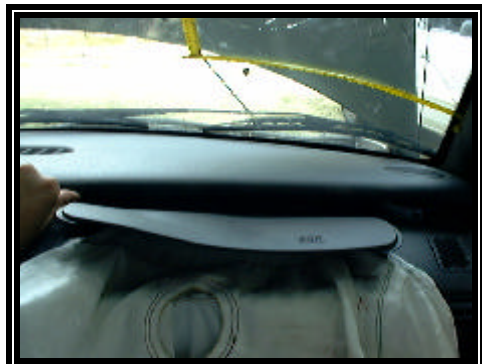
Figure 9: Front right passenger air bag module.

The front right passenger air bag module was configured as a top mount in the right aspect of the instrument panel, **Figure 9**. The passenger air bag module cover flap measured 33 cm x 15 cm (13 in x 6 in), width by height. The single vinyl flap design was hinged on the forward edge of the module and rotated forward during deployment. The left aspect of the cover flap was deformed relative to the right aspect. This deformation occurred as a result of the altered deployment sequence. There was not any direct evidence of occupant contact on the cover flap.

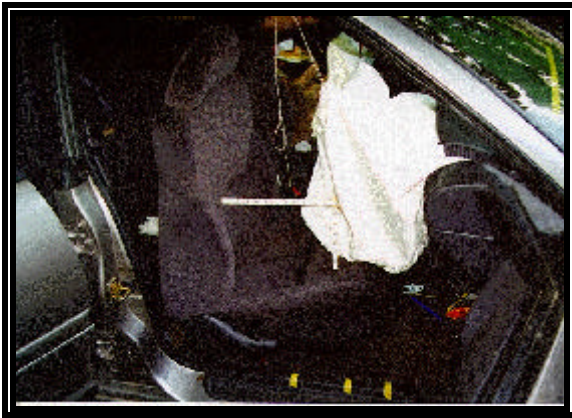
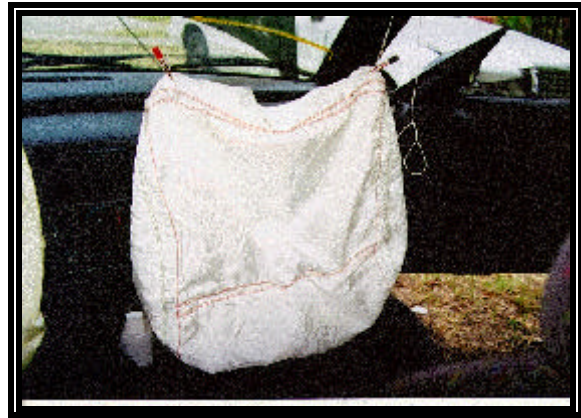
The passenger air bag measured 46 cm x 56 cm (18 in x 22 in) width by height at its extended face, **Figures 10 and 11**. The air bag extended rearward 33 cm (13 in) from aft edge of the module. The air bag was tethered by four 7.6 cm (3.0 in) wide straps sewn to the face of the air bag. The air bag was vented by a single 7.6 cm (3.0 in) port located in the 12 o'clock sector on the top surface of the bag. The following manufacturer's nomenclature was fixed to the module:

Figure 10: Right lateral view of the front passenger air bag.

Figure 11: View of the face of the front passenger air bag.

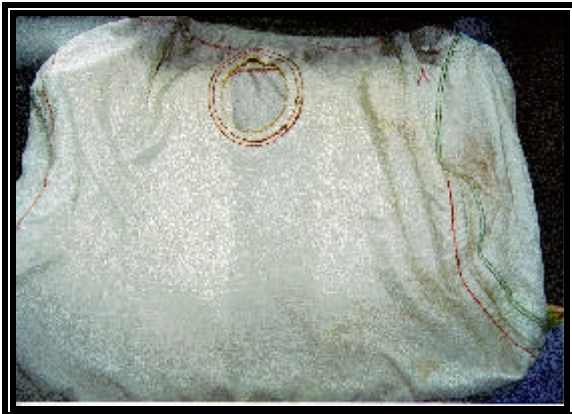
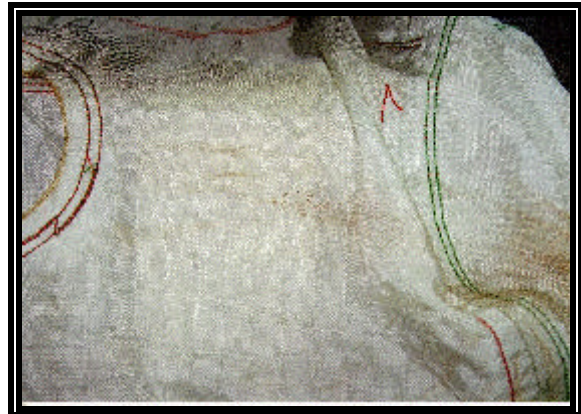
The bottom surface and face of the air bag did not exhibit any contact evidence. On the right aspect of the air bag's top surface was a dark tissue transfer and a large area of melanin transfer, **Figures 12 and 13**. The melanin transfer also extended onto the outboard surface of the bag. The tissue transfer measured 10 cm x 2 cm (4 in x 0.8 in), laterally by longitudinally, and was located 6.4 cm (2.5 in) rearward of the aft edge of the air bag module. The melanin transfer was dispersed over an area that measured 15 cm x 30 cm (6 in x 12 in), laterally by longitudinally, on the air bag's top surface. The melanin transfer on outboard aspect of the air bag was dispersed over an area that measured approximately 15.2 cm x 19.1 cm (6.0 in x 7.5 in), width by height.

Figure 12: Top surface of the air bag.

Figure 13: Close-up view of the tissue and melanin transfer.
