**CALSPAN ON-SITE DRIVER AIR BAG DEPLOYMENT/FATALITY INVESTIGATION**

**CALSPAN CASE NO. CA98-050**

**VEHICLE - 1995 FORD ESCORT**

**LOCATION - CONNECTICUT**

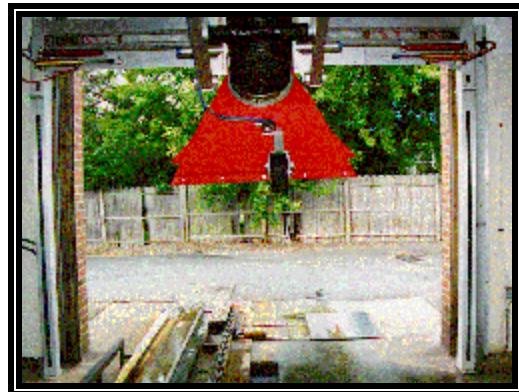
At the time of the crash, it was daylight and the weather was not a factor. The crash occurred on private property, at the exit from an automatic car wash located within the city limits. **Figure 1** is an on-scene police photograph of the car wash exit and crash scene.

**Figure 1:** On-scene police photograph of the car wash exit and point of impact.

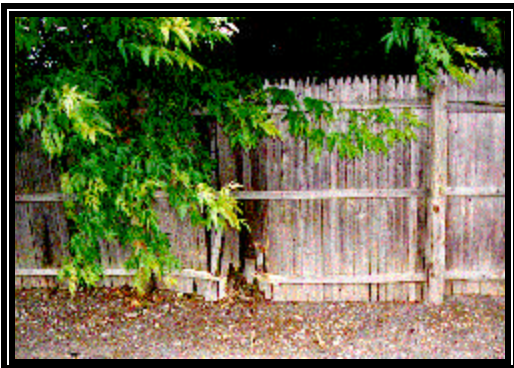
**Figure 2** is a close-up view of the fence at the point of impact. The fence consisted of 2.4 m (8.0 ft) sections of stockade type fencing attached to the back side of 10x10 cm (4x4 in) posts. The Ford’s front bumper impacted the left center aspect of the fence section, directly opposite the car wash exit. The right front corner of the vehicle fractured and penetrated the center aspect of the fence section and Ford’s bumper then impacted a 41 cm (16 in) diameter tree. The tree was located 25 cm (10 in) beyond the fence and backed up the fence at the impact site (**Figure 3**). The force of the impact with the tree caused the deployment of the Ford’s Supplemental Restraint System.

**Figure 2:** Close-up view of the fence at the point of impact taken during the police investigation.

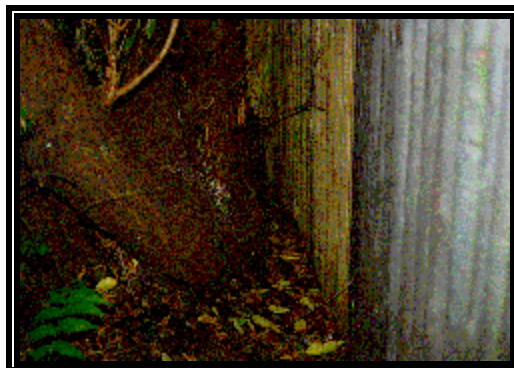
**Figure 3:** Close-up view of the base of the tree.

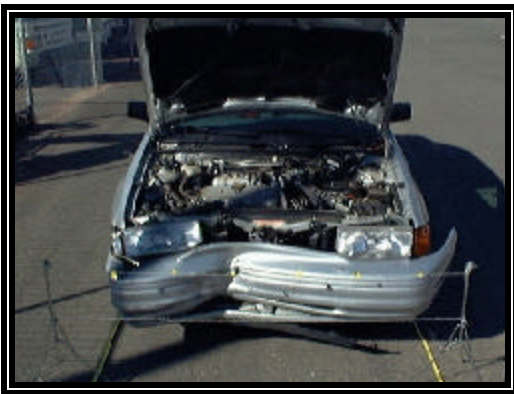
**Figures 4 and 5** are the front and right lateral views of the Ford Escort. The vehicle was operational and driven from the impound during the SCI inspection. The Ford sustained 127 cm (50 in) of direct contact damage to the front bumper as a result of the contact with the fence. The damage began 2.5 cm (1.0 in) inboard of the left front bumper corner and extended to the right front bumper corner. The resultant fence damage consisted of scratches and scuffs to the vertical surface of the bumper and probably resulted in minimal residual crush. The Collision Deformation Classification (CDC) of this impact was 12-FDEW-1.

The width of the direct contact damage from the tree impact measured 33.3 cm (13.1 in). The contact damage began 6.6 cm (2.6 in) right of the center and ended 39.9 cm (15.7 in) right of center. The front

bumper's construction consisted of a molded plastic hollow section. The bumper fractured in bending from the tree impact. The bumper's fracture was located 10.9 cm (4.3 in) right of the vehicle's centerline. The maximum residual bumper crush measured 25.9 cm (10.2 in) and was located 14.7 cm (5.8 in) right of centerline. The rearward deformation of the bumper impacted the radiator core. However, the radiator remained intact. The residual crush profile measured across the bumper's 130 cm (51 in) deformed end width was: C1=0 , C2=7.9 cm (3.1 in), C3=15.0 cm (5.9 in), C4=25.4 cm (10.0 in), C5=13.7 cm (5.4 in), C6=3.8 cm (1.5 in). The CDC of the tree impact was 12-FZEN-2. There was no measurable change in the wheelbase dimensions. All the doors remained operational. The windshield was fractured by the right front passenger air bag module cover during the deployment sequence. The side windows and backlight were intact. The barrier equivalent delta V calculated by the Barrier Model of the WINSMASH program was 21.9 km/h (13.6 mph).

**Figure 4:** Front view of the Ford Escort.

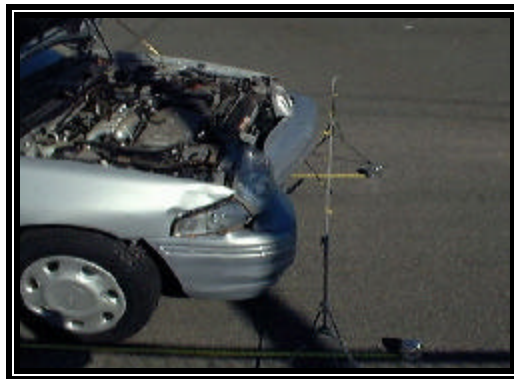
**Figure 5:** Right lateral view of the Ford.

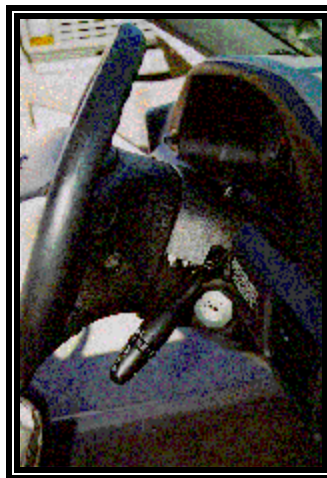
The steering assembly was configured with a four spoke, fixed steering wheel. **Figures 6 and 7** are the right and left lateral views of the damaged steering assembly, respectively. Inspection of the assembly revealed evidence that the occupant loaded the steering column through the deploying air bag during the crash sequence. The upper aspect of the steering wheel rim between the 10 and 2 o'clock sector was deformed forward approximately 1.2 cm (0.5 in). There was an estimated 3-6 mm (1/8-1/4 in) of residual displacement at the steering column's shear plate. The trim panels surrounding the column, forward of the steering wheel, were deformed

**Figure 6:** Right lateral view of the deformed steering wheel and column.

and displaced due to the compression of the column. The turn signal and wiper control stalks were also fractured. Additionally, it was noted that the rotation of the steering wheel was partially restricted (binding) due to the residual displacement of the steering column's components.

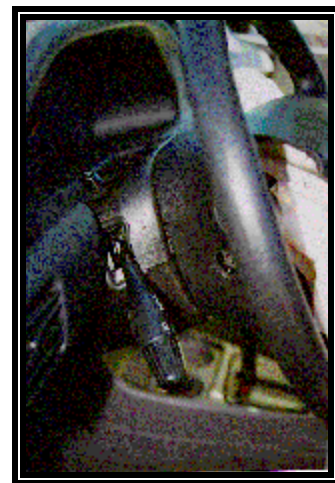
**Figure 7:** Left lateral view of the deformed steering wheel and column.

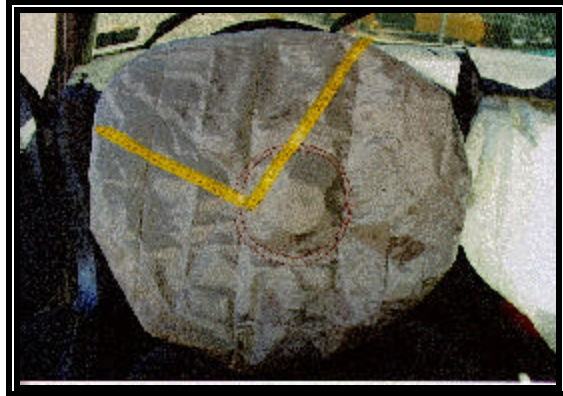
**Figure 8** is a view of the driver air bag. Dispersed over the 9 to 12 o'clock sector on the face of the air bag was a dark/black transfer to the bag's fabric. The transfer probably developed as a result of contact with the driver's clothing during the deployment and expansion of the air bag. Upon inspection, all four quadrants of the back side of the air bag exhibited signs of an impeded deployment. Black transfers, resultant to frictional contact with the interior surfaces of the cover flaps, were dispersed over the back surface of the bag. The transfers were heavier in the 9/12 sector consistent with the contact evidence on the face of the air bag. In the 6 o'clock sector on the perimeter of the air bag was a 13 cm (5 in) smear of blood and body fluid.

**Figure 8:** View of the driver air bag.
