**VERIDIAN ON-SITE AIR BAG RELATED
FETAL FATALITY INVESTIGATION
VERIDIAN CASE NO. CA98-055
VEHICLE: 1998 MITSUBISHI MIRAGE DE
LOCATION: PENNSYLVANIA
CRASH DATE: OCTOBER 1998**

1. <i>Report No.</i> CA98-055	2. <i>Government Accession No.</i>	3. <i>Recipient's Catalog No.</i>	
4. <i>Title and Subtitle</i> Veridian On-Site Air Bag Related Fetal Fatality Investigation Vehicle: 1998 Mitsubishi Mirage Location: Pennsylvania		5. <i>Report Date:</i> April 2001

14. <i>Sponsoring Agency Code</i>	
15. <i>Supplementary Notes</i> On-site investigation of an air bag deployment crash that resulted in a placental abruption and the still birth of a 33 week fetus.

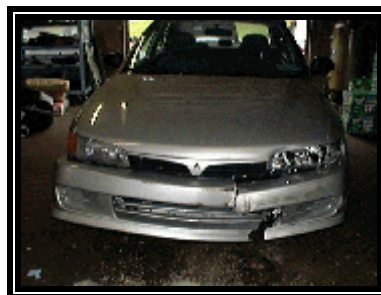
Figure 1 - Minor severity frontal damage to the Mitsubishi Mirage.

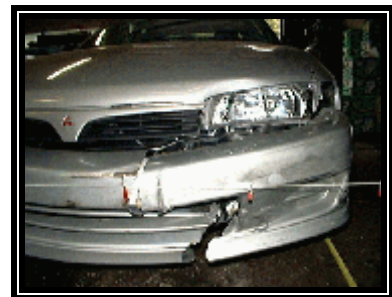
The front left and center areas of the Mitsubishi Mirage impacted the left rear side area of the truck, presumably at the left leading axle. The impact crushed the front bumper of the Mirage and displaced the left headlamp assembly and left front fender (**Figure 4**). The resultant directions of force were within the 1 o'clock sector for the Mirage and 12 o'clock for the truck. Although the truck was outside the scope of the WinSMASH reconstruction program, the damage algorithm computed a barrier equivalent total delta V of 16 km/h (10 mph) with a longitudinal delta V component of -15 km/h. (-9 mph) for the Mirage. This speed change estimate appeared reasonable for the damage to the vehicle. As a result of the crash, the Mitsubishi's frontal air bag system deployed.

Figure 4 - Close-up view of the direct contact area on the left frontal bumper of Vehicle #1

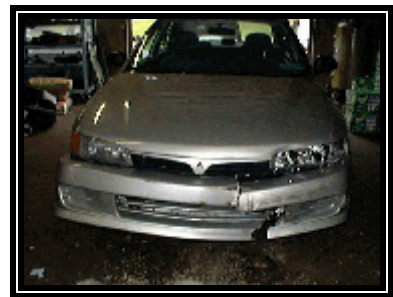
The front left and center area of the Mitsubishi Mirage impacted the left side (presumably the leading tire of the rear axle) of a 1998 Kenworth straight medium/heavy truck which was configured with an oil tank body. The direct contact damage began at the vehicle's centerline and extended 70.8 cm (27.875") to the left bumper corner (Figure 5). During the crash sequence, the bumper fascia separated from the bumper reinforcement bar and split into two pieces. Maximum crush was 18.4 cm (7.25") located on the bumper reinforcement bar at the left corner. The combined induced and direct contact damage was 141.6 cm (55.75") that extended the full width of the reinforcement bar. Components damaged by the impact included the front bumper fascia, the bumper reinforcement bar, the left headlight assembly, the left front fender, and the hood. Although the vehicle was towed from the scene of the crash, the Mirage was driveable. The assigned Collision Deformation Classification (CDC) was 01-FYEW-1. A frontal crush profile was documented at the bumper reinforcement bar. The crush values are listed in the following table:

Figure 5 - Overall frontal view of Vehicle #1

Crush Values: Frontal bumper reinforcement bar	C ₁ = 18.4 cm (7.25")	C ₂ = 12.1 cm (4.75")	C ₃ = 9.8 cm (3.875")
	C ₄ = 5.4 cm (2.125")	C ₅ = 3.8 cm (1.5")	C ₆ = 3.8 cm (1.5")

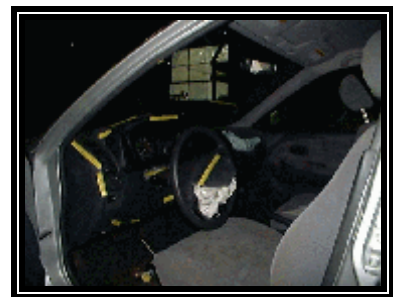
Interior vehicle damage to the 1998 Mitsubishi Mirage DE was attributed to driver contacts (Figure 6) and the deployment of the frontal air bag system. The left side of the windshield exhibited a spider web-type fracture pattern that was attributed to contact by the driver's left hand. The fracture point was located 43.2 cm (17.0") left of the vehicle centerline and 26.7 cm (10.5") below the windshield

Figure 6 - Angular view of the driver contact points within the Mirage.

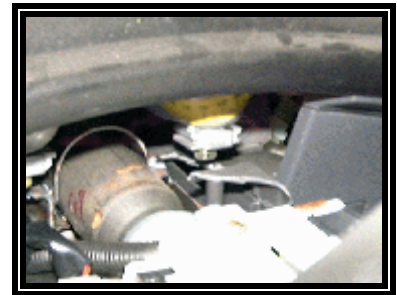
The energy absorbing steering column was displaced forward with total separation of the shear plate from the shear capsules (**Figure 7**). The shear plate displacement was measured at 3.8 cm (1.5") for both the left and right shear capsules. The steering wheel rim was not deformed. Rescue personnel indicated that the tilt column was re-adjusted upward to facilitate the extrication of the driver. The angle of the adjustable steering column measured 22 degrees when repositioned against the shear capsules. There was a beige color transfer mark along the lower outboard aspect of the steering column shroud which began at the junction of the steering wheel and extended 6.4 cm (2.5") downward. This was attributed to contact by the driver's left upper leg during the crash.

Figure 7 - View of the shear plate and shear capsule separation of the Mitsubishi Mirage.

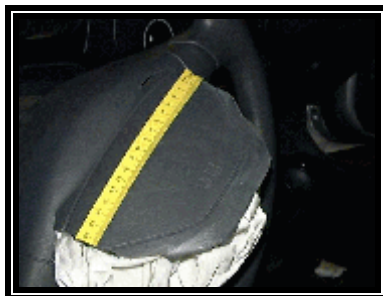
The front left driver air bag module cover exhibited heavy teal blue color fabric transfers along the sides and bottom periphery that were attributed to contact with the driver's teal blue shirt during the deployment sequence (**Figures 8 and 9**). Contact began 4.8 cm (1.875") below the top hinge point of the single flap and measured 1.3 cm (0.5") wide. The fabric contact pattern widened to 3.2 cm (1.25") at the bottom edge. The dimensions of the flap measured 17.5 cm (6.875") laterally along the top hinge which narrowed to 7.6 cm (3.0") along the bottom edge. The vertical height of the flap measured 12.1 cm (4.75").

Figure 8 - View of the front left air bag module cover flap showing the fabric transfer along the perimeter of the flap

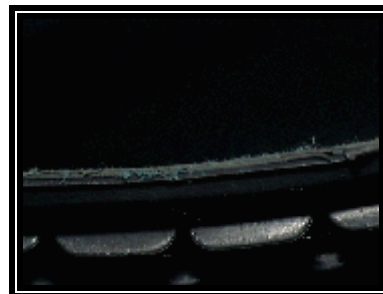
Figure 9 - Close-up view of the bottom edge of the air bag module cover showing the extent of fabric transfer

The front left driver air bag module cover exhibited a heavy teal blue fabric transfer along both sides and along the bottom edge. Contact began 4.8 cm (1.875") below the top hinge point along the vertical seam edges and measured 1.3 cm (0.5") wide. The fabric contact pattern widened vertically at the bottom edge to 3.2 cm (1.25"). The color of this transfer was consistent with the driver's description of her shirt color. Additionally, the 12.7-15.24 cm (5-6") lateral tear described by rescue personnel in the center upper abdominal area of the shirt was consistent with the 17.5 cm (6.875") lateral dimension of the flap.

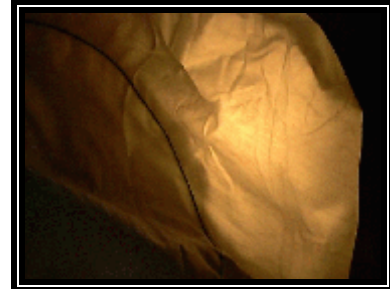
Figure 10 - View of the front left driver air bag

The front left driver air bag exhibited dark artifacts that were detected only when a light source was placed behind the air bag resulting in diffused light passing through the air bag material (**refer to Figure 10**). These artifacts were attributed to contact with the driver's shirt during air bag expansion.
