**VERIDIAN ON-SITE REDESIGNED AIR BAG DEPLOYMENT INVESTIGATION  
VERIDIAN CASE NO. CA98-056  
VEHICLE: 1998 CHEVROLET LUMINA  
LOCATION: NEW YORK  
CRASH DATE: OCTOBER 1998**

14. <i>Sponsoring Agency Code</i>	
15. <i>Supplementary Notes</i> On-site investigation of a head-on crash that resulted in deployment of the redesigned frontal air bags in a 1998 Chevrolet Lumina and the death of the belted 81 year old female driver.

**VERIDIAN REDESIGNED AIR BAG DEPLOYMENT INVESTIGATION**  
**VERIDIAN CASE NO. CA98-056**  
**VEHICLE: 1998 CHEVROLET LUMINA**  
**LOCATION: NEW YORK**  
**CRASH DATE: OCTOBER 1998**

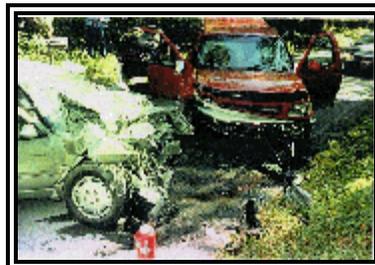
**Figure 1. On-scene view of the frontal damage patterns.**

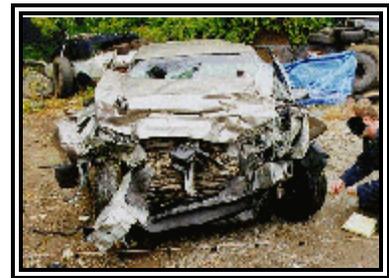
Exterior damage to this vehicle was severe with crush damage extending across the full frontal width of the vehicle (**Figure 5**). Damaged components included the front bumper (separated from the frame rails), grille, headlight assemblies, hood, radiator, both front fenders, both front doors, the windshield, and the roof panel. Damage was also noted to basic structural components including both front suspensions and the front chassis frame rails. Both wheelbase dimensions were reduced with the left side dimension reduced by 4.4 cm (1.75") and the right side dimension reduced by 10.2 cm (4.0"). The engine was shifted rearward toward the passenger compartment and the panel separating the engine compartment and passenger compartment was also shifted rearward. The direct contact damage was measured along the vehicle profile and was 143.5 cm (56.5") in width, extending from fender edge-to-fender edge. The impact separated the front bumper cover and the reinforcement beam, therefore the crush was documented at the levels of the upper and lower radiator supports. Maximum frontal crush at the lower radiator support was 71.8 cm (28.25") located 17.1 cm (6.75") left of center. The maximum crush at the upper radiator support was

**Figure 5. Full frontal damage to the Lumina.**

88.1 cm (34.7") located 30.5 cm (12.0") left of center. The crush profiles at both heights of the radiator support were measured as follows:

<u>Lower Radiator Support</u>	<u>Upper Radiator Support</u>
$C_1 = 61.6 \text{ cm (24.25")}$	$C_1 = 80.5 \text{ cm (31.7")}$
$C_2 = 71.8 \text{ cm (28.25")}$	$C_2 = 88.1 \text{ cm (34.7")}$
$C_3 = 65.8 \text{ cm (25.9")}$	$C_3 = 83.6 \text{ cm (32.9")}$
$C_4 = 57.8 \text{ cm (22.75")}$	$C_4 = 81.0 \text{ cm (31.9")}$
$C_5 = 52.7 \text{ cm (20.75")}$	$C_5 = 82.6 \text{ cm (32.5")}$
$C_6 = 34.0 \text{ cm (13.4")}$	$C_6 = 87.6 \text{ cm (34.5")}$

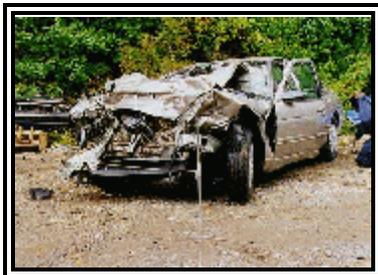
The measured crush dimensions for the upper radiator support were utilized for the WinSMASH program. This profile provided the best representation for the damage algorithm of the reconstruction program. Program results indicated that the total delta V level for this impact was 50.9 km/h (31.6 mph) with a longitudinal component of -47.8 km/h (-29.7 mph). The Collision Deformation Classification (CDC) for this impact was 11-FDEW-4. **Figures 6-8** document the frontal damage to the Lumina.

**Figure 6. Front left view of the Lumina's frontal damage.**

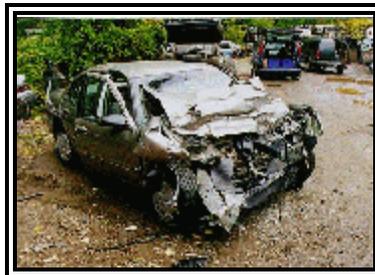
**Figure 7. Front right view of the damage pattern.**

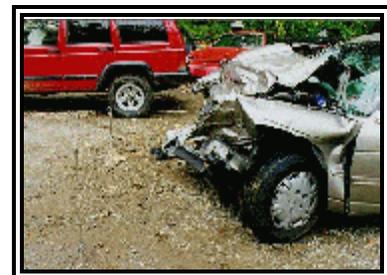
**Figure 8. Left profile view of the crush depth.**

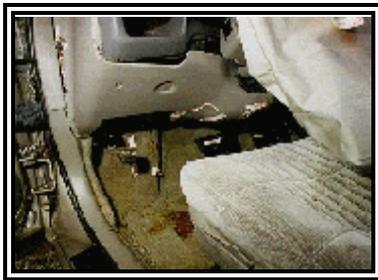
Evidence of driver contact with interior components was noted to the deployed driver's air bag, the knee bolster, the brake pedal, and the left toe pan. Evidence of contact with the knee bolster consisted of two fabric transfers deposited as a result of the drivers knees contacting the bolster (**Figures 9 and 10**). Both transfers were approximately 15.2 cm (6.0") in length with the left knee contact centered 44.5 cm (17.5") to the left of the vehicle's centerline and the right knee contact centered 31.2 cm (12.3") to the left of the vehicle's centerline.

**Figure 9. Knee contacts to the plastic bolster panel.**

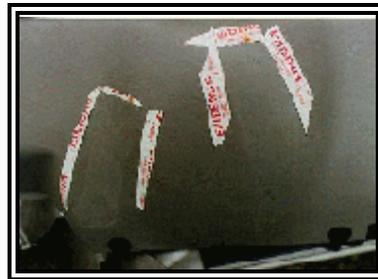
**Figure 10. Close-up view of the knee contacts.**

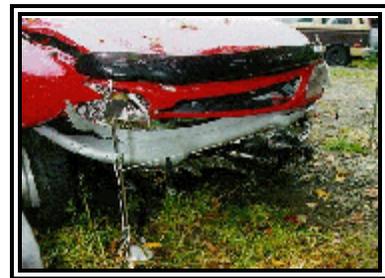
Exterior damage to this vehicle was considered to be moderate with crush damage extending across the full frontal width of the vehicle (**Figure 11**). Damaged components included the front bumper, grille, both headlight assemblies, hood, both front fenders, and both front doors. Direct contact damage initiated at the right corner position and extended 137.2 cm (54.0") to the left. The Field L dimension was 161.3 cm (63.5") that extended the full width of the bumper. Maximum frontal crush was 44.5 cm (17.5") located at the right front ( $C_5$ ) position. Although the front right corner area appears to have greater displacement, the contour of the bumper is greatest at the corner, therefore maximum residual crush was inboard of the corner.

**Figure 11. Frontal damage to the Ford pickup truck.**

The full set of crush dimensions measured at bumper height was as follows:  $C_1 = 8.6$  cm (3.375"),  $C_2 = 17.1$  cm (6.75"),  $C_3 = 29.8$  cm (11.75"),  $C_4 = 41.9$  cm (16.5"),  $C_5 = 44.5$  cm (17.5"),  $C_6 = 40.6$  cm (16.0"). The CDC for this vehicle was 01-FDEW-2.

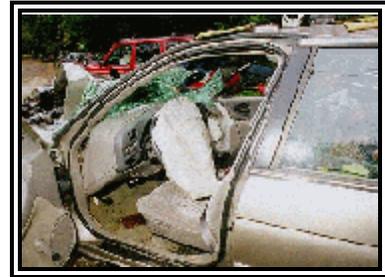
The 1998 Chevrolet Lumina was equipped with redesigned frontal air bags for the driver and right front passenger seated positions. The driver's air bag module was mounted in the steering wheel and the passenger air bag was mounted in the instrument panel in a top mount configuration (**Figure 12**). This redesigned system was identified by a sticker on the left front door glazing which specified that the vehicle was equipped with, "Next Generation Air Bags". Both air bag modules deployed during the frontal impact sequence with the Ford pickup truck. In addition to the air bag modules, the system utilized a single point sensing system and control module that was mounted to the floor of the Lumina under the front right seat.

**Figure 12. Deployed redesigned frontal air bags.**

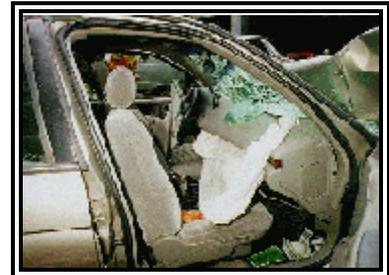
The right front passenger bag was mounted in the right instrument panel as a top mount design (**Figure 13**). The module deployment cover was 38.7 cm (15.3") wide and was 25.4 cm (10.0") high at the left edge and 21.6 cm (8.5") high at the right edge. The module cover was hinged at the rear and opened upward. The passenger air bag was 58.4 cm (23.0") wide and 48.3 cm (19.0") deep. This was a tethered bag design with a 25.4 cm (10") wide by 22.3 cm (8.8") deep mesh tether located at the rear of the bag. There was no evidence of driver involvement with this module.

**Figure 13. Front right passenger air bag.**

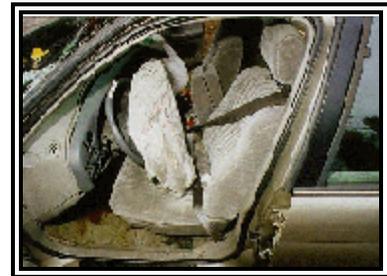
This 81 year old driver of the Lumina was described by the investigating officer as a short stature female with a slender build. Her specific height and weight were not available. The driver was seated in a normal driving posture prior to the crash. The left front seat track was adjusted to a forward position 5.4 cm (2.1" rearward of the full forward position and 14.2 cm (5.6" forward of the full rearward position] and the seat back was reclined 23 degrees rearward of vertical (**Figure 14**). The post-crash horizontal distance between the center of the driver air bag module and the seat back support was 41.3 cm (16.25"). It should be noted, however, that this measurement was inclusive of the 6.4 cm (2.5") of forward displacement of the energy absorbing steering column.

**Figure 14. Forward seated position of the driver.**

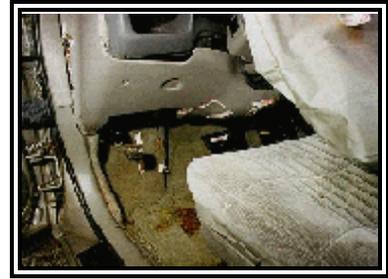
At impact, the redesigned frontal air bag system deployed. The driver initiated a forward trajectory in response to the frontal impact force. The driver's knees contacted the knee bolster (**Figure 15**), depositing fabric transfers and scuff marks on the bolster at the steering column location (beneath the column) and again, to the left of the steering column cutout. These transfers were approximately 15 cm (6.0") in length with the length of the contact pattern reflecting a combination of the driver's forward motion and the rearward displacement of the instrument panel.

**Figure 15. Driver knee contacts to the knee bolster.**

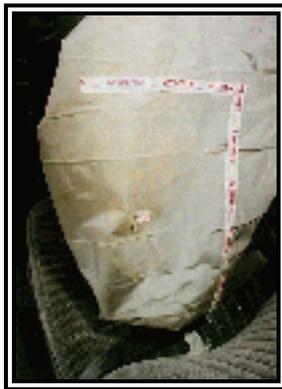
The driver's face and upper torso loaded the deployed front left air bags as she began moving forward with respect to the decelerating vehicle. A large make-up transfer (flesh-tone make-up and red lipstick) was noted to the bag surface (**Figure 16**). The largest portion of this transfer was located on the lower left quadrant of the bag although the transfer did extend into other quadrants. The lipstick transfer was symmetrical in shape and not streaked which indicated the driver loaded a deployed, or near fully deployed air bag. The driver's loading force was transmitted through the bag, due to the relatively large crash pulse, which resulted in forward deflection of the upper steering wheel rim (spoke deflection) and compression of the energy absorbing steering column (**Figure 17**). The column shear capsules were completely separated with 6.4 cm (2.5") of separation movement documented.

**Figure 16. Make-up transfers on the front left air bag.**

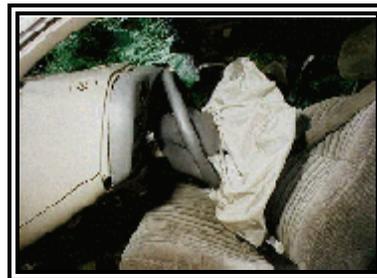
**Figure 17. Forward deflection of the steering wheel and steering column.**

The Lumina driver sustained bilateral rib fractures involving 13 ribs and a puncture wound of the heart. It is believed that these injuries were sustained as a combination of loading the manual restraint system belt webbing and loading of the steering assembly through the air bag.
