**ON-SITE AIR BAG RELATED CHILD PASSENGER FATALITY INVESTIGATION**

**VERIDIAN CASE NO: CA98-058**

**VEHICLE: 1996 GEO METRO**

**LOCATION: NORTH CAROLINA**

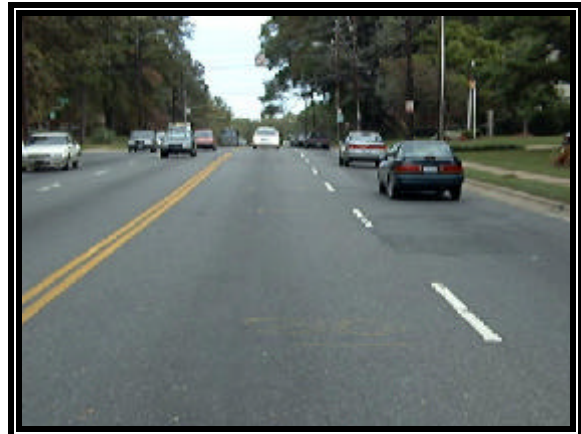
**Figure 1:** Trajectory view of the Geo 30 m (100 ft) south of the point of impact.

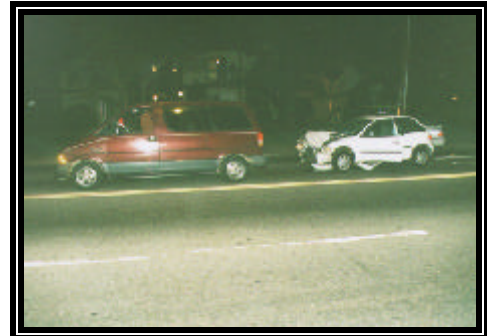
The northbound momentum of the Geo displaced the Ford forward (north) 15.5 m (50.9 ft) from the point of impact. The Ford came to rest on the inboard northbound lane facing north. The Geo came to rest on the northbound lane 14.2 m (46.6 ft) north of the POI. These final rest locations were documented during the police investigation and subsequent SCI on-site investigation. **Figure 2** is an on-scene police photograph of the vehicles at final rest.

**Figure 2:** On-scene police photograph of the vehicles at final rest.

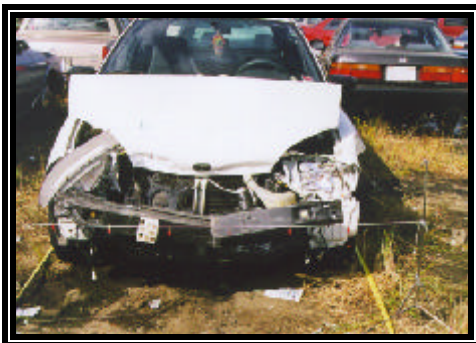
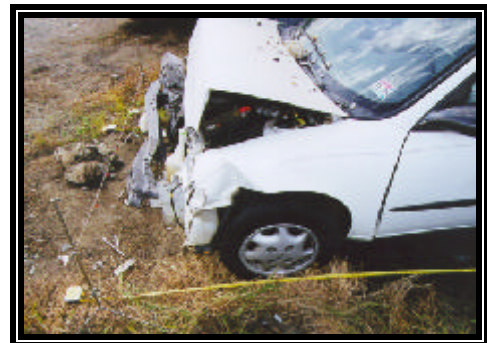
#### *Exterior Damage*

**Figures 3 and 4** are the front and left lateral views of the Geo's exterior damage. The vehicle's front plane sustained 92.7 cm (36.5 in) of direct contact damage that began 29.2 cm (11.5 in) right of center and extending to the left corner. The width of the combined direct and induced damage extended across the vehicle's entire 127 cm (50 in) frontal end width. The exterior damage to the vehicle involved the front bumper, grille, hood, left headlamp assembly and left front fender. The bumper reinforcement bar was fractured and had separated from the left mounting bracket. The reinforcement bar fracture point was located 3.8 cm (1.5 in) left of center. The crush profile along the bumper reinforcement was as follows: C1=10.3 cm (4.1 in), C2=12.2 cm (3.8 in), C3=15.4 cm (6.1 in), C4=12.2 cm (3.8 in), C5=8.4 cm (2.3 in), C6=2.8 cm (1.1 in). There was no measurable change in the wheelbase dimensions. The doors remained operational and all glazings were intact. The Collision Deformation Classification (CDC) was 12-FDEW-2.

**Figure 3:** Front view of the Geo.

**Figure 4:** Left lateral view of the Geo.

The Geo's total delta V calculated by the Damage algorithm of the WINSMASH model was 22 km/h (13.7 mph). The longitudinal and lateral components were -22.0 km/h (-13.7 mph) and 0 km/h, respectively. The WINSMASH trajectory algorithm calculated an impact speed of 46.9 km/h (29.1 mph). These analyses were consistent with the damage the vehicle and dynamics of the crash.

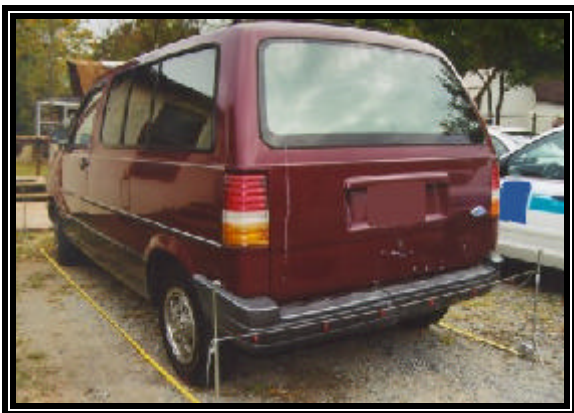
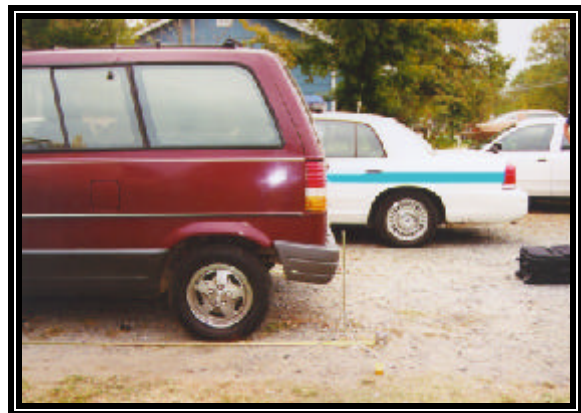
**Figures 5 and 6** are the Aerostar. The vehicle's back plane sustained 117 cm (46 in) of direct contact damage which began 33 cm (13 in) left of center and extended to the right corner. The width of the combined direct and induced damage extended across the vehicle's entire 168 cm (66 in) entire width. The exterior damage was limited to the rear bumper with some minor paint transfers and abrasions to the rear lift gate. The impact force caused the rear bumper to rotate downward (clockwise) when viewed from the left, Figure 6. The crush profile measured along the bumper was as follows: C1=0, C2=0, C3=1.3 cm (0.5 in), C4=2.4 cm (0.9 in), C5=3.2 cm (1.2 in), C6=4.1 cm (1.6 in). There was no change in the wheelbase dimensions. All the doors remained operational and there was no glazing damage. The CDC of the Aerostar was 06-BDEW-1. The Aerostar sustained a WINSMASH computed delta V of 11.0 km/h (6.8 mph) and had a calculated speed at impact of 10.9 km/h (6.8 mph). These calculated values were consistent with the extent of the vehicle's damage and the crash dynamics.

**Figure 5:** Aerostar left rear three-quarter view.

**Figure 6:** Left side view of the Aerostar.

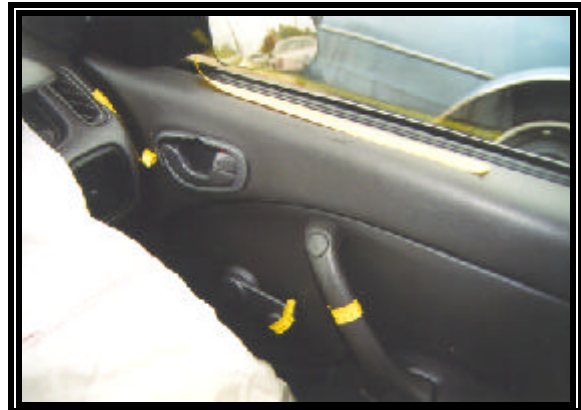
The passenger seat track was adjusted to a full forward position. The passenger seat back angle measured 21 degrees (aft of vertical). The horizontal distance from the rearward edge of the passenger air bag module to the seat back measured 66.0 cm (26 in). Contact evidence to the front right interior components resulted primarily from expansion contacts with the expanding passenger air bag during its altered deployment. The altered deployment of the passenger air bag was a result of the forward position of the front right child passenger. These contacts consisted of heavy abrasion to the interior trim panel of the right door, grab handle window crank and door release, **Figure 7**. The surface of the instrument panel immediately surrounding the passenger air bag module exhibited numerous minor scuffs and abrasions from the bag expansion. A tissue transfer to the right sunvisor, near its leading edge, was attributed to contact by the child passenger following the expansion of the passenger side air bag. Bodily fluid residue was located along the right aspect of the front passenger seat cushion and sill area and indicated the probable final rest location of the child.

**Figure 7:** Expansion contacts to right door interior panel.

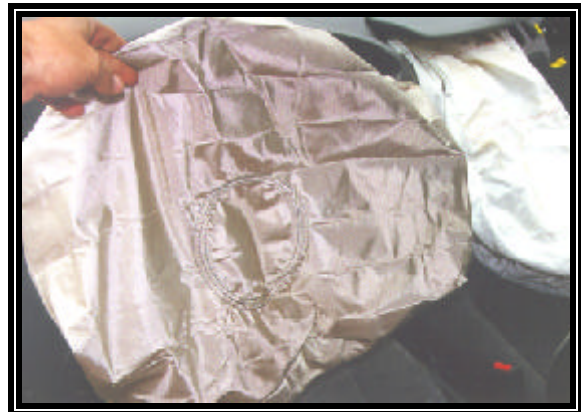
The driver air bag, **Figure 8**, was designed in the typical manner and located in the center hub of the steering wheel rim. The driver air bag module I-configuration cover flaps were symmetrical and measured 15 cm x 6.9 cm (6 in x 2.7 in), width by height. The vinyl flaps were not damaged and exhibited no contact evidence. The deployed driver air bag measured 61 cm (24 in) in its deflated state and was tethered by four internal straps sewn to the face of the bag. It was vented by two 3.8 cm (1.5 in) diameter ports on the back side of the bag in the 10/2 o'clock positions. The face of the bag exhibited no contact evidence. The driver bag was identified by the following: *PE5114100-01 TBS6039B1736*.

**Figure 8:** Driver air bag.

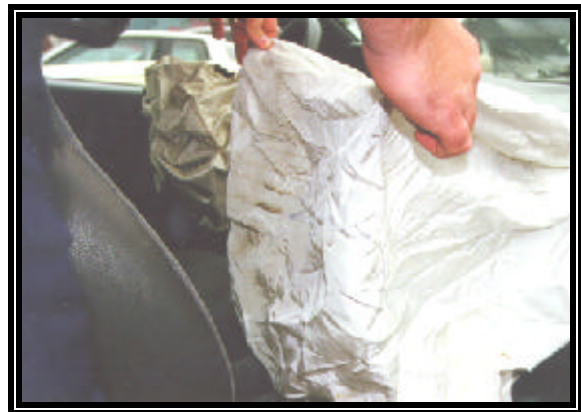
The front right passenger air bag was a top mount design located in the right instrument panel. The rigid vinyl cover flap measured 36 cm x 18 cm (14 in x 7 in). There was no contact evidence to the flap. The face of front right passenger air bag measured 47.0 cm (18.5 in) square and it extended rearward 48 cm (19 in) from the module, **Figure 9**. The bag was not tethered and was not externally vented. No manufacturer's identifiers were found on the passenger bag.

**Figure 9:** Rearward excursion of the PAB.

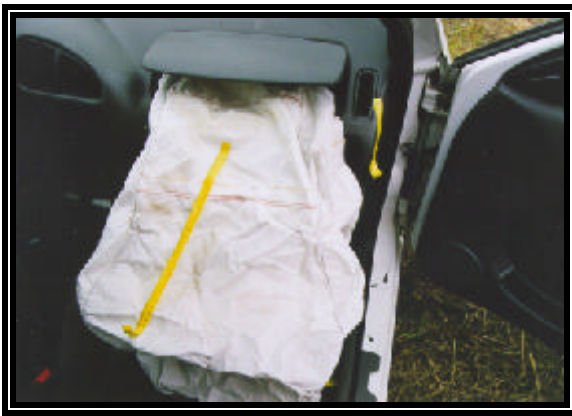
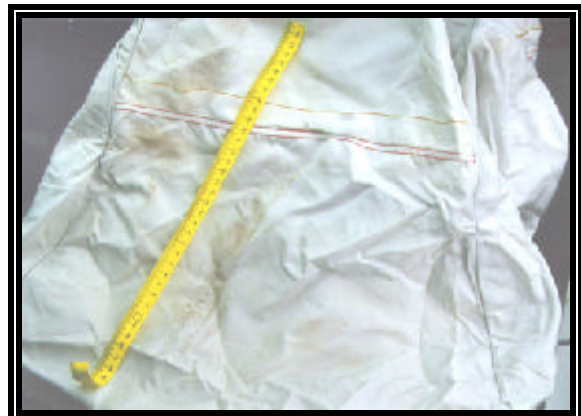
Inspection of the deployed front right passenger air bag revealed evidence of direct contact to the child passenger. Two heavy tissue transfers, **Figures 10 and 11**, were noted on the top horizontal surface of the bag. These transfers measured 6.4 cm x 21.6 cm (2.5 in x 8.5 in) and 3.8 cm x 29.2 cm (1.5 in x 11.5 in), width by length, and were located on the right inboard and center aspects of the bag, respectively. The center transfer extended onto the face of the bag 29.2 cm (11.5 in). The tissue transfers were consistent with the large facial and neck abrasions noted by the medical examiner. A blue fabric transfer was located adjacent to the tissue transfer of the bag's face and was associated to the child's clothing. The bag was initially folded in an accordion pattern. It was noted the heaviest tissue and fabric transfers occurred at the pleats of the folds. The location and nature of the transfers indicated the child was contacted by the air bag very early in its expansion sequence.

**Figure 10:** View of the tissue transfers to the top surface of the PAB.

**Figure 11:** Close-up view of the tissue transfers.

Direct contact to the expanding air bag was evidenced by the large areas of tissue transfer to the bag membrane and the associated abrasions to the child face and neck. The child’s head was turned to the left exposing the right side of his face at the time of the contact. The expansion of the air bag applied an upward and rearward force to the child’s head, hyper-extending the neck. This hyper-extension resulted in a fracture/dislocation of the atlanto-occipital joint. The continued bag expansion lifted the child from the seat as evidenced by the tissue transfer to the right sunvisor. The child then rebounded back into the passenger seat and came to rest along its right aspect evidenced by the bodily fluid transfers to the right sill and right aspect of the cushion.

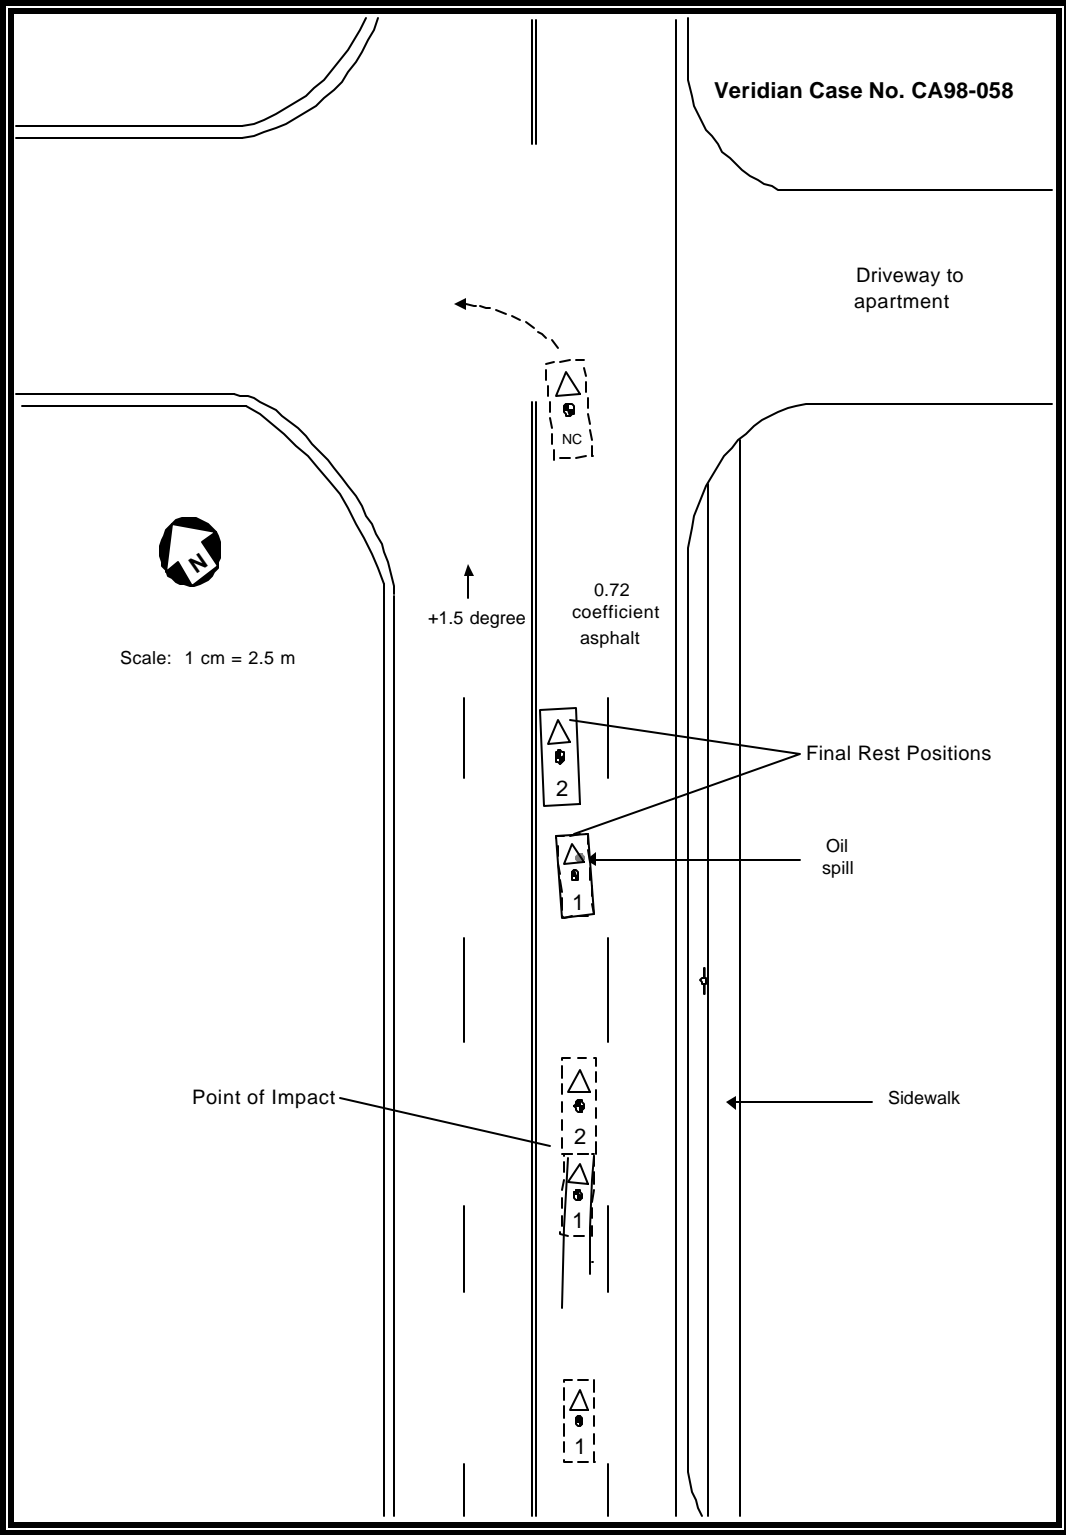
Figure 12: Crash Schematic.

The Ford driver slowed the Aerostar in response to a non-contact vehicle ahead of him. This non-contact vehicle had stopped to turn left onto an intersecting street that was located north of the point of impact. The driver of the Geo did not initially detect the Ford's reduced speed but upon recognition of the impending crash, steered the vehicle to the right and locked the vehicle's brakes. The Geo skidded forward, in a tracking mode, to impact with the Ford. Inspection of the crash scene documented two pre-crash skid marks attributed to the front tires of the Geo. The left and right skid marks measured 7.0 m (23.0 ft) and 5.5 m (18.0 ft), respectively. **Figure 12**, page 10, is a schematic of crash.
