**TRANSPORTATION SCIENCES
CRASH RESEARCH SECTION**

**CALSPAN ON-SITE DRIVER AIR BAG FATALITY INVESTIGATION
CASE NO. CA98-063
VEHICLE: 1993 TOYOTA COROLLA
LOCATION: NEW JERSEY
CRASH DATE: OCTOBER 1998**

14. <i>Sponsoring Agency Code</i>	
15. <i>Supplementary Notes</i> On-site investigation of an air bag deployment crash that resulted in fatal cervical injuries to the belted female driver of the 1993 Toyota Corolla.

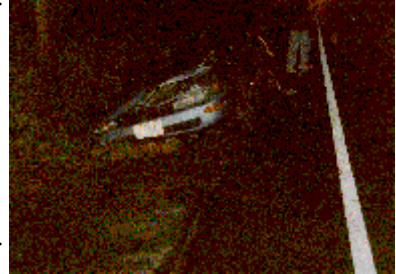
Figure 1. Final rest of the Toyota Corolla.

The Toyota Corolla came to rest with the front undercarriage area of the vehicle resting against the edge of the asphalt driveway at the struck culvert location, facing in a northerly direction. The right side tires were resting on the downslope to the drainage ditch as the left side tires were positioned on the outboard edge of the asphalt shoulder. At rest, the engine remained running (**Figure 1**).

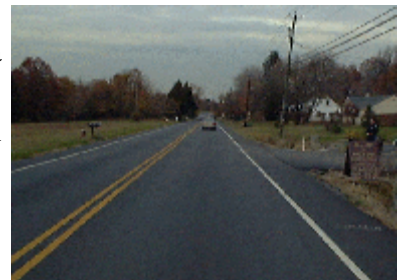
Figure 2. Overall view of the crash site and pre-crash trajectory of the Toyota.

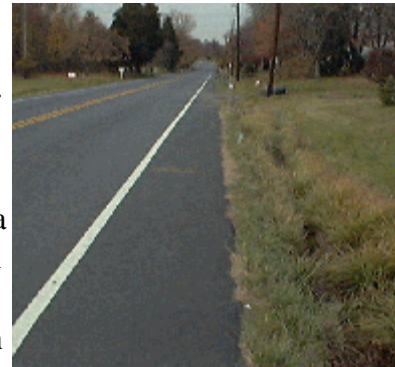
Figure 3. Departure and struck delineators.

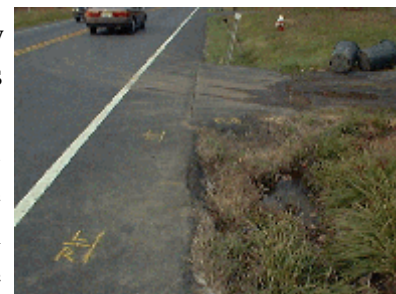
Figure 4. Struck culvert.

WinSMASH program computed a barrier equivalent speed of 18.1 km/h (11.2 mph) for the culvert impact with a longitudinal component of -18.1 km/h (-11.2 mph). As a result of the culvert impact, the Toyota's supplemental frontal driver air bag system deployed. The Crash Schematic is included as **Figure 11, Page 12** of this report.

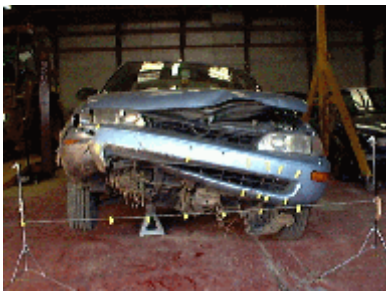
The Toyota Corolla sustained moderate damage as a result of the multiple event run-off-road crash sequence. The primary damage that resulted in air bag deployment occurred from the culvert impact to the undercarriage of the vehicle at the lower radiator support. The direct contact damage consisted of abrasions to the lower bumper fascia with mud and debris embedded into the frontal undercarriage components (**Figure 5**). The direct contact damage began 10.2 cm (4.0") right of center and extended 45.7 cm (18.0") to the right. Although the front lower bumper fascia was involved, there was no residual crash at bumper level. The culvert impact displaced the lower radiator support panel to a maximum depth of 14.6 cm (5.75") located 35.6 cm (14.0") right of center (**Figure 6**). The crush profile at the lower radiator support panel was as follows: C1 = 0.6 cm (0.25"), C2 = 4.8 cm (1.9"), C3 = 9.5 cm (3.75"), C4 = 13.7 cm (5.4"), C5 = 14.6 cm (5.75"), C6 = 9.5 cm (3.75").

Figure 5. Overall view of the frontal undercarriage damage to the Corolla.

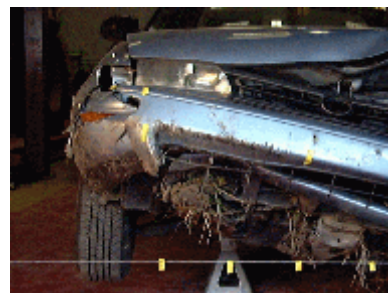
Figure 6. Undercarriage damage to the Corolla.

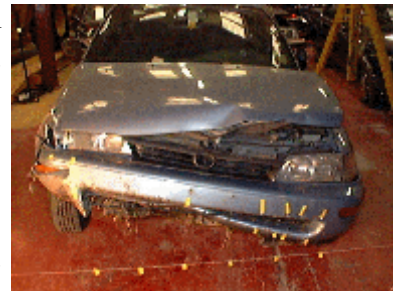
The secondary damage to the vehicle involved minor damage from impact with three delineators (**Figure 7**). The initial delineator impact damage was located on the upper surface of the bumper fascia 60.3-68.6 cm (23.75-27.0") right of center, above the parking light lens. The damage consisted of vertically oriented abrasions and a separated turn signal assembly. The fascia was split at this location, however, the tear probably resulted from frontal deformation as a result of the culvert impact.

Figure 7. Delineator impact to the bumper fascia.

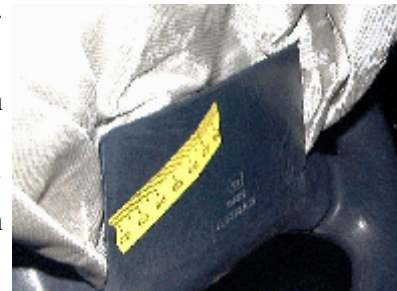
There was no occupant contact evidence or damage noted to the upper cover flap. A diagonally oriented abrasion pattern was noted to the upper left corner of the lower cover flap (**Figure 8**). The abrasion pattern extended 4.4 cm (1.75") inboard of the left upper corner and extended vertically 2.9 cm (1.125"). Although unconfirmed by clothing damage or specific injury patterns, the abrasions probably resulted from contact against the driver's upper abdominal/chest area.

Figure 8. Abrasion to the lower cover flap.

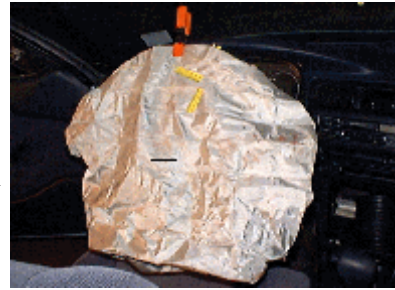
Two faint lipstick transfers was noted to the center area of the air bag (**Figure 9**). The upper lip transfer was located 6.4-7.0 cm (2.5-2.75") above the horizontal centerline and 1.9-4.4 cm (0.75-1.75") left of the vertical centerline of the bag. The lower lip transfer was located 4.4-5.1 cm (1.75-2.0") above the horizontal reference line and 1.9-4.4 cm (0.75-1.75") left of center. A make-up transfer was noted surrounding the left peripheral seam of the bag 7.0-12.1 cm (2.75-4.75") above the centerline which extended 2.5 cm (1.0") fore and aft of the internally stitched seam. A second area of flesh-tone make-up was centered at the right of the bag, extending 5.7 cm (2.25") above the reference line to 6.4 cm (2.5") below the horizontal centerline. The transfer was located 10.2-17.8 cm (4.0-7.0") right of center.

Figure 9. Tissue and make-up transfers on the air bag.

A diagonally oriented bloody transfer with tissue fragments extended across the upper centerline of the face of the bag (**Figure 9**). The transfer extended 2.5 cm (1.0") left of center to 4.4 cm (1.75") right of center and 7.6-19.1 cm (3.0-7.5") above the horizontal centerline. Several blood related spatters were noted to the bag at the 2:30 o'clock sector adjacent to the peripheral seam.

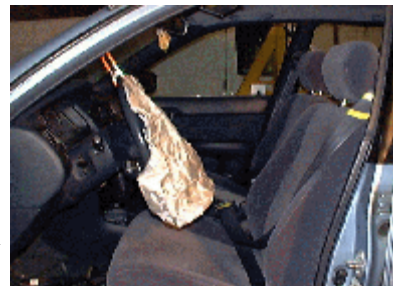
The driver of the 1993 Toyota Corolla was seated in a normal driving posture with the manual seat track adjusted to a mid track position. The seat track was adjusted 9.5 cm (3.75") rearward of the full forward position and 15.2 cm (6.0") forward of the full rear track position. The seat back support was reclined to a measured angle of 25 degrees. In this position, the horizontal distance between the center of the driver air bag module cover flap and the seat back support (**Figure 10**) was 48.3 cm (19.0"). The tilt steering wheel was adjusted to a mid position with a column angle of 31 degrees.

Figure 10. Driver seat track position with respect to the deployed air bag.
