SCI/NASS COMBINATION CASE REPORT

CASE NUMBER - NASS-99-13-079E

VEHICLE - 1998 NISSAN MAXIMA GLE

CRASH DATE - May 1999

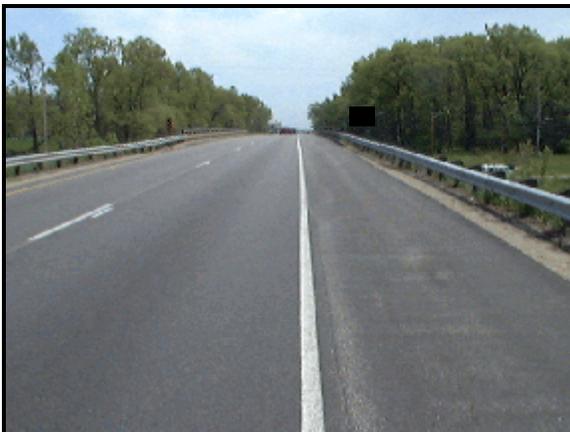
Figure 1: Case vehicle’s southbound approach toward crash sequence

The case vehicle was traveling south in the outside, southbound lane of a two-lane roadway that was part of a four-lane, divided, U.S. trafficway (Figure 1). Presumably, the case vehicle’s intent was to continue in a southerly travel path. As the case vehicle was traveling up a positive grade to the south, it approached a bridge. The driver suffered a syncopal episode (“blacked out”) and the case vehicle drifted to the right onto the west shoulder and struck the west W-beam guardrail with its right side (Figure 2). Immediately after separating from the west guardrail, the case vehicle’s right front wheel and tire struck a 15 centimeter (6 inch) concrete barrier curb, causing the

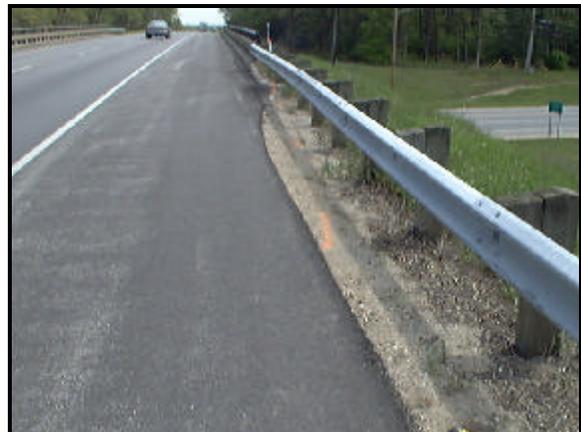
Figure 2: Orange paint marks show case vehicle’s path toward first contact with west guardrail

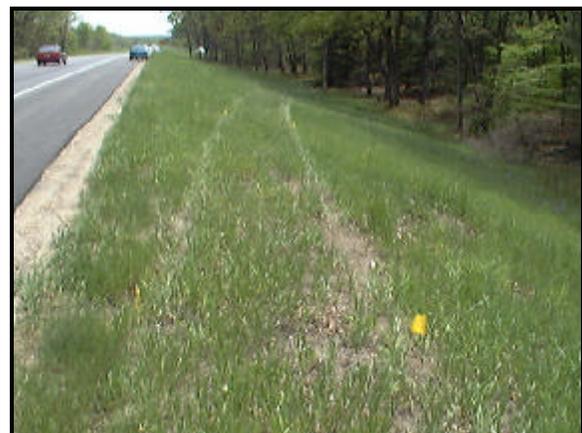
Figure 3: Case vehicle’s diagonal descent along embankment toward trees

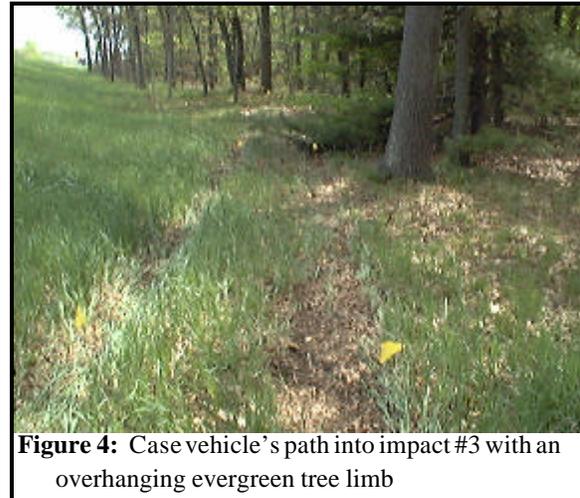
Figure 4: Case vehicle's path into impact #3 with an overhanging evergreen tree limb

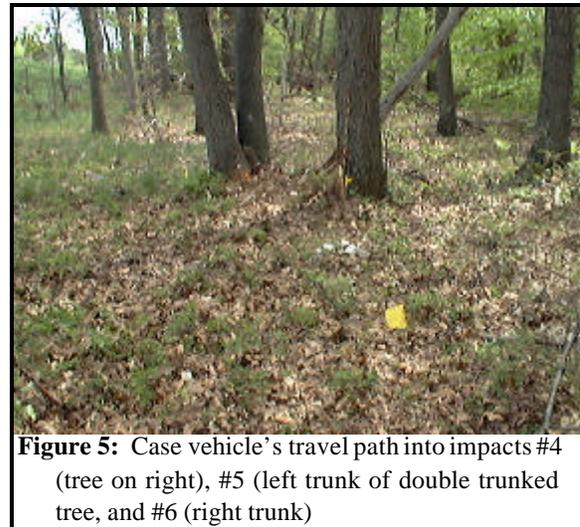
Figure 5: Case vehicle's travel path into impacts #4 (tree on right), #5 (left trunk of double trunked tree, and #6 (right trunk)

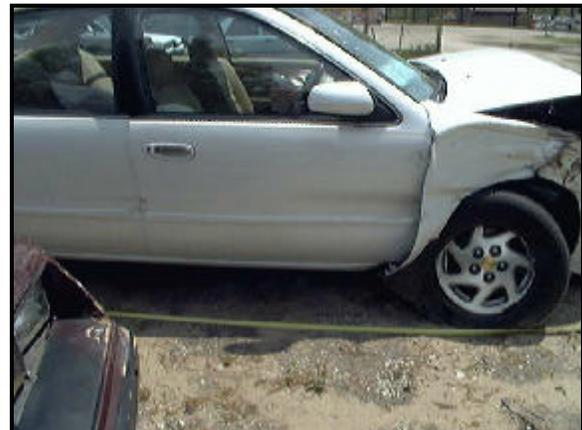
This crash sequence had six events. The first impact involved a W-beam guardrail on the southbound roadway’s west side and the right side of the case vehicle (determined CDC: **12-RDES-1 (010)**, WinSMASH not applicable). Direct damage began at the front right bumper corner and extended 365 centimeters [143.7 inches] rearward. Sheet metal scraping was the only damage, involving the right front bumper corner, the right front fender, the right front door, the right rear door, and the right rear quarterpanel (**Figures 6 and 7**). The second of six events was the right front wheel and tire striking a 15 centimeter [6 inch] concrete barrier curb, breaking the tire bead and deflating the tire. Rim gouges defined the case vehicle’s location as it traveled south on the west shoulder and, ultimately, off road (determined CDC: **12-FRWN-3 (000)**, WinSMASH not applicable). The third of six impacts involved a low-hanging evergreen tree limb and the front right two-thirds of the case vehicle. Again, damage was negligible with, perhaps, some paint scratching that was not identifiable in the photographs (determined CDC: **12-FDEW-1 (000)**, WinSMASH not applicable). Impact four was a sideswipe contact to the extreme front right corner of the case vehicle with the first struck tree (determined CDC: **12-FRES-6 (000)**, WinSMASH not applicable). Direct damage began 61 centimeters [24 inches] right of center front and extended to the front right bumper corner. Damage along the right front fender almost reached the center of the right front wheel well, displacing the right front wheel and tire rearward into the right lower A-pillar; also, the right

Figure 6: Case vehicle’s right front side damage from guardrail contact (case photo #ID=70040)

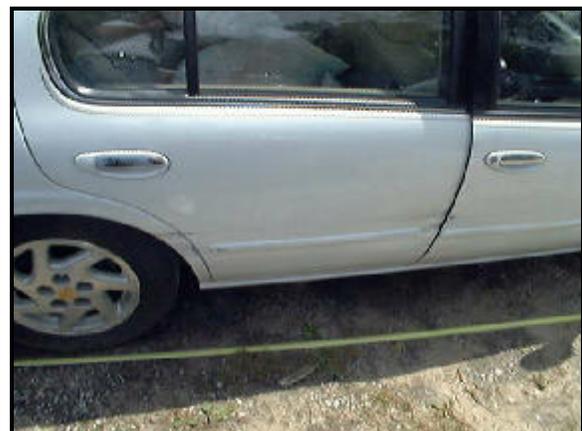
Figure 7: Case vehicle’s right rear side damage from guardrail contact (case photo #ID=70039)

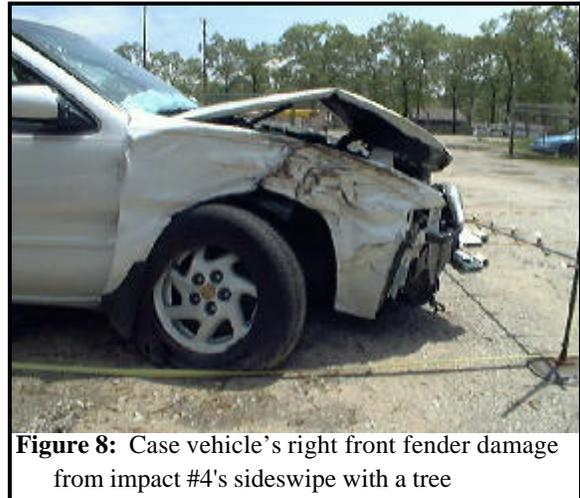
side rearview mirror was contacted (**Figure 8**). Fifth of the six events, and the most severe impact sustained by the case vehicle, involved the second of the three trees. Direct damage began at the center front and extended 53 centimeters [20.9 inches] left, with a maximum crush of 41 centimeters [16.1 inches]. Direct damage of components included: the front bumper fascia (separated from the case vehicle) and its reinforcement bar were displaced rearward, the front grille shattered, the front left headlamp assembly dislodged from its original location, and the left half of the hood's forward edge shoved rearward (**Figure 9**). The last of the six events involved the westernmost trunk of the double-trunked tree (determined CDC: **12-FCEN-1 (000)**, WinSMASH not applicable). The case vehicle rotated slightly counterclockwise during impact number five and came to rest against the third tree with minimal contact. Damaged components included the front hood edge just right of center and the front bumper reinforcement bar vertically aligned with the hood damage.

Figure 8: Case vehicle's right front fender damage from impact #4's sideswipe with a tree

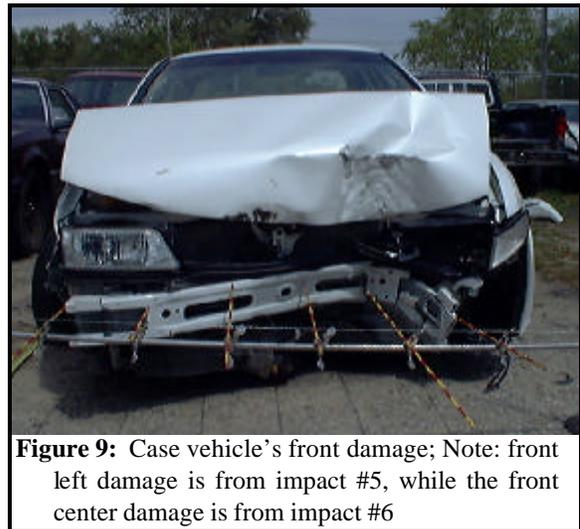
Based on the vehicle inspection, a CDC for impact #5 was determined to be: **12-FYEW-02 (000)**. The WinSMASH reconstruction program, CDC-only algorithm, was used on the case vehicle's highest severity impact. The Total, Longitudinal, and Lateral Delta Vs are, respectively: 31.0 km.p.h. [19.3 m.p.h.], -31.0 km.p.h. [-19.3 m.p.h.], and 0.0 km.p.h. [0.0 m.p.h.]. Thus, the crash severity for the case vehicle was moderate (24-40 km.p.h. [15-25 m.p.h.]).

Figure 9: Case vehicle's front damage; Note: front left damage is from impact #5, while the front center damage is from impact #6

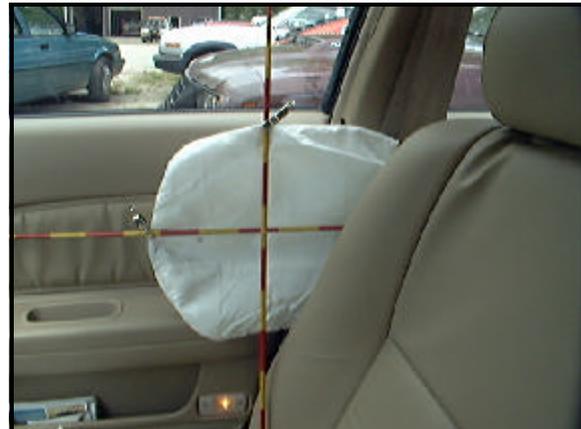
inches]. It was untethered but did have one vent port at the 3 o'clock position. No contact to the air bag fabric was identified by the NASS investigator (**Figure 10**). The side air bag cover flap deployed with such force that it shattered a portion of the vinyl covering over the lower right B-pillar and drove the unused male safety belt latch into the lower B-pillar's vinyl covering, where it was tightly wedged (**Figure 11**).

Figure 10: Case vehicle's front right passenger deployed side air bag; Note: there was no occupant in this seat position

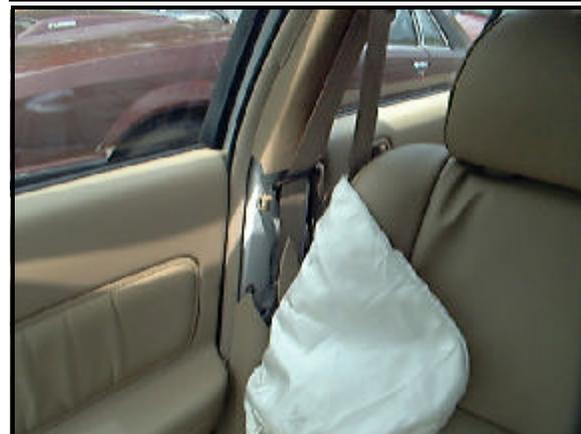
Figure 11: Case vehicle's lower right B-pillar damage from module cover flap contact

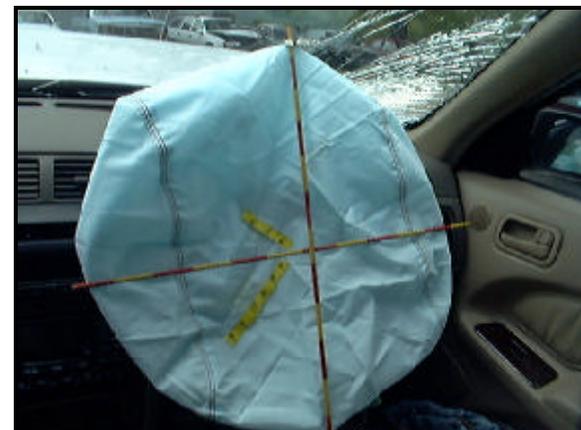
The front right passenger air bag was mounted on the top of the instrument panel. The single module cover flap rectangular, with a width of 25 centimeters [9.8 inches] and a height of 7.5 centimeters [2.9 inches]. The cover flap opened at its designated tear points and probably caused the glazing damage to the bottom right of the windshield. The passenger's front air bag was rectangular, with a height of 50 centimeters [19.7 inches] and a width of 40 centimeters [15.7 inches]. This air bag was untethered and without vent ports. Blood and mucus were detected by the NASS investigator above and below the horizontal center, and immediately to the left of the vertical center of the air bag's fabric (**Figure 12**).

Figure 12: Case vehicle's front right passenger front air bag; Note: yellow tape outlines presence of blood and mucus on the fabric
