**REDESIGNED AIR BAG SPECIAL STUDY (RABSS)
SCI TECHNICAL SUMMARY REPORT**

NASS CDS CASE NO. 1999-41-026J

RABSS VEHICLE - 1998 TOYOTA CELICA GT CONVERTIBLE

CRASH DATE - FEBRUARY, 1999

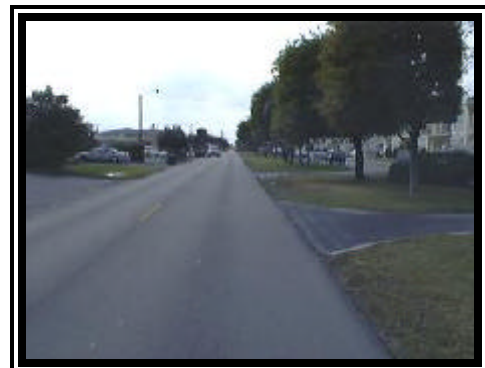
The 53 year old female driver of the 1998 Toyota Celica GT was operating the vehicle westbound (**Figure 1**) when she allowed the vehicle to depart the right (north) pavement edge in a forward tracking mode. The vehicle traveled approximately 76.5 meters (251.0 feet) alongside the north pavement edge prior to the first impact. The police reported no brake marks at the scene indicative of driver avoidance maneuvers.

Figure 1. Westbound approach for the 1998 Toyota Celica GT convertible.

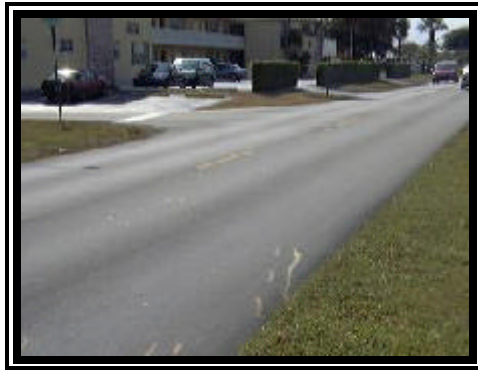
Figure 2. Southwest trajectory as the vehicle re-enters the roadway.

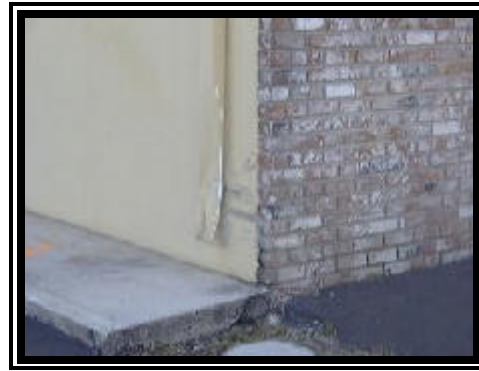
Figure 3. Struck building (impact #3).

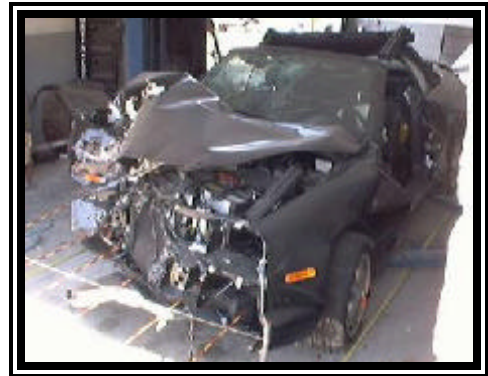
The 1998 Toyota Celica GT sustained moderate frontal damage as a result of the impact with the building (**Figure 4**). *Erroneous field documentation necessitated SCI revisions to the crush profile and deformation classification.* The direct contact damage began at the front right bumper corner and extended approximately 45.0 cm (17.7 in) inboard. The impact deformed the entire front end width resulting in a combined direct and induced damage length (Field L) of 140.0 cm (55.1 in). Six crush measurements were documented at the level of the lower radiator (*bumper reinforcement bar and fascia separation*): C1= 0 cm, C2= 2.0 cm (0.8 in), C3= 9.0 cm (3.5 in), C4= 34.0 cm (13.4 in), C5= 78.0 cm (30.7 in), C6= 47.0 cm (18.5 in). The Collision Deformation Classification (CDC) for this impact to the Toyota was 12-FZEW-3 with a principal direction of force of (+)10 degrees. The windshield was fractured from (exterior) impact forces and (interior) occupant contact. The hood was deformed up and rearward from engagement against the building. The right fender was displaced rearward which jammed the right door and restricted the right front wheel/tire. Reduction in the right side wheelbase measured 19.0 cm (7.5 in). Lateral and rearward displacement of the left fender jammed the left door and restricted the left front wheel/tire. Pry marks were noted to the left door (removed) frame from driver extrication activities post-crash.

Figure 4. Front right damage to the 1998 Toyota Celica GT Convertible.

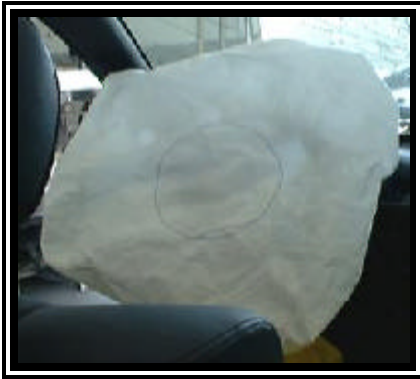
The 1998 Toyota Celica GT was equipped with redesigned frontal air bags for the driver and front right passenger positions. The air bags deployed as a result of the crash. The driver air bag was housed in the center of the steering wheel with a horizontally oriented flap tear seam (H-configuration). The flaps were symmetrical in shape and measured 13.5 cm (5.3 in) in width and 12.0 cm (4.7 in) in height. Although no contact evidence was identified on the exterior surface of the module cover flaps, an unspecified transfer was noted to the upper right quadrant of the air bag face. The NASS researcher measured the diameter of the driver air bag at 62.0 cm (24.4 in) in its deflated state (**Figure 5**). The bag was tethered by two internal straps and vented by two ports not located on the rear aspect by the NASS researcher.

Figure 5. 1998 Toyota Celica GT deployed redesigned driver air bag.

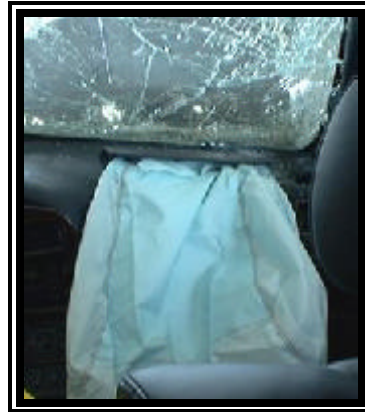
The front right passenger air bag deployed from the right top instrument panel area with a single cover flap design hinged at the forward aspect. No contact evidence was identified on the air bag or exterior surface of the module cover flap. The cover flap was rectangular in shape and measured 35.0 cm (13.8 in) in width and 6.0 cm (2.4 in) in height. No air bag dimensions or port locations were provided by the NASS researcher (**Figure 6**). No internal tether straps were reportedly present.

Figure 6. 1998 Toyota Celica GT deployed passenger air bag.

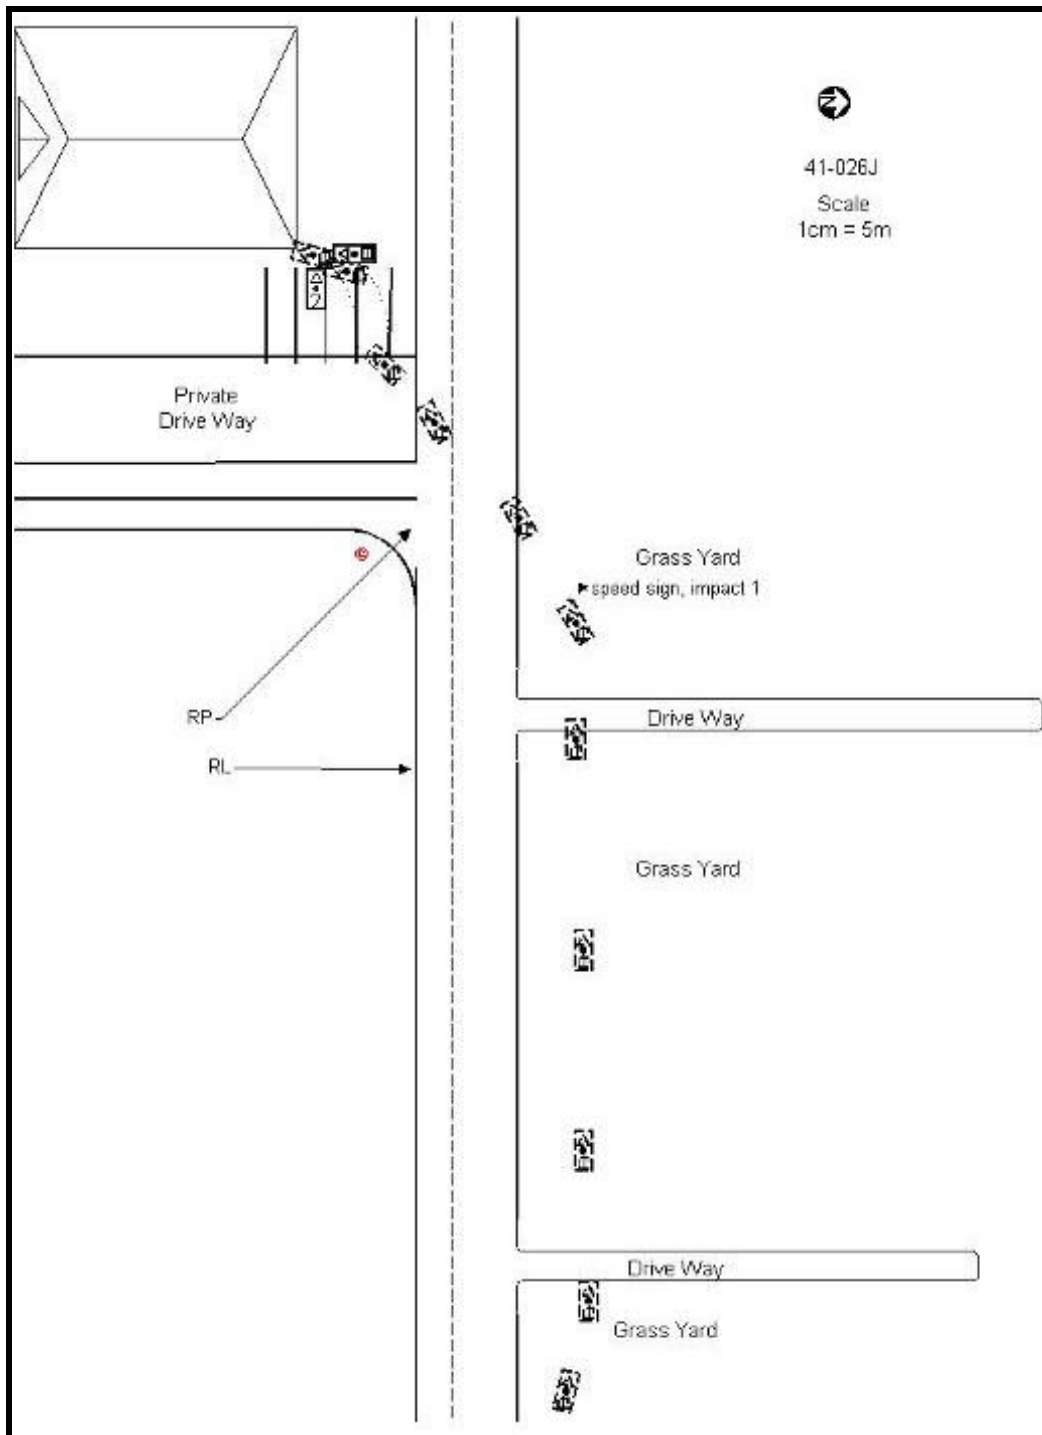
This single vehicle crash occurred during the late evening hours of February, 1999. At the time of the crash, it was dark (street lighted) with no adverse conditions as the road was dry. The crash occurred off the north pavement edge of a (straight/level) urban 2-lane east/west roadway (see **Figure 7 - page 6**). The asphalt roadway was bordered by a grassy area to the north and residential buildings to the south. No traffic control was present at the scene which had a posted speed limit of 56 km/h (35 mph).

Figure 7. NASS Scene Diagram (physical evidence not plotted, physical plant and collision dynamics incorrectly plotted by researcher).
