**REDESIGNED AIR BAG SPECIAL STUDY (RABSS)
SCI TECHNICAL SUMMARY REPORT**

NASS CDS CASE NO. 1999-45-211J

RABSS VEHICLE - 1999 FORD ESCORT SE

CRASH DATE - DECEMBER, 1999

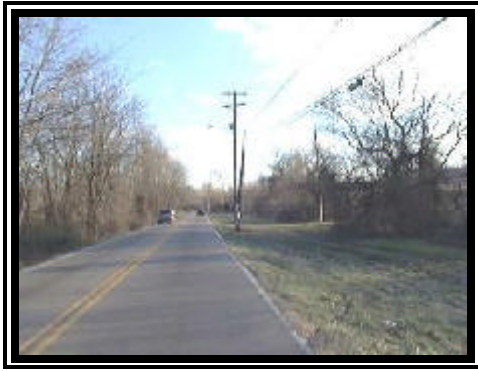
The 67 year old female driver of the 1999 Ford Escort SE was operating the vehicle southbound (**Figure 1**) at a (driver reported) speed of 56 km/h (35 mph) when she allowed the vehicle to depart the right (west) pavement edge in a forward tracking mode. The NASS interview stated that an unidentified northbound vehicle encroached into her lane of travel. As the right side wheels "*slipped off the apron*", multiple steering maneuvers were unsuccessful in her attempts to regain control of the vehicle. However, scene evidence suggests she may have been distracted and allowed the vehicle to simply drift off the road.

Figure 1. Southbound approach for the 1999 Ford Escort SE.

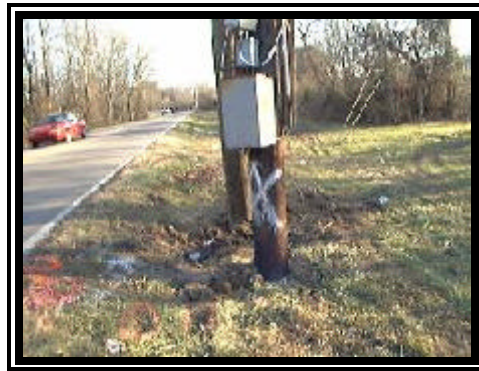
Figure 2. Struck utility pole.

As the Ford Escort departed the right (west) pavement edge of the rural 2-lane roadway, the front left area impacted a wooden utility pole (**Figure 2**) resulting in moderate damage. Although the impact was classified as out-of-scope (pole fractured/replaced), the WinSMASH reconstruction program computed a barrier equivalent velocity change of 34.4 km/h (21.4 mph) with a matching negative longitudinal component. The impact induced deceleration was sufficient to deploy the Ford's redesigned frontal air bag system. At this point, the vehicle rotated approximately 25 degrees counterclockwise and came to rest off the west road edge in close proximity to the point of impact facing southeast.

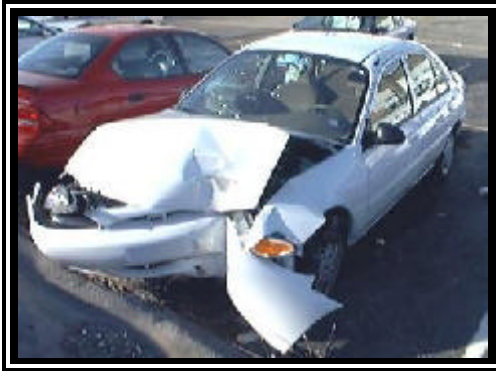
The 1999 Ford Escort sustained moderate frontal damage as a result of the impact with the utility pole (**Figure 3**). The direct contact damage began 10.0 cm (3.9 in) to the left of the vehicle centerline and extended 45.0 cm (17.7 in) outboard. The impact deformed the entire front end width resulting in a combined direct and induced damage length (Field L) of 100.0 cm (39.4 in). Six crush measurements were documented at the level of the bumper: C1= 23.0 cm (9.1 in), C2= 59.0 cm (23.2 in), C3= 37.0 cm (14.6 in), C4= 18.0 cm (7.1 in), C5= 3.0 cm (1.2 in), C6= 0 cm. The Collision Deformation Classification (CDC) for this impact to the Ford was 12-FYEW-3 with a principal direction of force of

0 degrees. The hood was deformed up and rearward from engagement against the pole. The left fender was displaced slightly rearward which restricted the left front wheel/tire (not deflated). The windshield was fractured by (exterior) impact forces and the (interior) front right air bag module cover flap. Reduction in the left side wheelbase measured 10.0 cm (3.9 in).

Figure 3. Front left damage to the 1999 Ford Escort SE.

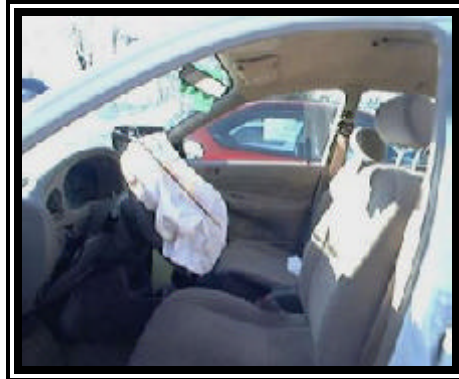
Figure 4. Interior view.

Interior damage to the Ford identified through the vehicle inspection was minimal and was attributed to occupant contact and component intrusion (**Figure 4**). A scuff mark was documented on the left knee bolster and mid-instrument panel area. The side mirror and defroster adjustment knobs were deformed. The accelerator pedal was deformed to the right. Longitudinal intrusions into the driver space involved 12.0 cm (4.7 in) of toe pan and 3.0 cm (1.2 in) of instrument panel intrusion. The NASS researcher reported a front left seat track anchor failure (*rear right seat anchor*), however, this could not be confirmed during the SCI review due to inadequate field documentation.

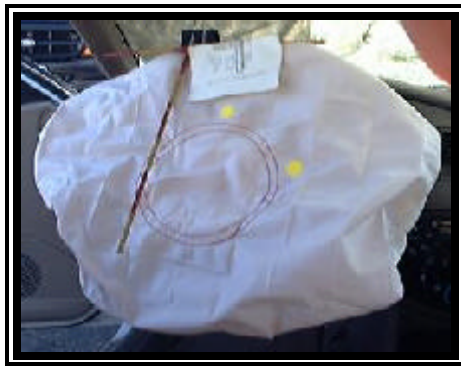
The 1999 Ford Escort SE was equipped with redesigned frontal air bags for the driver and front right passenger positions. The air bags deployed as a result of the crash. The driver air bag was housed in the center of the steering wheel with a horizontally oriented flap tear seam (H-configuration). The flaps were symmetrical in shape and measured 22.0 cm (8.7 in) in width along the tear seam and 10.0 cm (3.9 in) in height. Although no contact evidence was identified on the exterior surface of the module cover flaps, makeup transfers were documented at the upper right quadrant of the air bag face along with lipstick transfers to the lower right quadrant. The NASS researcher measured the diameter of the driver air bag at 61.0 cm (24.0 in) in its deflated state (**Figure 5**). The bag was tethered by two internal straps and vented by two ports located at the 11 o'clock and 1 o'clock sectors on the rear aspect of the air bag.

Figure 5. 1999 Ford Escort deployed redesigned driver air bag.

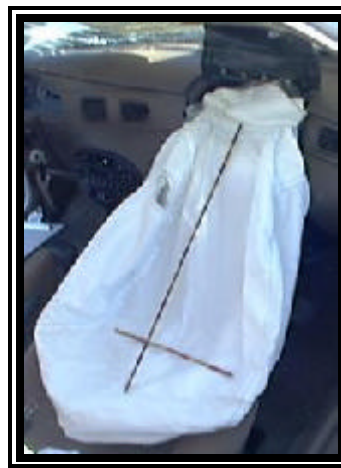
The front right passenger air bag deployed from the right mid-instrument panel area with a single cover flap design hinged at the top aspect. No contact evidence was identified on the air bag or exterior surface of the module cover flap. The cover flap was rectangular in shape and measured 31.0 cm (12.2 in) in width and 15.0 cm (5.9 in) in height. The NASS researcher measured the passenger air bag at 60.0 cm (23.6 in) in width and 78.0 cm (30.7 in) in height in its deflated state (**Figure 6**). The bag was vented by two ports located at the 10 o'clock and 2 o'clock sectors on the side aspect of the air bag. No internal tether straps were present.

Figure 6. 1999 Ford Escort deployed redesigned passenger air bag.

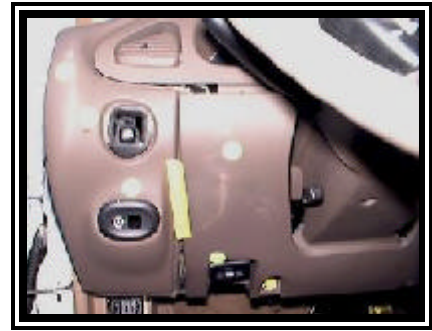
available 3-point manual lap and shoulder belt system, evidenced by the contusions sustained across the abdomen and left mid-chest. In addition, the medical reported a soft tissue injury that followed the size and orientation of the driver restraint (“v” shaped contusion). At impact, she initiated a forward trajectory in response to the 12 o’clock impact force and loaded the manual restraint, knee bolster and deployed redesigned driver air bag. Loading of the manual restraint resulted in the above mentioned soft tissue injuries, mesentery contusion, and fractures of the left 2-3 ribs. The posterior/lateral aspect of the rib fractures indicates improper placement of the shoulder belt harness under the left arm. Contact to the knee bolster resulted in a contusion to the left knee as evidenced by the scuff mark documented to this component (**Figure 7**). Contact to the deployed driver air bag was confirmed by the makeup transfers documented across the right portion of the air bag face. She also sustained a contusion to the right posterior hand and fracture of the right distal radius from contact to the left mid-instrument panel, evidenced by the deformed adjustment knobs and indentations documented to this component. The driver was removed from the vehicle by rescue personnel due to perceived serious injury and was transported by ambulance to a local trauma center for treatment and admitted for 17 days. The redesigned air bag provided protection against further contact to the steering wheel hub/rim, and potential serious injury.

Figure 7. Scuff marks and indentations to the driver knee bolster and mid-instrument panel area.

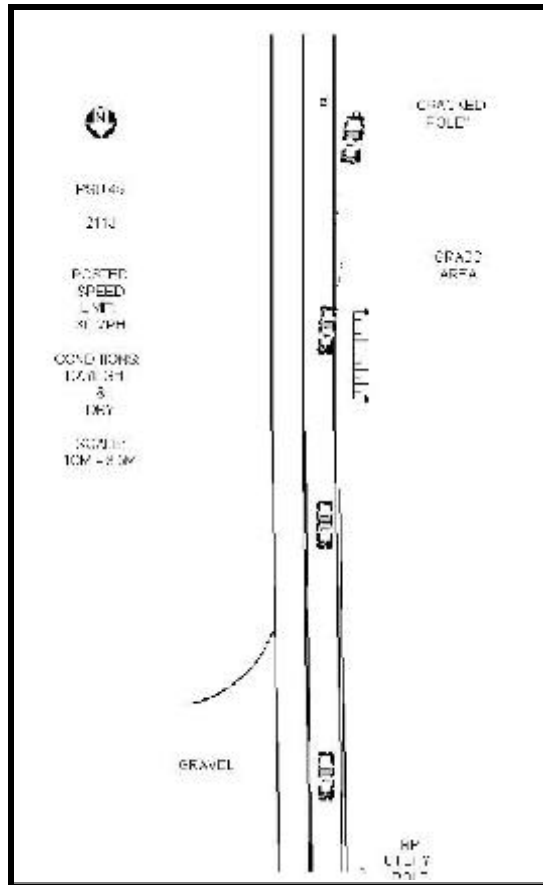
Figure 8. NASS Scene Diagram.

This single vehicle crash occurred during the afternoon hours of December, 1999. At the time of the crash, it was daylight with no adverse conditions as the road was dry. The crash occurred off the west pavement edge of a (straight/level) 2-lane north/south rural roadway (see **Figure 8 - page 5**). The asphalt roadway was bordered by grass shoulders with a utility pole located approximately 2.3 meters (7.5 feet) off the west pavement edge. No traffic control was present at the crash site which had a posted speed limit of 48 km/h (30 mph).
