Remote, Redesigned Air Bag Special Study

Dynamic Science, Inc., Case Number (1999-048-135C)

1999 Toyota Camry

Alabama

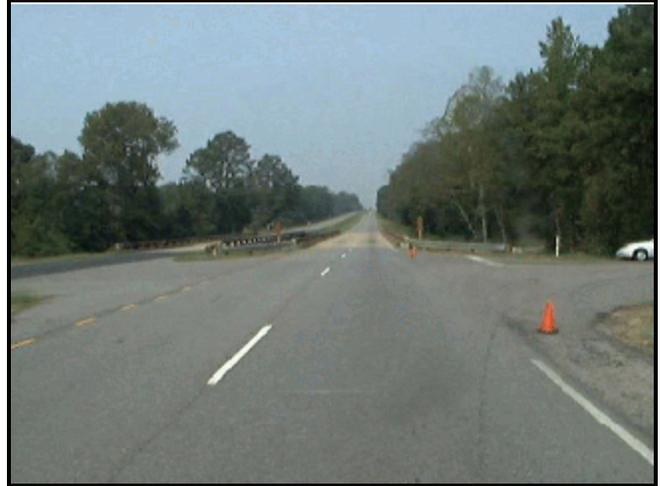
Figure 1. Path to point of impact.

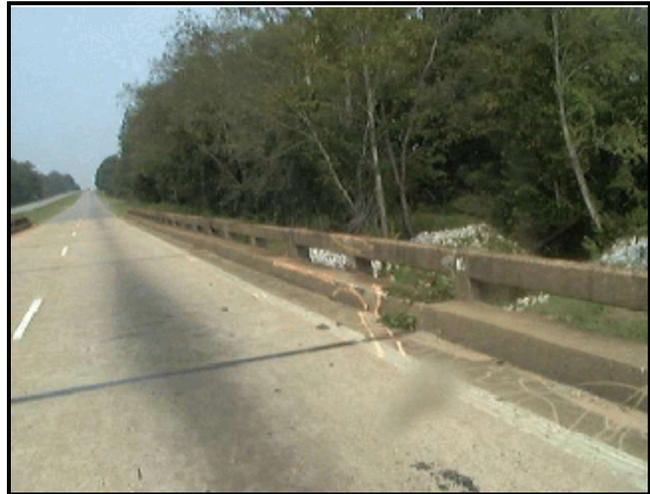
Figure 2. Point of impact with guard rail.

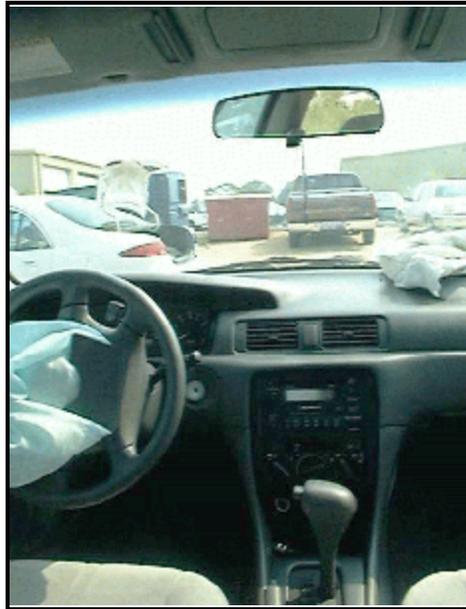
Figure 5. Interior, front left.

The interior of the case vehicle was undamaged as a result of the moderate frontal crash. The case vehicle maintained its integrity and there were no intruding components. The interior was void of any remarkable areas of occupant contact evidence—though there was a fluid spill on the right side of the steering wheel rim. This vehicle is equipped with front bucket seats and adjustable head restraints. The front left seat was in the middle track position.

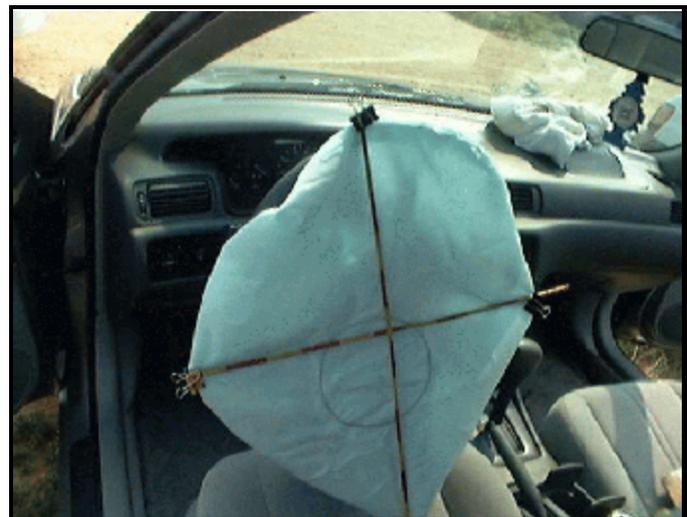
Figure 7. Driver front air bag.

The driver’s air bag is housed in the steering wheel hub. The double, horizontal module cover flaps are asymmetric in design and opened at their designated tear points. The circular air bag is equipped with two tether straps and two exhaust vent port holes. The rigid plastic knee bolster was undamaged and did not reveal any detectable occupant contacts.
