Remote, Redesigned Air Bag Special Study

Dynamic Science, Inc., Case Number (1999-75-112B)

1998 Dodge 1500 Ram Pickup

Colorado

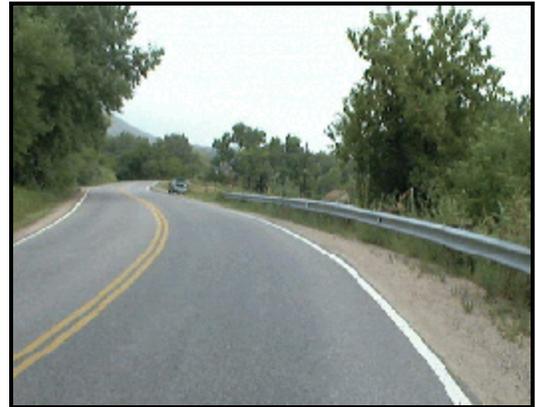
Vehicle 1, a 1992 Volkswagen Golf GTI three-door hatchback, was being driven by an 18 year-old-female (165 cm/ 65 in., 56 kg/ 123 lbs.) who was properly restrained by the available two-point automatic (non-motorized) shoulder belt and the manual two-point lap belt. The front right seat was occupied by a 15 year-old-female (158 cm/ 62 in., 43 kg/ 95 lbs.) who was wearing the two-point automatic shoulder belt, but not the manual lap belt. Vehicle 1 was traveling westbound and the driver was negotiating a left curve in the roadway when the vehicle's right side tires departed the roadway, onto the sand/gravel shoulder. Driver 1 was able to place the vehicle back onto the roadway as it initiated a slight counterclockwise yaw. The driver of Vehicle 1 applied an aggressive right steering input which over-corrected the vehicle attitude as Vehicle 1 initiated a clockwise rotation. Vehicle 1 traversed the double yellow centerlines and entered the eastbound travel lane.

Figure 1. Pre-impact trajectory of Vehicle 1

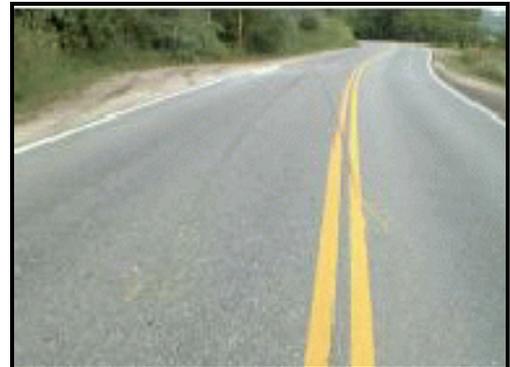
Figure 2. Vehicle 1 traverses roadway center lines

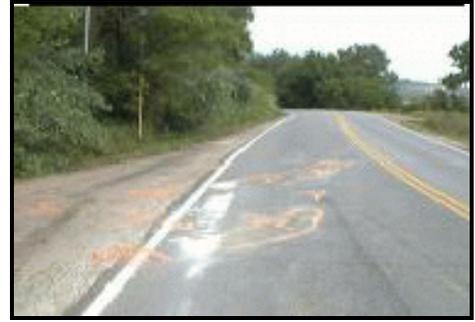
Vehicle 2 continued in its forward trajectory while it was deflected slightly to the right. Vehicle 1 (Volkswagen Golf) was pushed approximately 8.7 m (28.7 ft.) in an easterly direction before coming to rest straddling the south road edge line and facing northeast. Vehicle 2 was slightly askew in the eastbound travel lane and was facing easterly.

Figure 3. Point of impact and final rest position

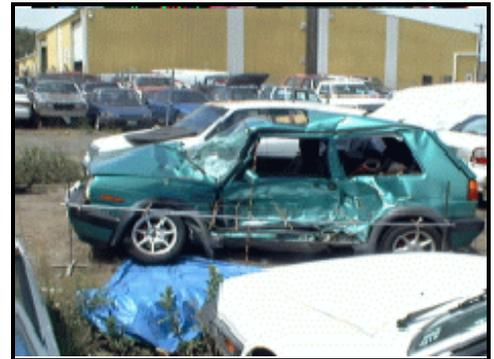
Figure 4. Left side deformation to Vehicle 1 (VW Golf GTI)

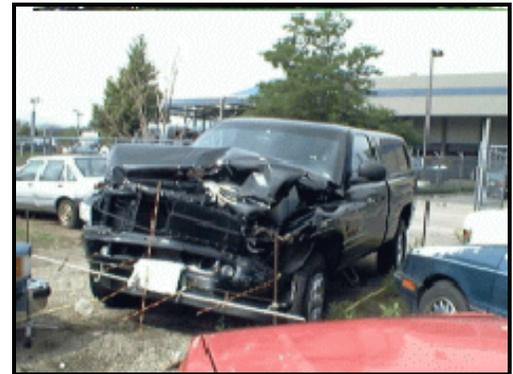
The full frontal plane of Vehicle 2 (12FDEW2) impacted the left side of Vehicle 1 (09LYAW5). The frontal air bag systems in Vehicle 2 (Dodge Ram) deployed as a result of the moderate/severe frontal impact. The calculated latitudinal delta V for Vehicle 1 was 69.05 km/h (42.9 mph) and its impact speed was calculated at 29.9 km/h (18.6mph)¹. Vehicle 2's longitudinal delta V was calculated at -31.8 km/h (-19.7 mph) with an estimated impact speed of 64.6 km/h (40.1 mph). The impact was sufficient to deploy the frontal air bags.

Figure 5. Frontal damage to Vehicle 2 (1998 Dodge Ram 1500)

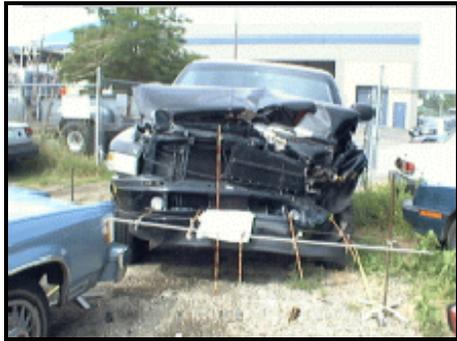
Figure 6. Full frontal view of Vehicle 2 (1998 Dodge Ram)

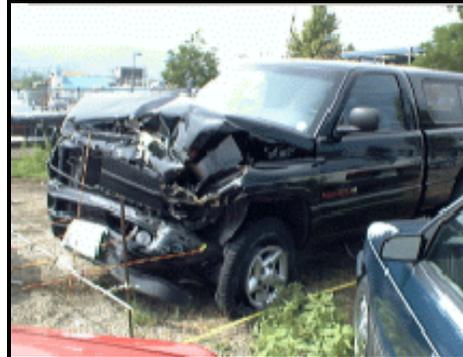
Figure 7. Three-quarter view of Vehicle 2—showing frontal deformation

Plane of Impact	Field L cm/in.	C1 cm/in.	C2 cm/in.	C3 cm/in.	C4 cm/in.	C5 cm/in.	C6 cm/in.
Front Bumper	164	44	32	26	19	12	16
	64.6	17.3	12.6	10.2	7.5	4.7	6.3

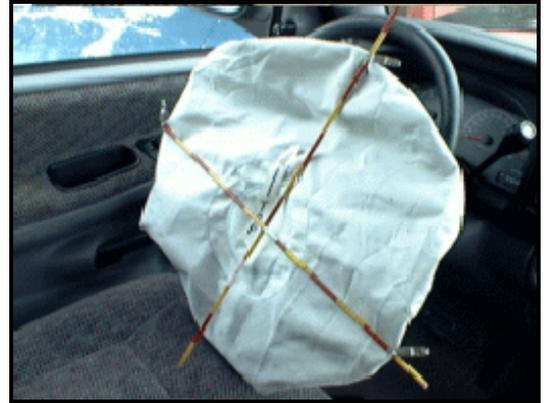
The driver's air bag is housed in the steering wheel hub and encases the nylon air bag unit. The module cover consists of a single rectangular flap door that opened at its designated tear points. The circular air bag is tethered by four straps and is equipped with only one exhaust vent port located at the 12 o'clock position. The rigid plastic knee bolster was undamaged and did not reveal any detectable occupant contacts.

Figure 8. View showing deployed driver's air bag

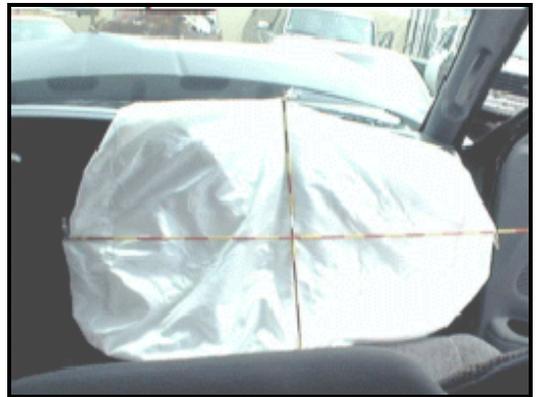
The front, right passenger air bag is located in the right hand side of the instrument panel (mid-mount) immediately above the glove box door. The single, rectangular module deployment door opened at its designated tear points. Upon deployment, the encased air bag fully deployed. The non-tethered air bag was undamaged and was not equipped with exhaust vent ports.

Figure 9. View showing deployed passenger air bag

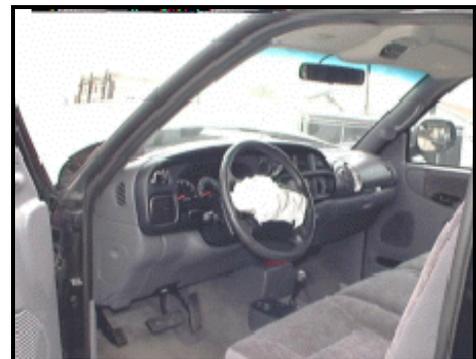
The 54 year-old-male driver of the 1998 Dodge Ram 1500 pickup truck was fully restrained and responded to the 12 o'clock direction of force by moving directly forward. He loaded the applied lap belt webbing which prohibited extended forward movement of his lower torso. His upper torso engaged the applied shoulder belt webbing as the driver's air bag deployed. His left forearm was contacted significantly by the deploying air bag which resulted in contusions and abrasions (AIS-1) of his left forearm (ventral aspect) which extended down to the volar region (palm). The driver rebounded into the seatback support which did not result in any additional injuries.

Figure 10. View showing driver's position

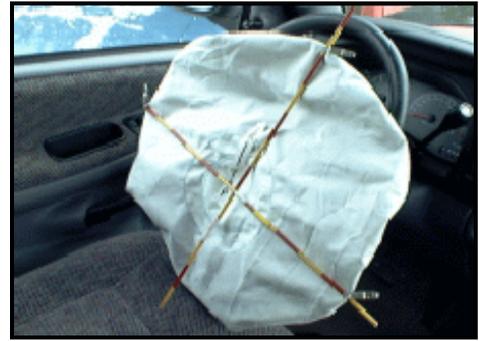
Figure 11. View showing deployed air bag
