Remote, Redesigned Air Bag Special Study
FOR NHTSA'S INTERNAL USE ONLY
Dynamic Science, Inc., Case Number (1999-75-801E)
1998 Saturn SC2
Colorado
May/1999

Summary

This remote investigation focused on the redesigned air bag system deployment of a 1998 Saturn SC2 two-door sedan. This moderate injury crash occurred in May, 1999 in the early morning. The weather was clear and the bituminous roadways were dry. The crash occurred in a four-legged intersection. The northbound roadway is a straight two-way divided roadway and is comprised of three northbound travel lanes, a grass covered center median, and two southbound lanes. The southbound roadway is a straight two-way undivided roadway and is comprised of two southbound lanes, two northbound lanes, and a left hand turn lane. The intersection is controlled by overhead traffic signals; the lights were green for northbound and southbound traffic. The asphalt road is level at the area of impact.

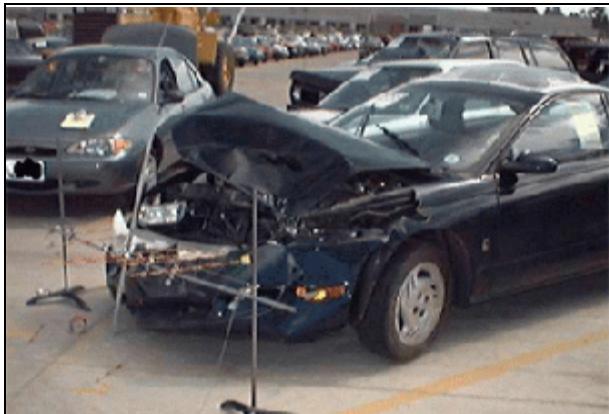
Figure 2. Left front corner view of case vehicle

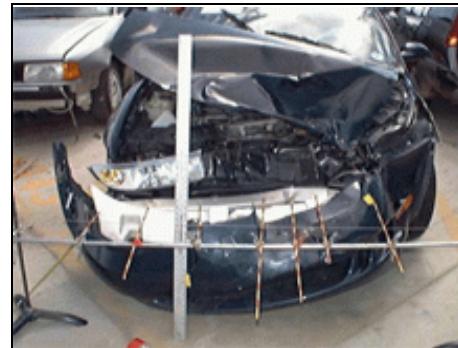
Figure 3. Front of case vehicle

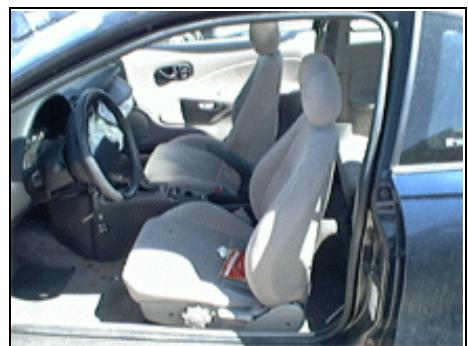
The case vehicle was equipped with bucket seats with adjustable head restraints in the front left and front right seating positions. The front left seat was adjusted to the rear most track position; the front right seat was adjusted to the forward most seat position. The rear of the vehicle was equipped with split bench seats with folding backs with no head restraints in all three seating positions.

Figure 4. Driver's seated position

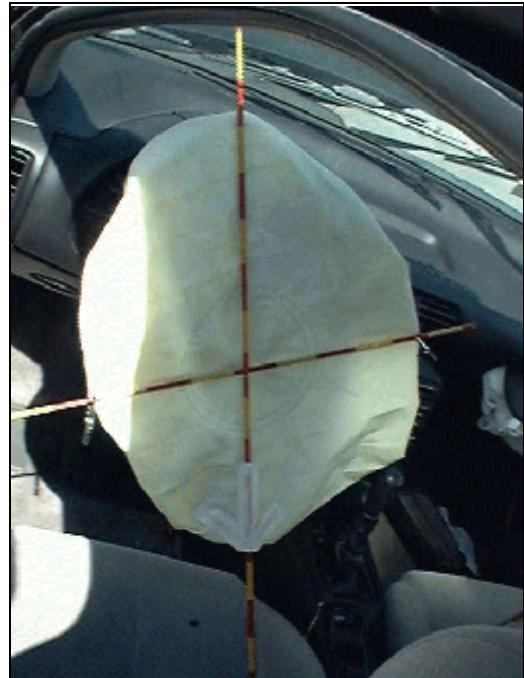
The Saturn SC2 was equipped with a redesigned air bag system which consisted of front left and front right air bag modules which housed air bags and depowered inflator units. The front left air bag was housed in the steering wheel hub and was concealed by I-configuration cover flaps that were not damaged. The circular air bag was equipped with three tethers and two vent ports. No contact evidence was found on the air bag and the air bag was not damaged. The front right air bag was housed in the mid instrument panel. The air bag did not come equipped with either vent holes or tethers. Neither the air bag nor the module covers were damaged.

Figure 5. Deployed driver's frontal air bag

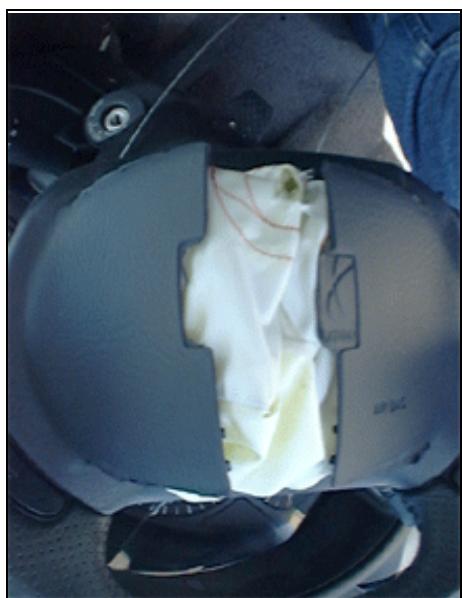
Figure 6. Driver's frontal air bag module cover

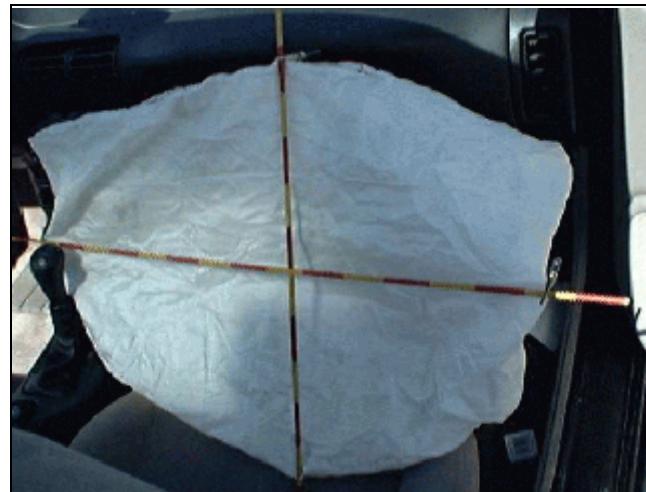
Figure 7. Deployed passenger's frontal air bag

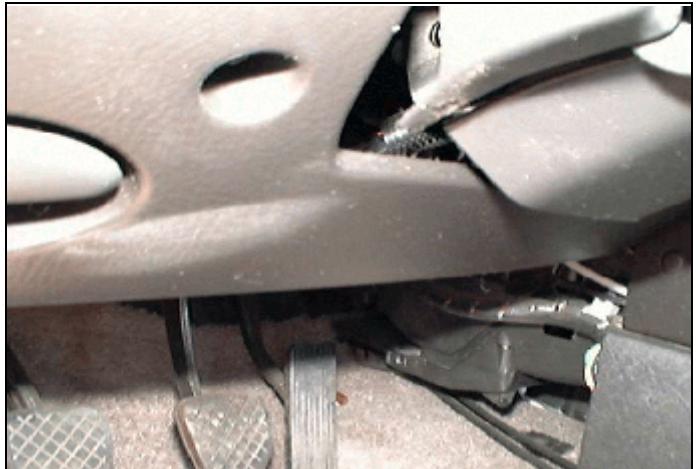
The interior of the Saturn SC2 sustained minor contact damage from occupant contact; a scuff was found below the left instrument panel and the right side seat back was deformed. There were no areas of intrusion into the passenger compartment..

At impact, the front left occupant reacted to the 340E direction of principal force by moving forward and to the left. Her right forearm came into contact with the deploying air bag and sustained a contusion. Her right knee came forward and engaged the lower instrument panel, causing a minor contusion. At impact, the front right occupant reacted to the 340E direction of principal force by moving forward and to the left. As the air bag deployed, it struck the inside of her right forearm, causing a contusion. As the air bag continued to deploy, it pushed her arm laterally into the side door, causing a contusion to the outer portion of her forearm. As this occupant pitched forward, she engaged the deploying air bag with her forehead, causing a minor abrasion near the hair line. At impact, the rear right occupant reacted to the 340E direction of principal force by moving forward and to the left. As this occupant pitched forward, she was locked into place by the lap and shoulder belt. This movement caused the occupant to load the lap portion of the belt which caused a contusion to her left hip. There was a contact mark to the rear of the front right seat, but no associated injury.

Figure 8. Contact mark to left instrument panel area

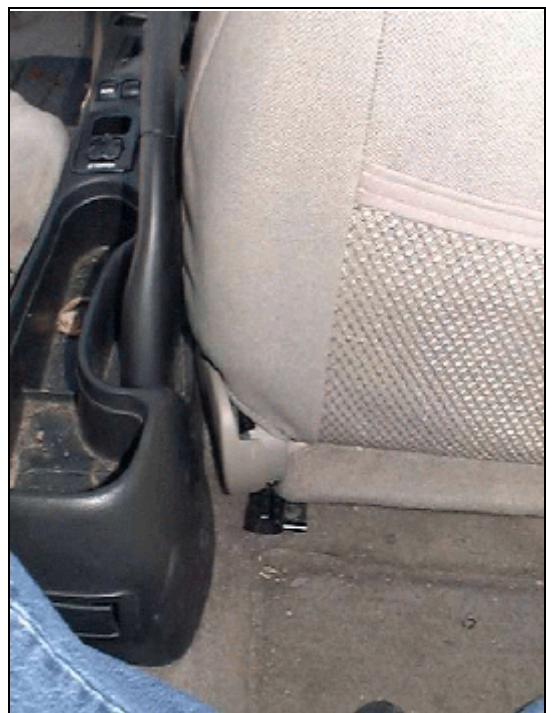
Figure 9. Rear of front right seat
