Remote, Redesigned Air Bag Special Study
Dynamic Science, Inc., Case Number (1999-79-056E)
1998 Ford Escort four-door sedan
California
May/1999

1. Report No. 1999-79-056E	2. Government Accession No.	3. Recipient Catalog No.	
4. Title and Subtitle		5. Report Date April 14, 2000	6. Performing Organization Report No.

Summary

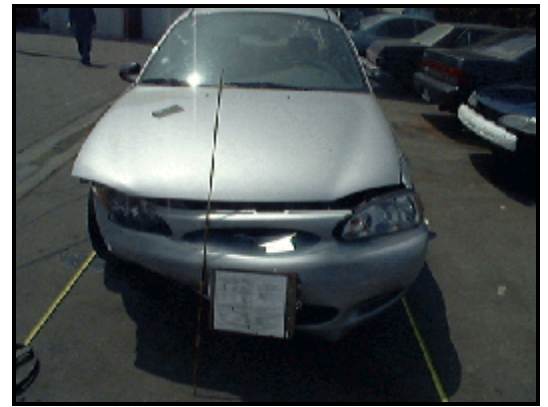
As the vehicles reached the intersection, the driver of Vehicle 1 attempted to make a left hand turn to go to the west. The driver of Vehicle 2 was unable to stop and the front (71FLEE3) of Vehicle 2 struck the right front of Vehicle 1 (01FZEW2). Upon the significant frontal impact, the air bags in Vehicle 1 deployed. The calculated Delta V for Vehicle 1 was 17.0 km/h (10.6 mph) with a longitudinal Delta V of -16 km/h (9.9 mph) which was of sufficient force to deploy both the frontal air bags. The delta V for Vehicle 2 was calculated at 19 km/h (11.8 mph) with a longitudinal delta V of -16 km/h (-9.9 mph)¹.

Figure 3. Exterior, Vehicle 1

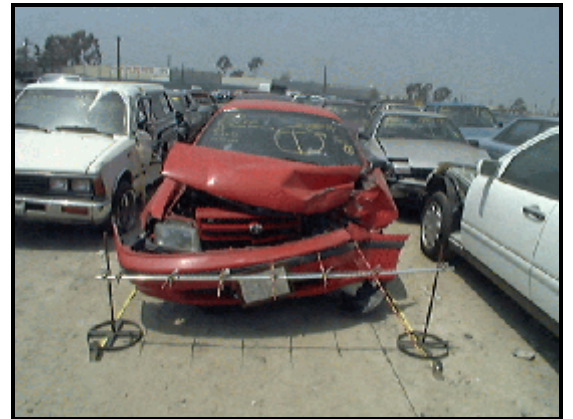
Figure 4. Exterior, Vehicle 2

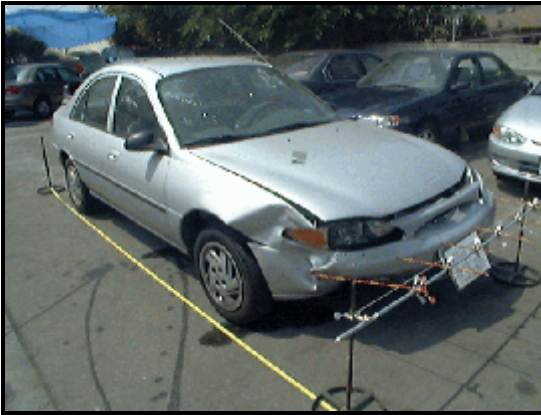
Figure 5. Exterior, Vehicle 1

Plane of Impact	Field L cm/in.	C1 cm/in.	C2 cm/in.	C3 cm/in.	C4 cm/in.	C5 cm/in.	C6 cm/in.
Bumper	147	1	1	6	10	14	34
	57.9	0.4	0.4	2.4	3.9	5.5	13.4

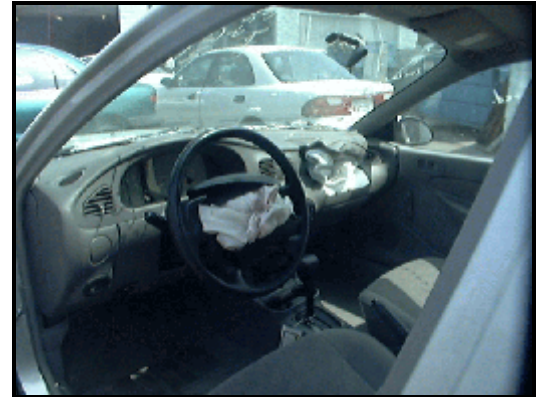
The interior of the 1998 Ford Escort did not sustain any integrity loss or any intrusion. The laminated windshield glazing was damaged from the impact forces.

Figure 6. Interior, Vehicle 1

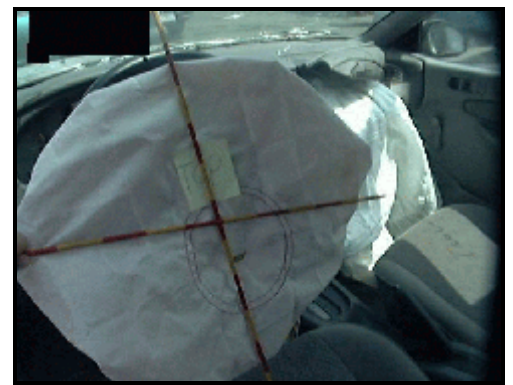
The driver's air bag is housed in the fixed column steering wheel hub and encases the nylon air bag unit. The double, horizontal module cover flaps are asymmetric in design and opened at their designated tear points. The circular air bag is equipped with two tether straps and two exhaust vent port holes. The vent ports are located at the 11 and 1 o'clock positions.

Figure 7. Driver air bag

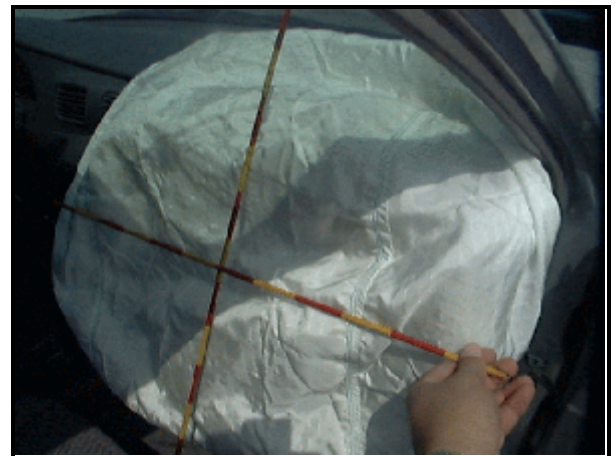
The front, right passenger's air bag is located on the instrument panel (top mounted). The module cover was rectangular. The air bag is equipped with two vent ports and does not have any tethers.

Figure 8. Passenger frontal air bag

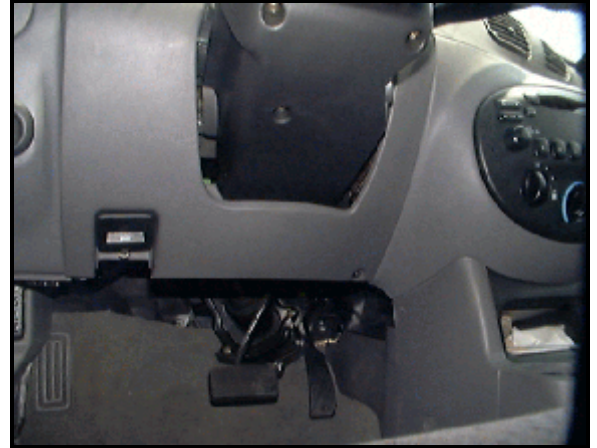
She responded to the 20E direction of force by moving forward and to the right. She was restrained by the lap and shoulder belt, but did move forward enough to engage the lower instrument panel/knee bolster with her right knee and sustained a minor contusion (AIS-1). As the driver's air bag deployed, she engaged it but did not sustain any related injuries.

Figure 9. Lower instrument panel/knee bolster
