Remote, Redesigned Air Bag Special Study

Dynamic Science, Inc., Case Number ( 1999-79-058A)

1998 Toyota Camry

1. Report No. 1999-79-058A	2. Government Accession No.	3. Recipient Catalog No.	
4. Title and Subtitle		5. Report Date April 17, 2000	
		6. Performing Organization Report No.

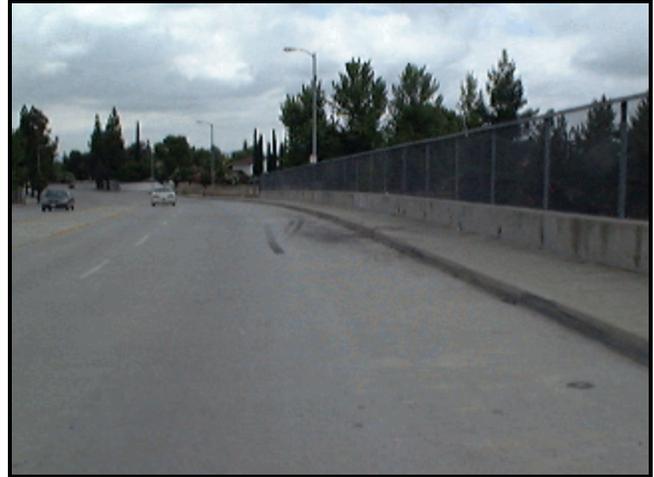
**Figure 1.** Approach to area of impact - south

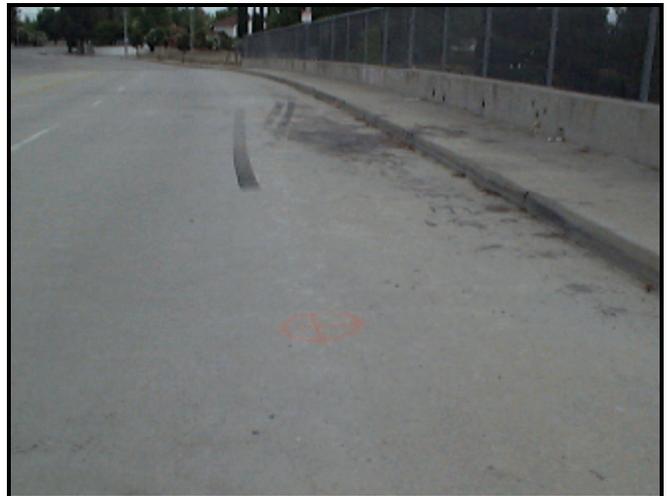
**Figure 2.** Area of impact - south

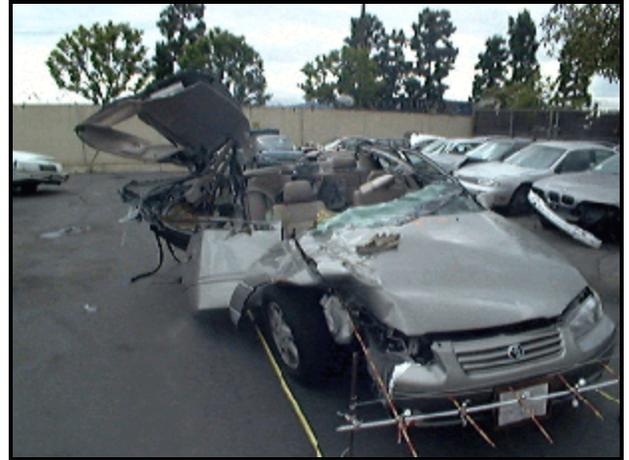
**Figure 3.** Exterior, Vehicle 1

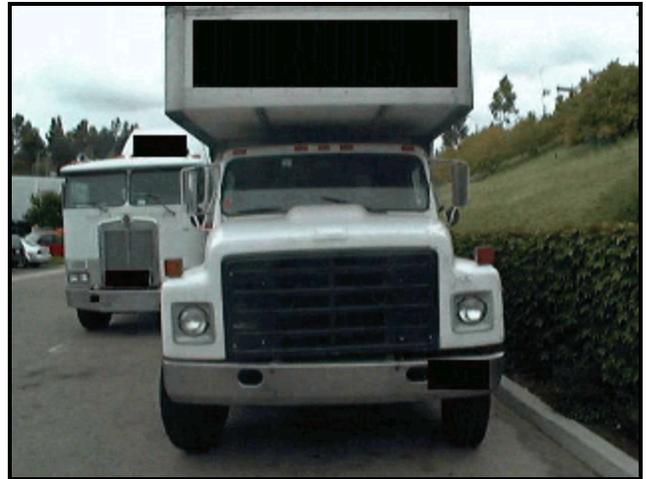
**Figure 4.** Exterior, Vehicle 2

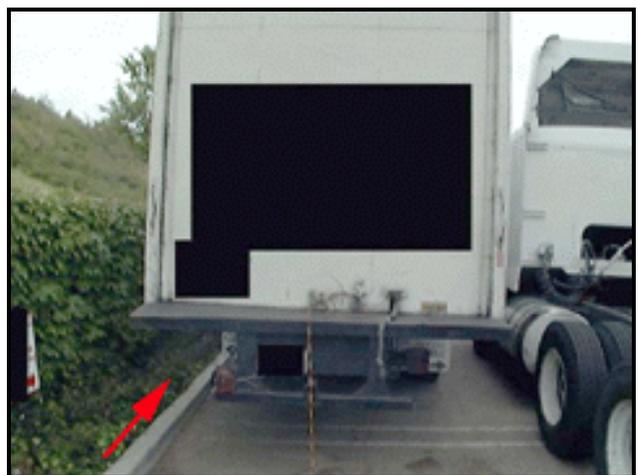
**Figure 5.** Exterior, Vehicle 2

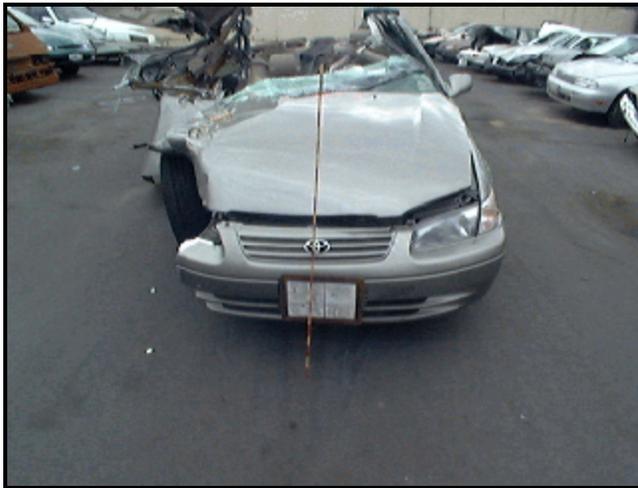
**Figure 6.** Exterior, Vehicle 1 (front view)

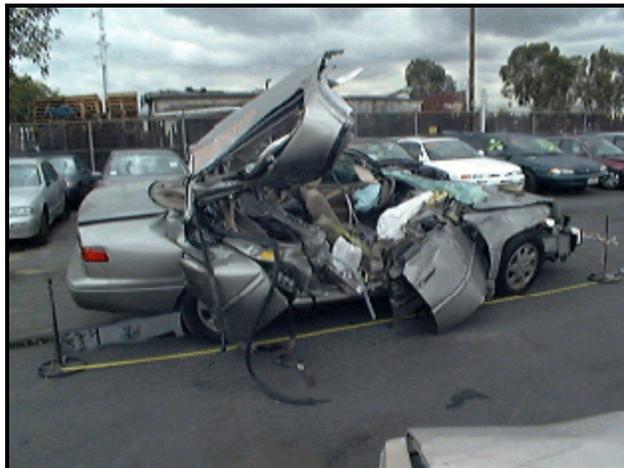
**Figure 7.** Exterior, Vehicle 1 (side view)

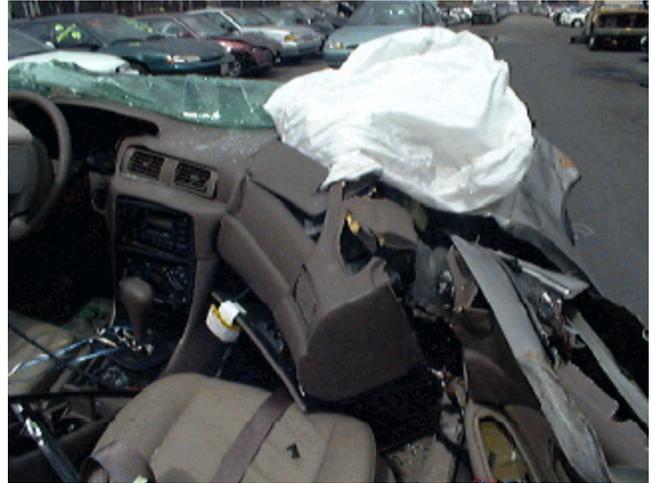
The interior of this 1998 Toyota Camry sustained considerable damage. There was major intrusion of the passenger compartment on the right side—primarily the windshield area and the instrument panel (see Table 3). The intrusion at the higher level was a result of penetration by the bed of the struck truck. The intrusion at the lower level was primarily related to contact over and through the wheel area. The vehicle sustained integrity loss through the windshield and through the right side glass.

**Figure 8:** Interior Vehicle

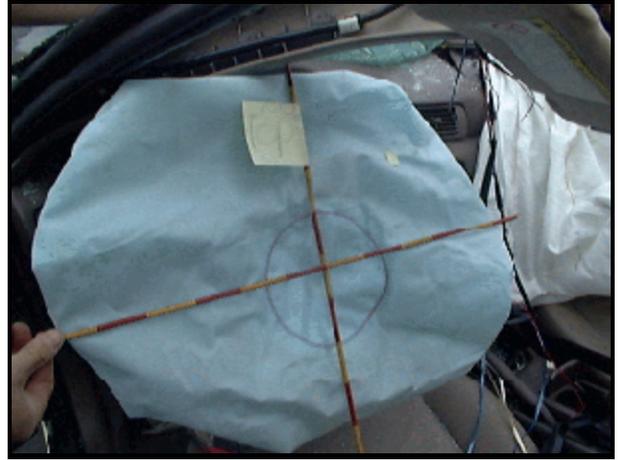
Vehicle 1 (1998 Toyota Camry) was equipped with a redesigned driver's frontal air bag, a redesigned front right passenger's frontal air bag, and driver and front passenger seat-mounted side-impact air bags. The driver's frontal air bag was mounted in the tilt steering wheel; it is circular in shape and is equipped with 4 tethers and two vent ports. There was no damage to either the air bag or its module cover.

Figure 9. Driver's frontal air bag

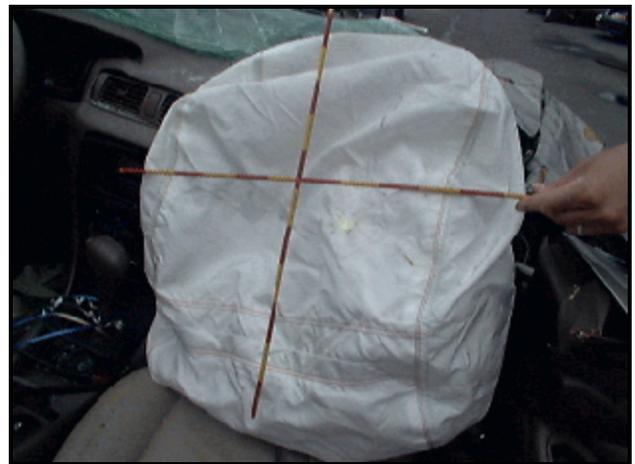
The passenger's frontal air bag was mounted on top of the instrument panel; it is square shaped and has one vent port and no tethers. The air bag opened normally and there was no damage to the module cover. There was, however, some tearing of the air bag itself. The cause the damage is not known. Both frontal air bags deployed at impact.

Figure 10. Passenger's frontal air bag

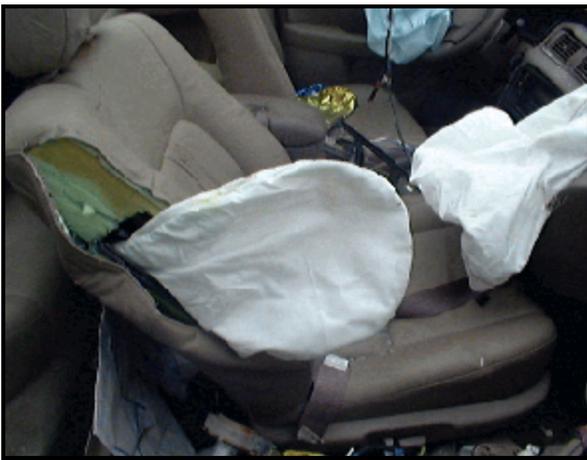
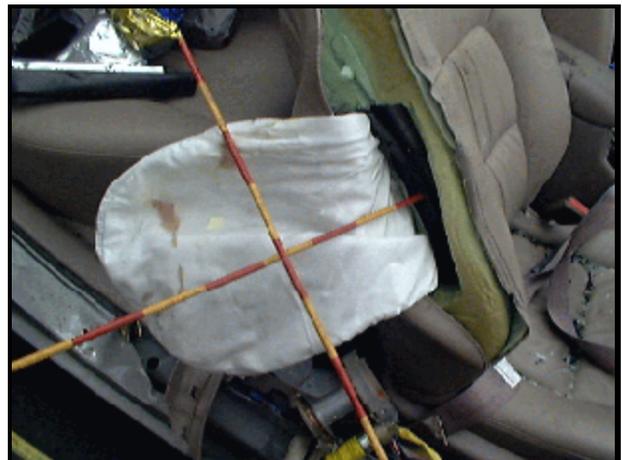
The front passenger side air bag was enclosed in the front right seat back. This air bag also deployed at impact. This deployment is likely a result of the unusual crush pattern from this accident and the significant amount of side contact. The driver's side air bag did not deploy.

Figure 11. Passenger side air bag

Figure 12. Passenger side air bag

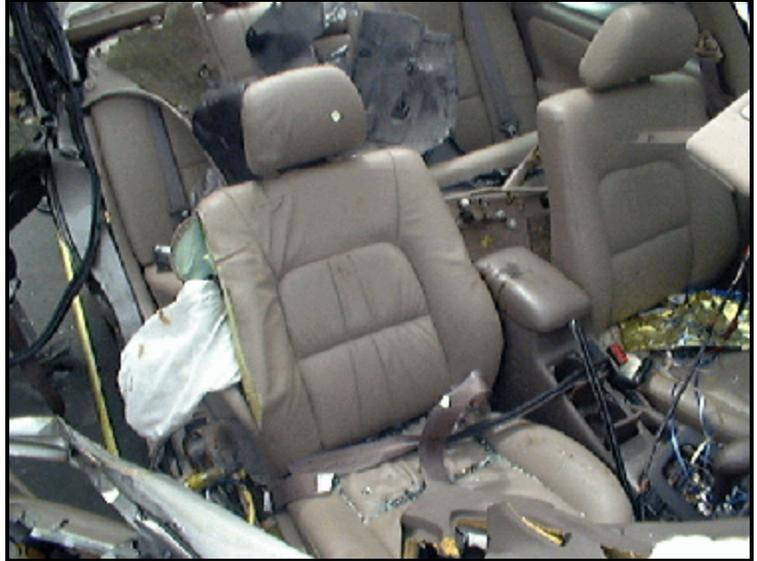
**Figure 13.** Interior, front right seat

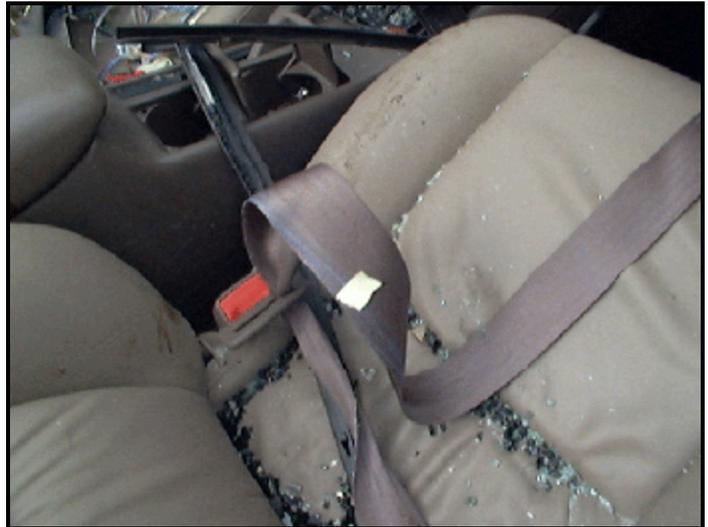
**Figure 14.** Front right seat—note load marks on seat belt
