Remote, Redesigned Air Bag Special Study

Dynamic Science, Inc., Case Number (1999-79-801E)

1999 Mitsubishi Mirage

April 1999

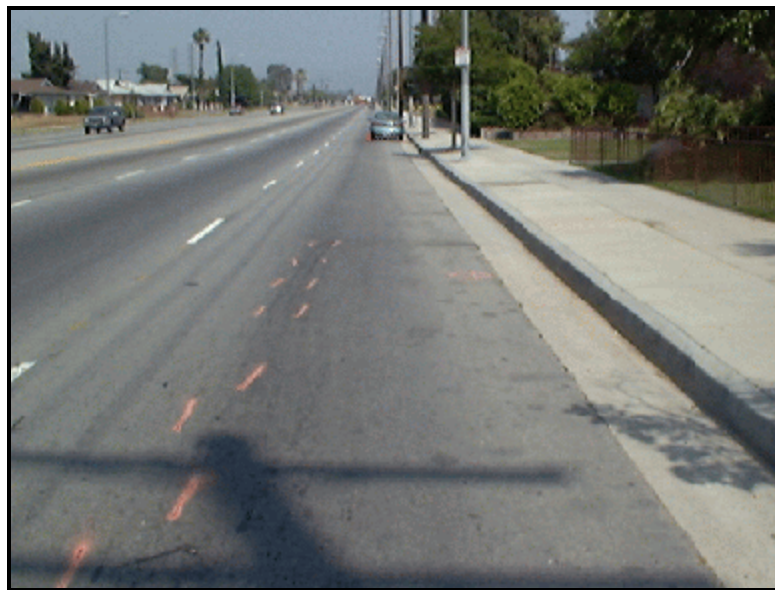
Figure 1. Approach to area of impact with parked vehicle

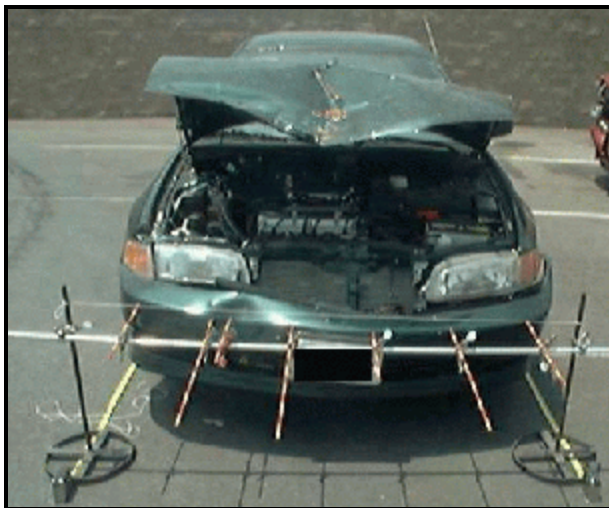
Vehicle 1 was traveling in the curbed lane eastbound and drifted to the right striking the legally parked truck. The front right corner of Vehicle 1 (12FZEW1) impacted the back of the parked vehicle (06BYEW2). The front driver's and passenger's air bag systems in Vehicle 1 deployed. The Delta V was calculated using the WinSmash algorithm program and the crush profile obtained from both vehicles. The longitudinal speed change for Vehicle 1 was calculated at -38.4 km/h (-23.9 mph). The longitudinal Delta V for Vehicle 2 was calculated at 29.7 km/h (18.5 mph). Vehicle 1 continued forward rotating slightly clockwise post impact. The final rest position for Vehicle 1 was on the roadway facing east. The parked vehicle was pushed forward and remained eastbound on the roadway.

Figure 2. Exterior, Vehicle 1. Front view.

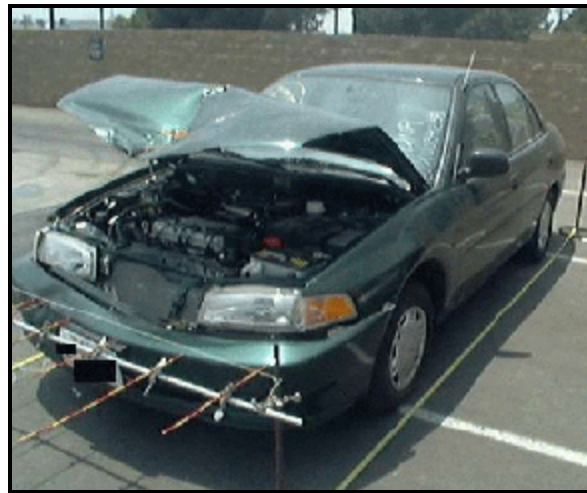
Figure 3. Exterior, Vehicle 1. Left quarter view

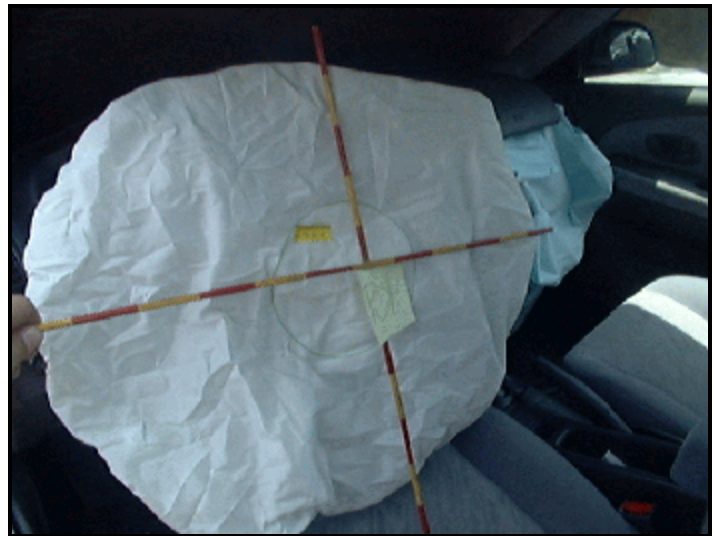
The original manufacturer installed driver's frontal air bag module is housed in the steering wheel hub and encases the nylon air bag unit. The single flap air bag deployed during the crash sequence and no damage to the bag was noted. The circular air bag is tethered by two straps and equipped with two exhaust vent port holes.

Figure 4. Driver's air bag

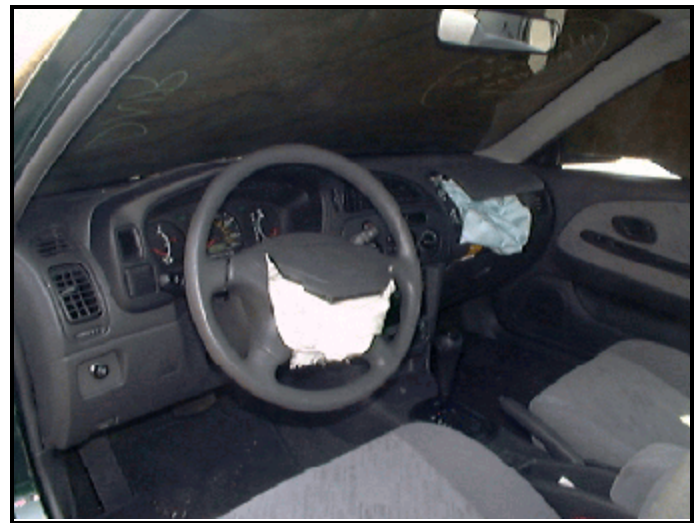
The interior of the 1999 Mitsubishi Mirage was undamaged as a result of the minor/moderate frontal impact. The Mitsubishi Mirage maintained its integrity and there were no intruding components. The left instrument panel and the driver's belt restraint webbing/buckle showed signs of occupant contact but no occupant injuries were reported that can be attributed to the contacts. The deployed driver's frontal air bag showed signs of smudging and occupant contact is evident due to the driver's facial injuries. This vehicle is equipped with front row bucket seats with adjustable head restraints and the second row has a bench seat with integral head restraints located at the outboard positions. The left front seat was positioned at the middle track position with the seat back in a normal, slightly reclined position as also was the right front seat. The second row bench seats are non-adjustable. No seat performance failures are noted. No vehicle glazing damage is reported.

Figure 5. Driver's seated position
