Remote, Redesigned Air Bag Special Study

Dynamic Science, Inc., Case Number (1999-081-046K)

1998 Dodge Neon

April/1999

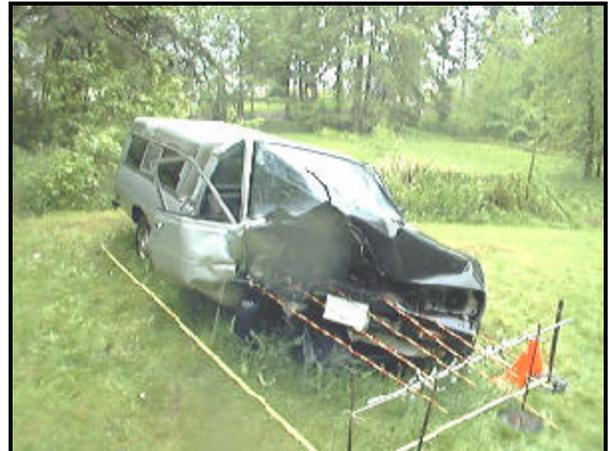
Figure 1. Exterior, Vehicle 1 (1986 Mitsubishi Pickup)

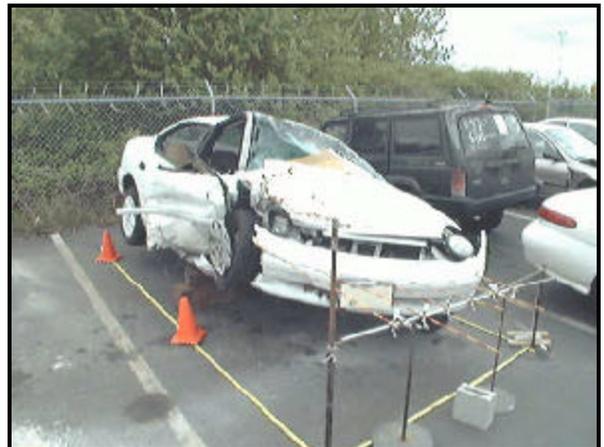
Figure 2. Exterior, Vehicle 2 (1998 Dodge Neon)

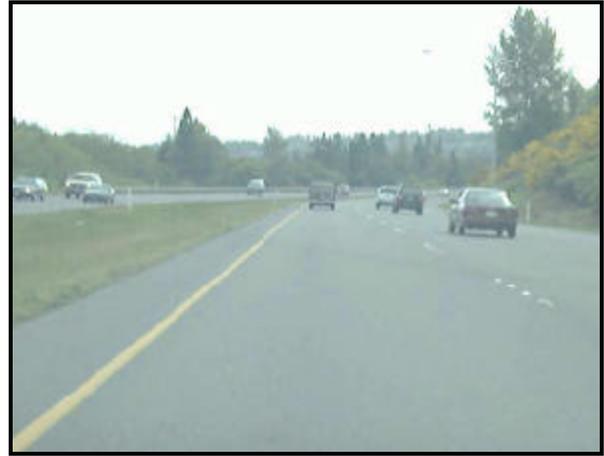
Figure 3. Crash scene, area of impact.

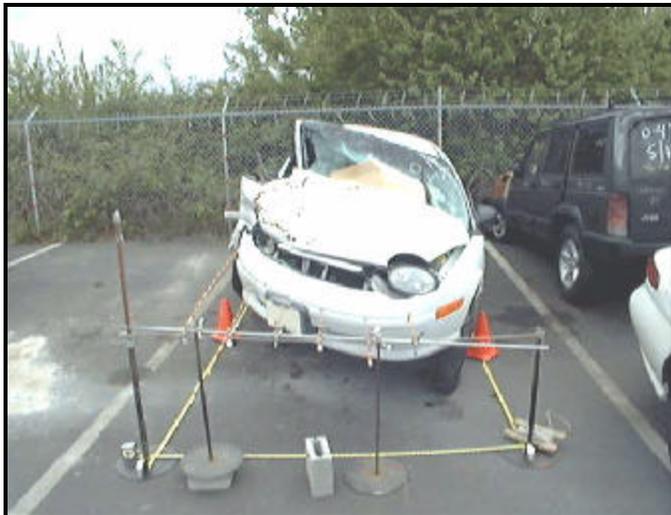
Figure 4. Exterior, Vehicle 2 (1998 Dodge Neon 4-door)

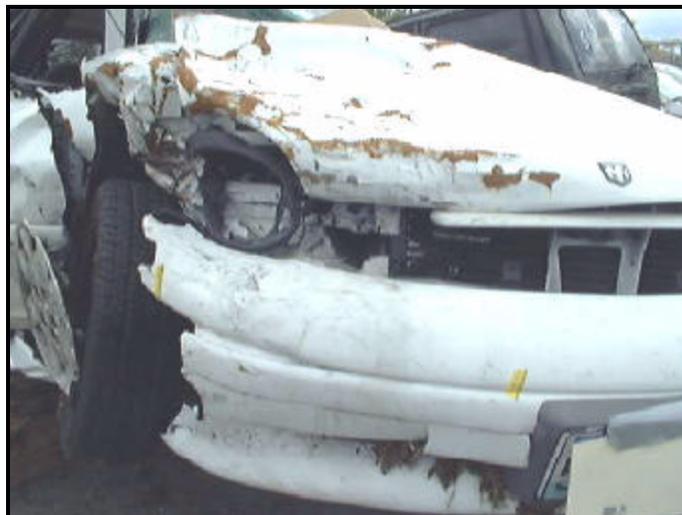
Figure 5. Direct damage, Vehicle 2 (1998 Dodge Neon 4-door)

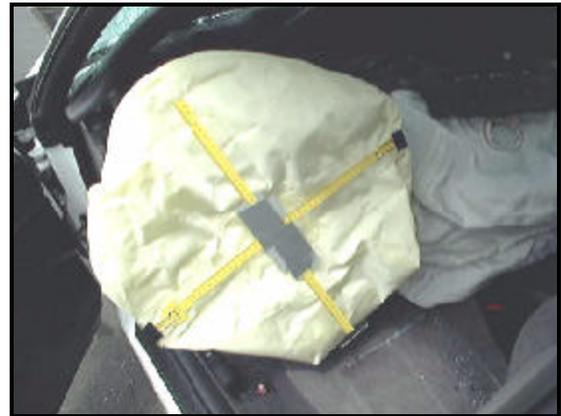
The front left air bag was housed in the steering wheel hub and was concealed by a single inverted D-shaped cover flap which was not damaged in the crash. The circular air bag was equipped with two vent ports and two tether straps. Contact evidence consisting of several blood spots was found on the upper left quadrant of the front of the bag. The air bag was not damaged.

Figure 6. Driver's frontal redesigned air bag.

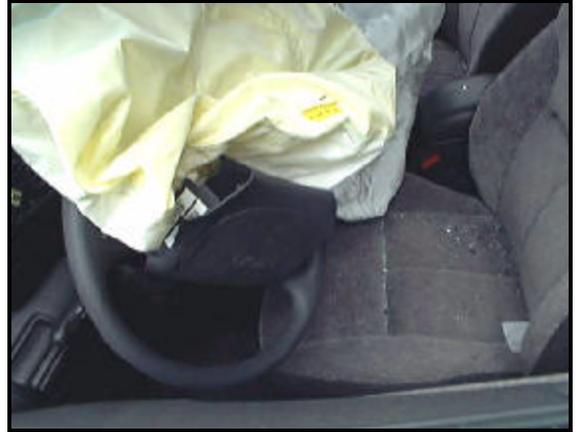
At impact, the driver reacted to the 0 degree principle direction of force by moving sharply forward. As the restraints locked, further frontal movement of the driver was prevented. The driver appears to have engaged the deploying frontal air bag with his face, leaving several blood spots on the front of the bag (see Figure 7).

Figure 7. Driver's frontal air bag contact evidence.
