Remote, Redesigned Air Bag Special Study
On-scene Investigation / Vehicle to Vehicle
Dynamic Science, Inc. / Case Number: DS99001
1998 Chevrolet Blazer
Maryland
September 1998

1. Report No. DS99001		2. Government Accession No.		3. Recipient Catalog No.	
4. Title and Subtitle In-Depth Accident Investigation				5. Report Date December 7, 1999

Description: This on-scene investigation focused on the redesigned air bag system deployment of a 1998 Chevrolet Blazer. The case vehicle, a 1998 Chevrolet Blazer, was equipped with a Supplemental Restraint System (SRS) that consisted of depowered driver and right front passenger air bags that deployed in the crash. The driver of the case vehicle sustained major injuries consisting of fractures, dislocations, contusions and abrasions; maximum AIS = AIS-3. The front right occupant sustained fatal chest injuries of an unknown nature. The two rear seat occupants were reported, by police, to have sustained minor injuries of an unknown nature or severity. NHTSA was notified of this crash through the Crash Injury Research and Engineering Network on January 8, 1999. NHTSA assigned this investigation to the DSI Special Crash Investigations team on Jan

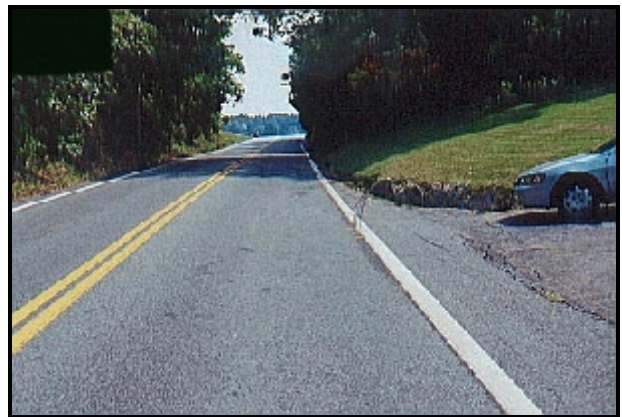
Figure 1. Path of case vehicle to area of impact.

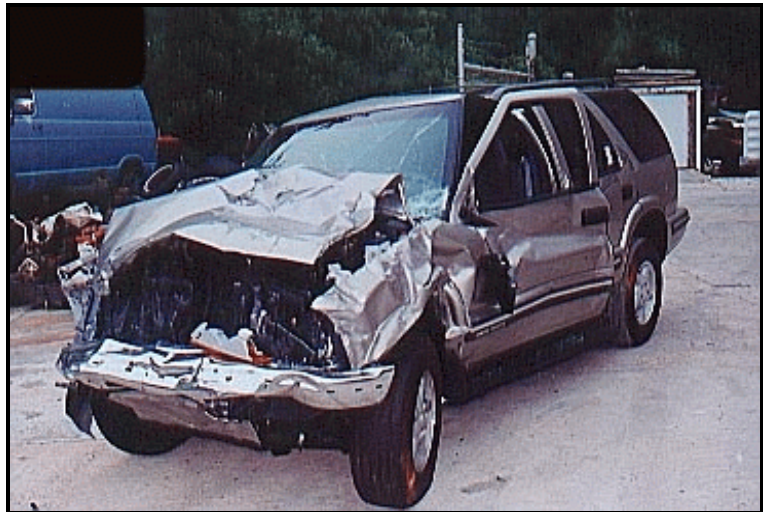
Figure 2. Exterior, case vehicle

Description:	1998 Chevrolet Blazer LS 4-door 4x4	
VIN:	1GNDDT13W9WKxxxxxxx	
Odometer:	Unknown	
Engine:	4.3 liter V6	
Reported Defects:	None noted	
Cargo:	Wheel chair	
Damage Description:	The damaged components included the front bumper, hood, grille, left front fender, right front fender, left front door and the front suspension. The windshield was cracked full width by impact forces, and there was intrusion into the left floor/toe pan. The left front and rear doors were jammed shut, but the front door had been pried open for extrication at the crash scene. All four tires remained inflated. The only wheel damage was minor scratching of the right front wheel.	
CDC:	12FDEW2	
Delta V:	Total	32.1 km/h (20 mph)
	Longitudinal	-31.6 km/h (19.6 mph)
	Latitudinal	5.6 km/h (3.5)

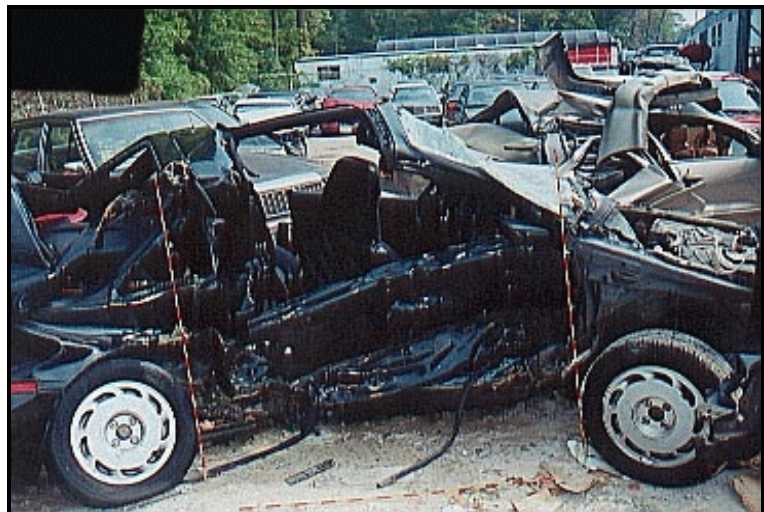
Figure 3. Exterior, Nissan Pulsar

Damage Description: Extensive right side crash and extrication damage with a maximum crush depth of approximately 86 cm (34 in) at the right "B" pillar (maximum side extension)

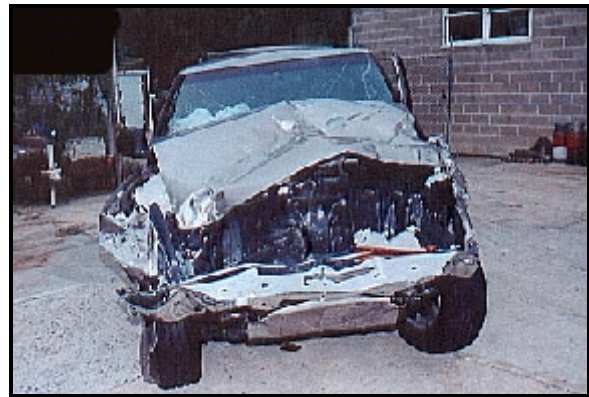
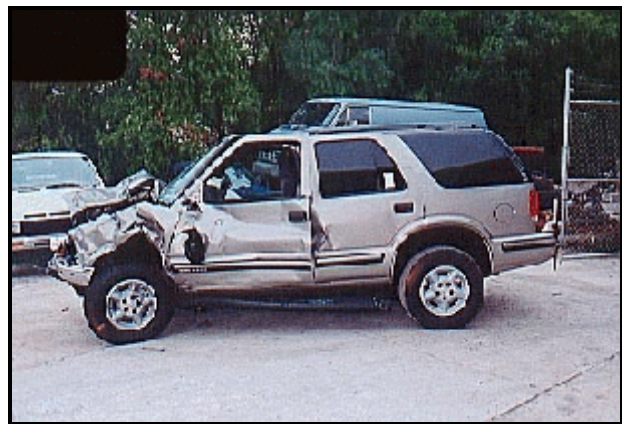
Figure 5. Exterior, case vehicle.

Figure 6. Exterior, case vehicle.

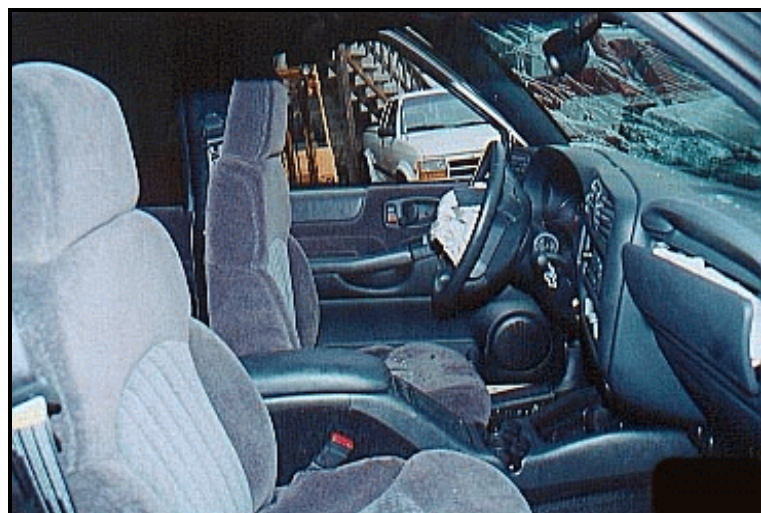
The vehicle's steering column was a tilt column adjusted to the center position. The four spoke steering wheel rim was deformed approximately 2 cm (1 in) forward on its upper half.

Figure 7. Interior, case vehicle.

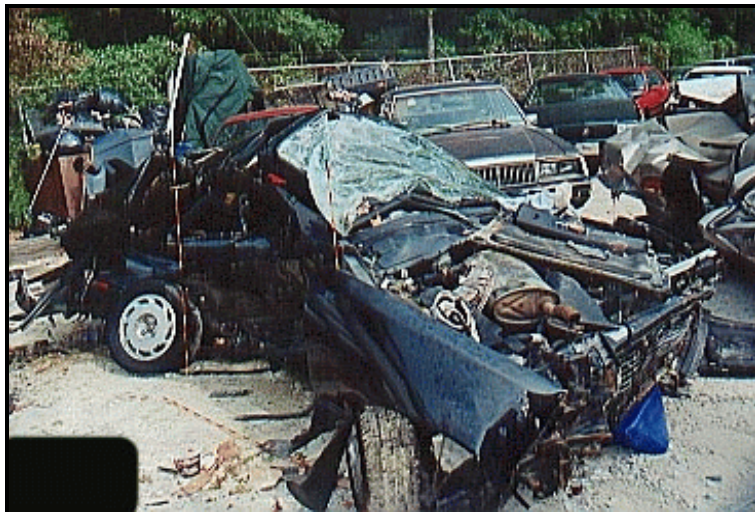
Figure 8. Exterior, Nissan Pulsar

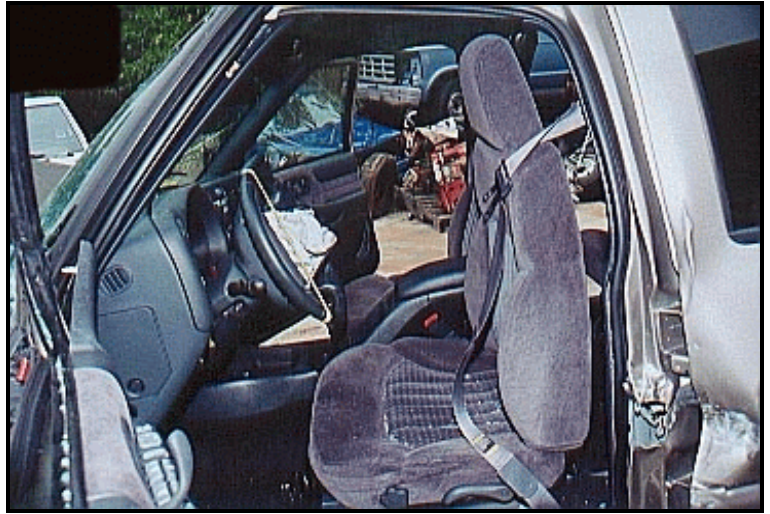
Figure 9. Interior, Vehicle 1. Driver position.

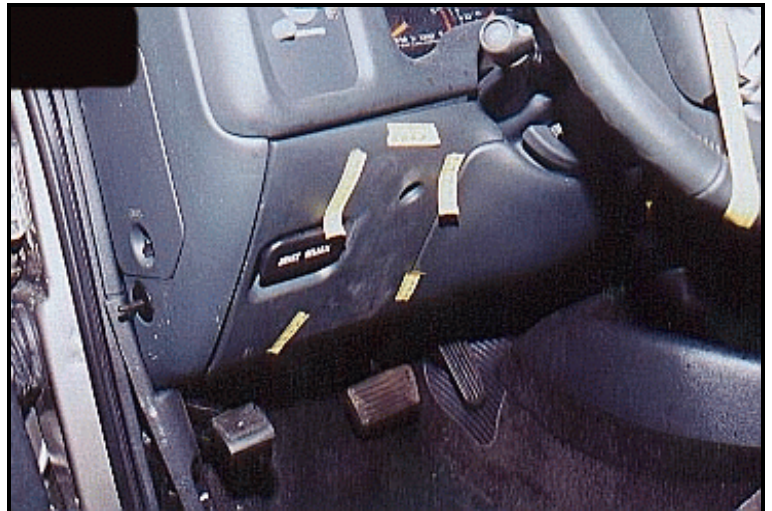
Figure 10. Interior, case vehicle. Knee contact.

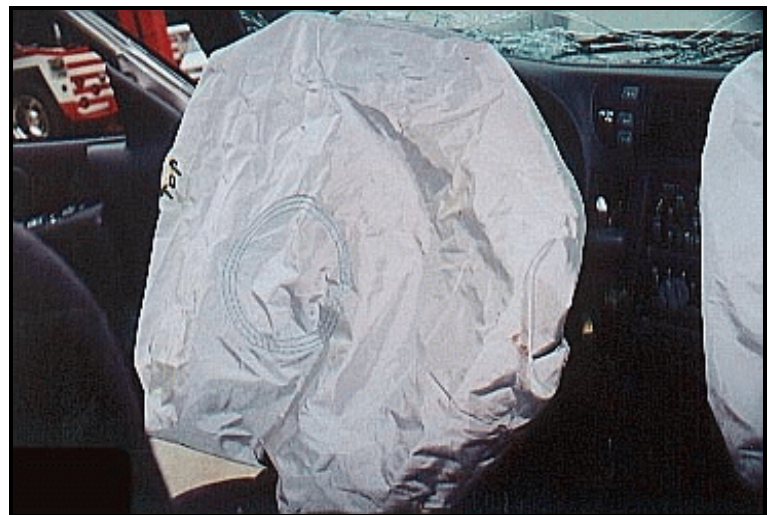
The driver air bag module was located in the center of the steering wheel. The "T" type cover flaps opened as designed during the deployment sequence. The symmetrical flaps measured approximately 10 cm (4 in) vertically by 7 cm (3 in) horizontally. The driver's air bag was a tethered bag, approximately 60 cm (24 in) in diameter. The two internal tether straps, sewn to the center of the bags front surface, were located at approximately the 3:00 and 9:00 o'clock positions. During inspection, the tether straps allowed the deflated bag to extend approximately 28 cm (11 in) from the module. There were two 2.5 cm (1 in) diameter vent ports located at the 1:00 and 11:00 o'clock positions on the back side of the bag. The lower half of the air bag had several drops of post-crash blood, but there was no residual evidence of occupant contact with the bag.

Figure 11. Driver side front air bag.

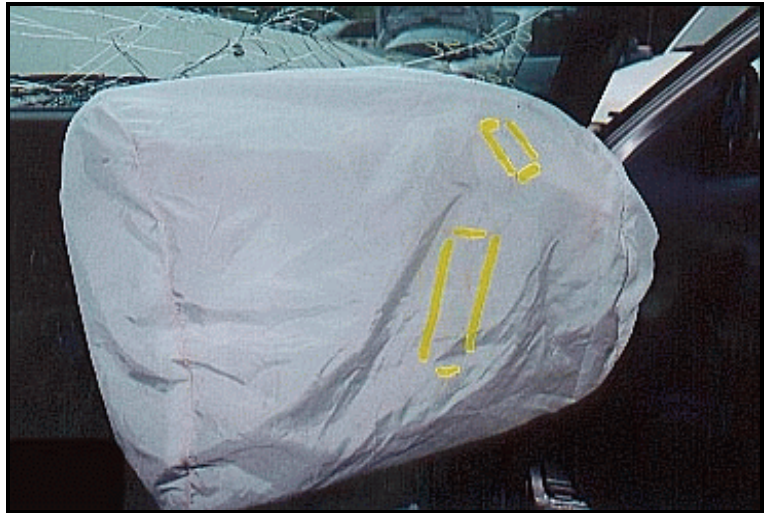
The passenger air bag module was a mid-mount housed in the right side of the instrument panel. The single module flap measured 31 cm (12 in) in width and 13 cm (5 in) in height, and was hinged at the bottom (opened outward and downward). The flap opened as designed during the deployment sequence. In its deflated state, the bag measured approximately 55 cm (22 in) in width and approximately 50 cm (21 in) in height at its extended face. The air bag extended approximately 58 cm (21 in) outward from the module. The air bag was not tethered, and was vented by two 5 cm (2 in) diameter vent ports located at the 9:00 and 3:00 o'clock positions on the bag's side panels. There were abrasions/fabric transfers on the air bag fabric located on the face panel in the center-right quadrant. In addition, while not damaged, the face of the module flap was abraded indicating probable contact with the right front passenger during the deployment sequence.

Upon impact with the Pulsar, the Blazer's occupants were projected forward, and approximately 10E left, in response to the 12 o'clock (350E) direction of impact forces. The forces involved in this crash exceeded the manufacture's SRS threshold in the case vehicle, and the driver's and right front passenger's depowered air bags deployed. All four occupants of the case vehicle loaded their respective lap/shoulder restraints, and the front seat occupants loaded the deployed depowered air bags. There was no evidence of occupant contact on the driver's air bag, but there were abrasions/fabric transfers on the face of the passenger's air bag that were likely due to the chest contact.

Figure 12. Passenger front air bag.
