**TRANSPORTATION SCIENCES
CRASH RESEARCH SECTION**

**VERIDIAN ON-SITE AIR BAG/INFANT FATALITY INVESTIGATION
VERIDIAN CASE NO. CA99-07
VEHICLE: 1995 SATURN SC2
LOCATION: ALABAMA
CRASH DATE: APRIL 1999**

<p>14. <i>Sponsoring Agency Code</i></p>	
<p>15. <i>Supplementary Notes</i> On-site investigation of an air bag deployment death of a 6 week old female front right passenger in a 1995 Saturn SC2.</p>			
<p>16. <i>Abstract</i> This on-site investigation focused on the injury mechanisms and cause of death of a 6 week old infant female positioned in the front right of a 1995 Saturn SC2. The vehicle was equipped with frontal air bags for the driver and right passenger positions which deployed during the crash. The infant was positioned in a rear-facing child safety seat (RFCSS) that was improperly secured by the manual 3-point lap and shoulder belt system. The frontal area of the Saturn impacted and underrode the rear of a stopped (disabled) 1988 Pontiac Grand Prix. The impact deployed the Saturn's frontal air bag system. The 23 year old female driver of the Saturn was unrestrained. She sustained multiple soft tissue injuries from contact with the knee bolster and the front left air ba

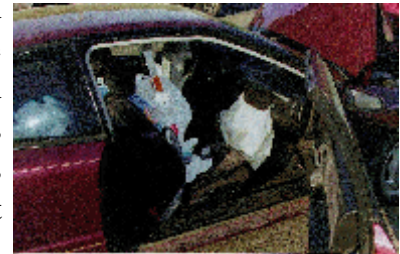
Figure 1. On-scene image of the deployed front right air bag and the child restraint following the removal of the infant.

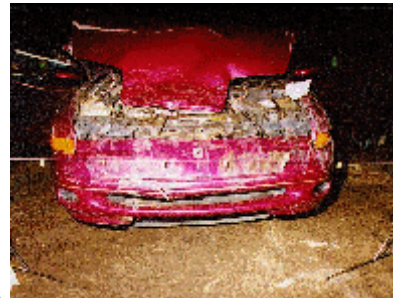
The full frontal area (**Figure 3**) of the Saturn impacted the rear of the disabled Pontiac Grand Prix in a 12 o'clock/6 o'clock impact configuration. Initial contact involved the face of the Saturn's front bumper against the lower face of the rear bumper of the Pontiac. The impact speed for the Saturn was computed at 28.8 km/h (17.9 mph) by the damage and trajectory algorithm of the WinSMASH program. As a result of the pre-crash braking which compressed the front suspension, and the wedge profile of the Saturn, the frontal area of the Saturn subsequently underrode the rear of the Pontiac. Consequently, the Saturn penetrated under the Pontiac which elevated the rear tires of the

Figure 3. Frontal damage to the Saturn SC2.

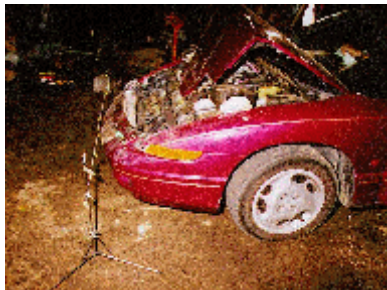
Exterior - The full frontal area of the Saturn engaged the rear plane of the disabled Pontiac Grand Prix. The front bumper initially impacted then underrode the rear bumper of the Grand Prix (**Figure 5**). The direct contact damage extended full width which resulted in a combined induced and direct damage length of 121.3 cm (47.75"). There was no residual crush at the level of the bumper reinforcement bar.

Figure 5. Profile view documenting the minimal crush profile.

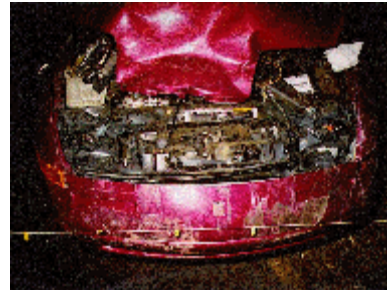
Figure 6. Underride damage to the hood face and upper radiator support panel.

bumper underrode the rear of the struck Pontiac. As a result of the elongated engagement, the direct contact damage extended onto the top surface of the Saturn's bumper fascia and subsequently involved the hood face of the Saturn. The hood latch released which allowed the aluminum hood to buckle at the designated fold point and deflect rearward as the Saturn penetrated under the Pontiac. Residual structural crush occurred at the upper radiator support panel (**Figure 6**). The crush profile was documented as follows: C1-0.6 cm (0.25"), C2-1.3 cm (0.5"), C3-1.9 cm (0.75"), C4-1.9 cm (0.75"), C5-2.9 cm (1.1"), C6-2.9 cm (1.1"). Maximum crush occurred at the C5-C6 locations. The Collision Deformation Classification (CDC) for this damage pattern was 12-FDEW-1.

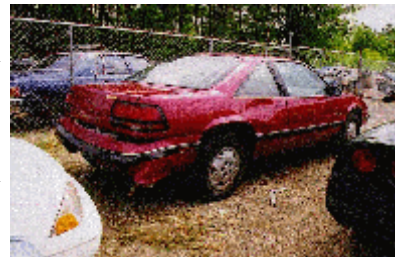
Exterior - The rear of the Pontiac Grand Prix sustained minor damage (**Figure 7**) from its impact sequence with the Saturn SC2. The initial contact deformed the rear bumper fascia in a forward direction, however, as the Saturn continued forward, the frontal area of the wedge profile underrode the rear plane of the Pontiac. There was longitudinal crush to the rear bumper system of the Pontiac. The honeycomb structure of the rear bumper system was displaced vertically. The tailpipe and spare tire well of the Grand Prix were deformed forward and vertically, respectively. Isolated buckling of the right rear quarter panel was noted forward of the wheel opening. The CDC for this damage was 06-BDLW-1.

Figure 7. Rear damage to the Pontiac Grand Prix.

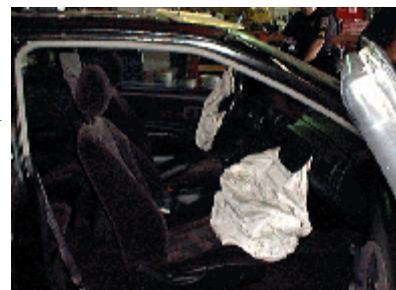
Figure 8. Deployed frontal air bag system.

The RFCSS was presumed to have been positioned within the deployment range of the mid mount flap. A faint "polishing" of the cover flap from probable contact against the shell of the RFCSS was noted to the leading edge of the vinyl flap. This scuff-type mark was located 7.6 cm (3.0") inboard of the left edge of the flap and extended 17.8 cm (7.0") to the right. The mark extended 1.3 cm (0.5") vertically onto the face of the flap.

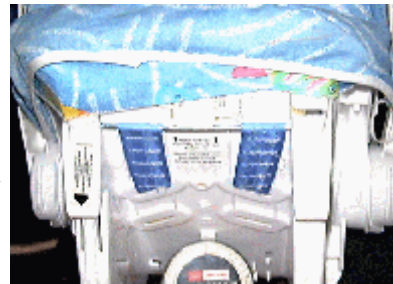
- The integral harness of the RFCSS was adjusted to the maximum adjustment points. The belt webbings were positioned through the top of two sets of slots in the backrest of the RFCSS shell (**Figure 9**). In addition, the adjustment rod was routed through the top slots of the belt webbing which resulted in the maximum adjustment length of the harness. Although the harness adjustment could not be verified with the infant, the restraint was rated to a maximum weight of 9.1 kg (20 lb), therefore the belts should have been considerably loose on the 4.5 kg (10 lb) infant.

Figure 9. Adjustment slots in the harness system.

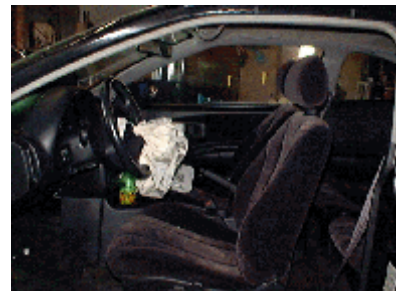
Figure 10. Adjusted seat track position, deployed air bag, and trajectory of the driver.

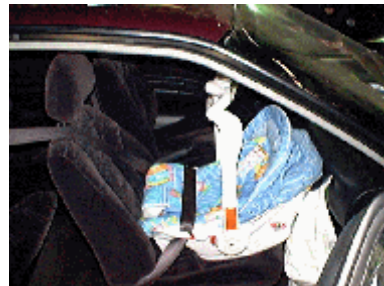
The front right seat track was adjusted to a forward position, set 3.8 cm (1.5") rearward of the full forward and 13.7 cm (5.4") forward of the full rearward position. With the seat track adjusted to this position and the seat back reclined to a 20 degree angle, the horizontal distance between the seat back support and the mid mount module cover was 67.3 cm (26.5"). The leading edge of the seat cushion was 8.9 cm (3.5") rearward of the vertical profile of the cover flap. In this position, the forward edge of the shell of the RFCSS was positioned approximately 2.5 cm (1.0") rearward of the mid mount front right air bag module cover flap (**Figure 11**). In addition, the shell of the RFCSS was positioned under the brow of the upper instrument panel.

Figure 11. Pre-crash position of the RFCSS.
