REMOTE AIR BAG DEPLOYMENT REPORT

CASE NUMBER - IN99-008

LOCATION - Maryland

VEHICLE - 1998 SATURN SL1

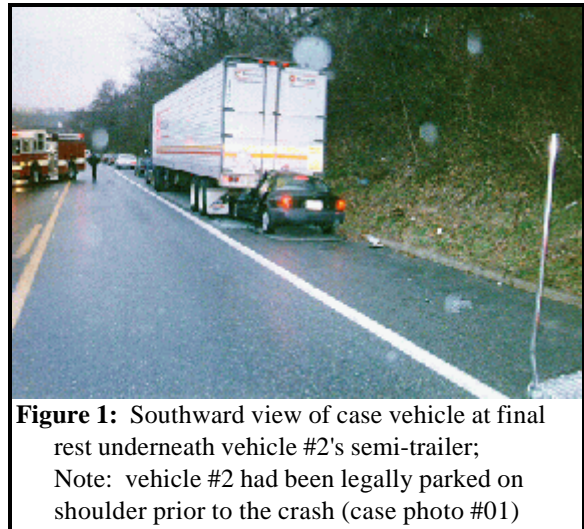
The case vehicle was traveling south in the southbound lane of a two-lane, undivided, city street (**Figure 1**). Vehicle #2 was unoccupied and legally parked on the right (west) shoulder, facing south. It was daylight, overcast, no rain at the time of the crash, and no visibility problems. The roadway was bituminous, dry, straight, and had no roadway defects. No assessment of the roadway's vertical alignment was available. Posted speed limit was 64 km.p.h. (40 m.p.h.). The crash occurred on the west (right) shoulder. The only traffic control devices consisted of regulatory SPEED LIMIT signs and pavement markings. Pavement markings included: a single broken yellow centerline with a solid yellow no passing line for southbound traffic and single solid white edge lines on the east and west pavement edges. Each side of the street had 2.8 meter (9.3 foot) asphalt shoulders bordered by concrete curbs of unmeasured height. The absence of pre-impact skid marks from the case vehicle and observations from two witnesses indicate that the case vehicle's driver did not attempt any avoidance maneuvers prior to impact.

Figure 1: Southward view of case vehicle at final rest underneath vehicle #2's semi-trailer;
Note: vehicle #2 had been legally parked on shoulder prior to the crash (case photo #01)

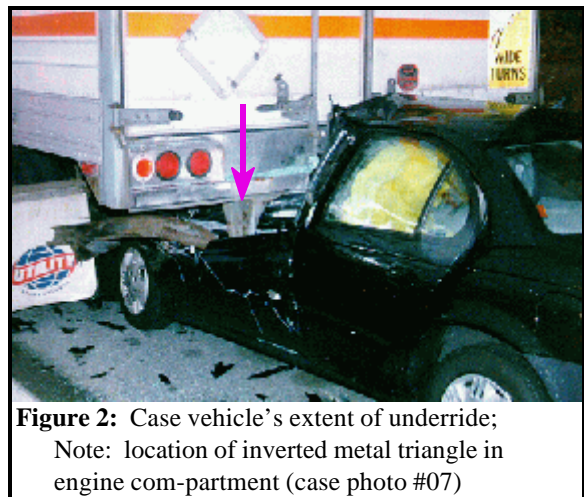
The front of the case vehicle impacted the rear of vehicle #2's semi-trailer, contacting the trailer's underride guard (i.e., a channel iron attached to the trailer's undercarriage by inverted triangles of metal designed to retard vehicles from sliding under the bottom of the trailer--**Figure 2**) and causing the case vehicle's driver and front right passenger air bags to deploy. Investigating officers measured the case vehicle's underride distance as 1.7 meters (5.67 feet),

Figure 2: Case vehicle's extent of underride;
Note: location of inverted metal triangle in engine compartment (case photo #07)

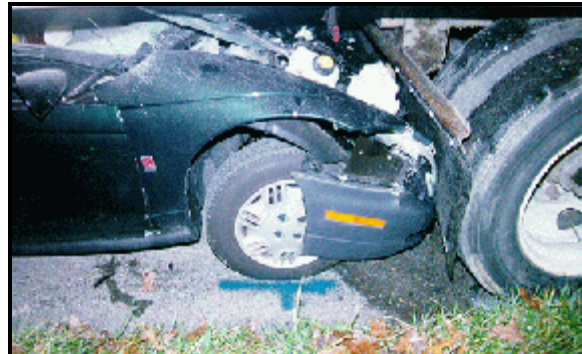
in a straight travel path. No contact was made with the left rear tandem wheels of the semi-trailer by the front left corner of the case vehicle. The case vehicle's front right corner contacted vehicle #2's rearmost tandem wheels on the semi-trailer's right side (**Figure 3**). Penetration of the case vehicle underneath the trailer almost reached the "B"-pillars. No post-impact rotation by the case vehicle was discovered.

Figure 3: Case vehicle's front right corner contact with vehicle #2's right rear tandem tires (case photo #12)

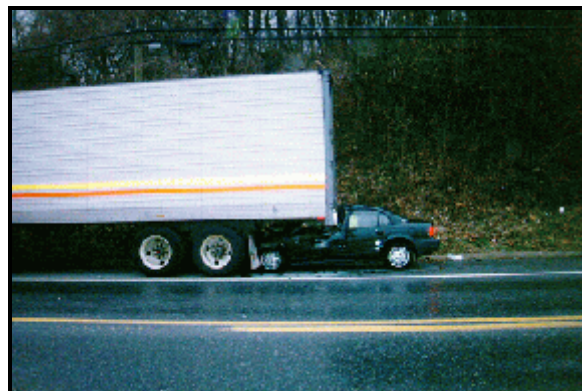
The case vehicle sustained direct contact across the entire width of its front end. The front bumper and fascia were shoved rearward and downward. The grille and headlamp assemblies were shattered and broken away. Front radiator and engine compartment brackets were laid over towards the cowl. The front hood was peeled rearward and folded in thirds, with the forward hood edge pointing forward. The left fender was also peeled rearward and the front of the right fender was pushed back and down. Many of the engine compartment components affixed on or around the engine block were shoved rearward and down. The lower edge of the trailer's back plane contacted the top third of the windshield and shoved it and the front header almost to the "B"-pillars (**Figure 4** above and **Figure 5**). The top third of the windshield

Figure 4: Case vehicle's underride of vehicle #2 showing extent of underride extending almost to "B"-pillars and is offset to back right of semi-trailer (case photo #05)

Heavy intrusion occurred into the case vehicle’s passenger compartment, but the intrusion was limited to the greenhouse area (i.e., top third of the windshield, the “A”-pillars, the front header, and the front portion of the roof). These components were pushed rearward almost to the “B”-pillars of the case vehicle by the bottom edge of vehicle #2’s semi-trailer. From available police photographs it appears that the tops of the instrument panel and the steering wheel were not damaged, neither were the window sills of the two front door panels.

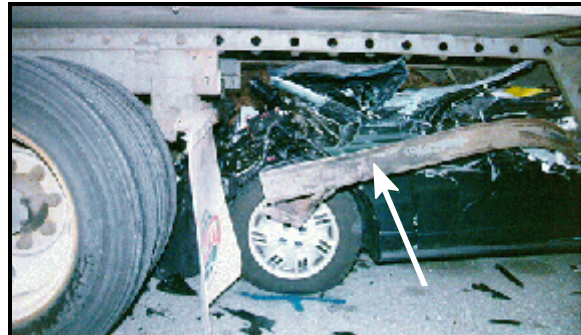
Figure 5: Case vehicle’s contact with vehicle #2’s undercarriage; Note: sheared underride guard channel iron (case photo #06)

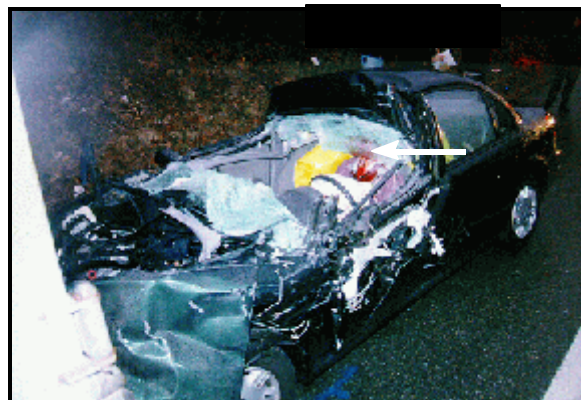
Figure 6: Case vehicle driver’s post-impact position sitting upright but back against his seat back; Note: driver’s face (arrow) is hidden behind the wind-shield which has intruded into front seating area and red spot is blood from the driver’s face which has dripped onto his shirt (case photo #15)

impacted the rear underride guard, the deceleration enabled the driver to continue forward, most likely loading his safety belt and the deploying air bag; although, this contractor cannot be certain of the degree to which the driver loaded his safety belt and/or air bag since there are no available photographs of the air bag’s surface and his medical records do not indicate any safety belt or air bag-related injuries. The lower edge of the semi-trailer’s back plane contacted the top third of the windshield and pushed the glazing into the head and face of the case vehicle’s driver (**Figure 6** above), stopping and reversing his forward momentum. This contact caused the driver’s head and facial injuries.
