REMOTE AIR BAG DEPLOYMENT REPORT

CASE NUMBER - IN99-009

VEHICLE - 1998 FORD CROWN VICTORIA POLICE INTERCEPTOR

CRASH DATE - April 1998

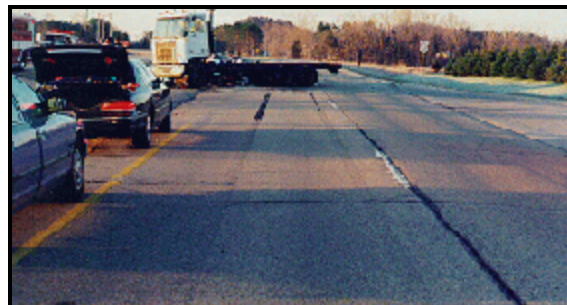
The case vehicle (vehicle #2) was traveling south in the inside (east), southbound lane of a four-lane, divided U.S. trafficway and was approaching a Tee-intersection (both the north and south roadways had two through lanes--**Figure 1**). Vehicle #1 was traveling east in the eastbound lane of the intersecting two-lane, undivided, county roadway and intended to turn left and travel north on the northbound roadway. Ambient conditions were dark, not lighted; the weather was clear, and the pavement was dry. Both roadways were bituminous, straight, and level, with a speed limit of 86 km.p.h. (55 m.p.h.). There was a stop sign for eastbound traffic on the county road. Investigating officers believe the case vehicle's pre-crash travel speed vastly exceeded the posted speed limit, but it was not estimated. The crash occurred within the intersection of the two trafficways, in the inside, southbound lane.

Figure 1: Case vehicle's southbound approach;
Note: straight skid marks (case photo #03)

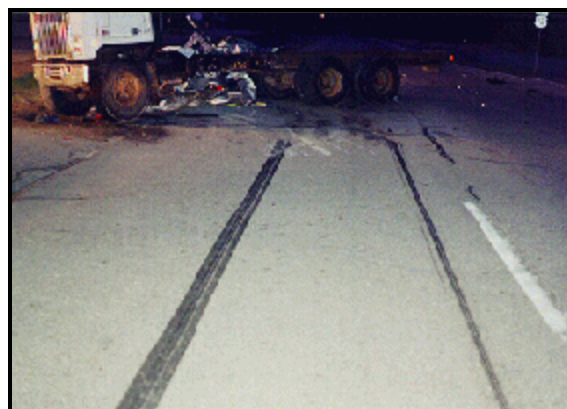
The front of the case vehicle impacted the left frame rail of vehicle #1, causing the case vehicle's driver and front right passenger supplemental restraints (air bags) to deploy. Pavement gouge marks and post-impact tire marks show that the case vehicle was initially deflected counterclockwise (**Figure 2**), then rotated clockwise as it moved underneath Vehicle #1's chassis. The case vehicle under rode almost all of vehicle #1's left and right frame rails with the case vehicle's right rear corner remaining under the right frame rail of vehicle #1 at final rest (**Figure 3** below). The case vehicle was headed southwest at its final rest position. The

Figure 2: Case vehicle's at-impact deflection marks; Note: case vehicle's at-rest position partially under vehicle #1 (case photo #05)

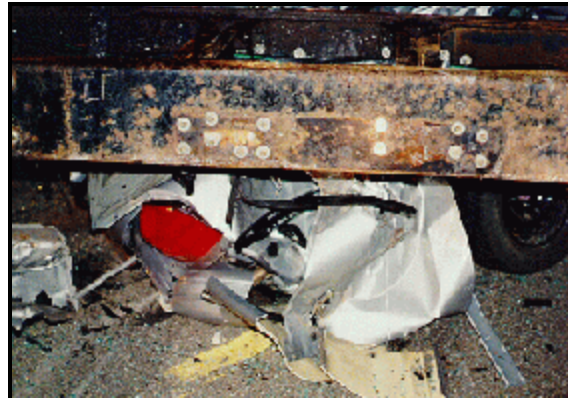
distance between the bottom edge of vehicle #1's frame rails and the road surface was approximately 91 centimeters (36 inches). Vehicle #1 rotated counterclockwise and was headed northeast at its final rest position. The crash severity for the case vehicle was high [greater than 40 km.p.h. (25 m.p.h.)]. This was an unsurvivable crash for the case vehicle's occupant.

Figure 3: Southeastward view of case vehicle's right rear corner under vehicle #1's right frame rail; Note: left frame rail in foreground (case photo #23)

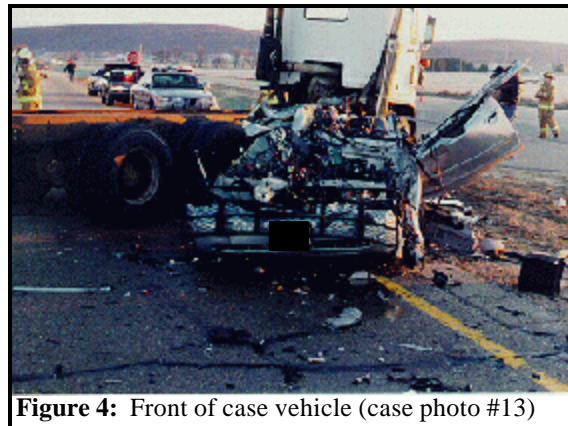
The case vehicle sustained direct contact damage across its entire front width, consisting of crushing and shearing off of all structures from the headlights to the "C"-pillars (**Figure 4**). The case vehicle passed almost entirely under the left and right frame rails of vehicle #1, with only the right rear corner of the case vehicle remaining under the right frame rail of vehicle #1 at final rest (**Figure 3** above). Case vehicle components that sustained direct contact damage include: the front mesh-metal "deer catcher," left and right headlamp assemblies, the grille, the hood, left and right front fenders, the windshield, the top portion of the firewall, left and right upper "A"-pillars, the roof, left and right front doors, left and right upper "B"-pillars, left and right rear doors and the left and right upper "C"-pillars. The CDC for the case vehicle, estimated from police photographs, is: **12-FDHW-9**. This crash is out-of-scope for the WinSMASH reconstruction program. Investigating officers measured 42.7 meters (140 feet) of pre-impact skid marks for the case vehicle. This indicates

Figure 4: Front of case vehicle (case photo #13)

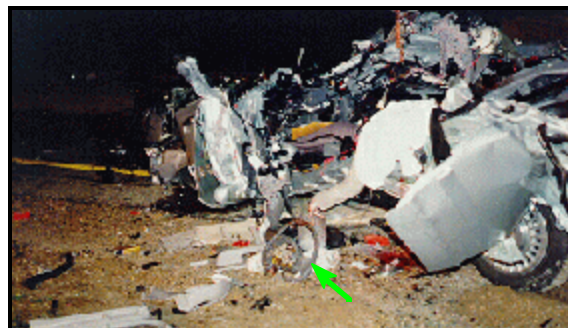
Figure 5: Left side of case vehicle showing passenger compartment intrusion; Note: steering wheel near left front door (case photo #17)

There was catastrophic destruction of the case vehicle’s passenger compartment (**Figure 5** above). The instrument panel was pushed rearward and upward, the toe pan and floor were pushed up, the windshield and roof were pushed rearward, the steering wheel hub and rim were separated from the steering column, the driver and front right passenger seat backs were broken and pushed rearward. The separated steering wheel, deformed and bloodied, was laying on the ground near the sprung-open left front door.

Pre-impact braking probably caused the case vehicle’s driver to move forward, but his forward motion was restricted because he was restrained. At impact, he was probably leaning slightly forward, loaded against the lap-and-shoulder safety belt due to braking deceleration. The impact caused the driver and front right passenger air bags to deploy and caused the front components and hood to be crushed rearward as the case vehicle passed under vehicle #1's frame rails. The coroner’s report indicates that the driver sustained decapitation, flail chest, fractures of the pelvis and multiple fractures of the extremities, with no further details. The available photographs do not provide sufficient detail to enable a kinematic reconstruction of the specific injury producing mechanisms, other than to note that the entire case vehicle was massively destroyed in this unsurvivable crash. At final rest, the driver’s headless body was laying back in the driver’s seat position (**Figure 5** above).

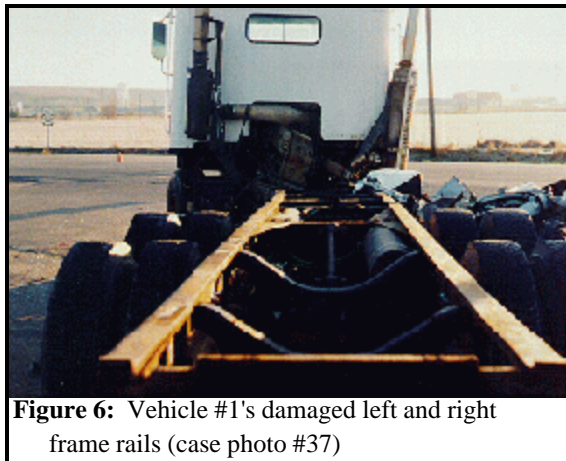
Vehicle #1 was a 1986 GMC 9500 Series cab-over-engine 6 x 4, incomplete straight truck with air brakes (VIN: 1GDT9K4C0GV-----). Vehicle #1 was towed due to disabling damage (**Figure 6**). The case vehicle severed vehicle #1's drive shaft (**Figure 7**). The driver [37-year-old, White (unknown if Hispanic) male--height and weight unknown] sustained police-reported "B" (non-incapacitating) injuries but did not seek treatment.

Figure 6: Vehicle #1's damaged left and right frame rails (case photo #37)

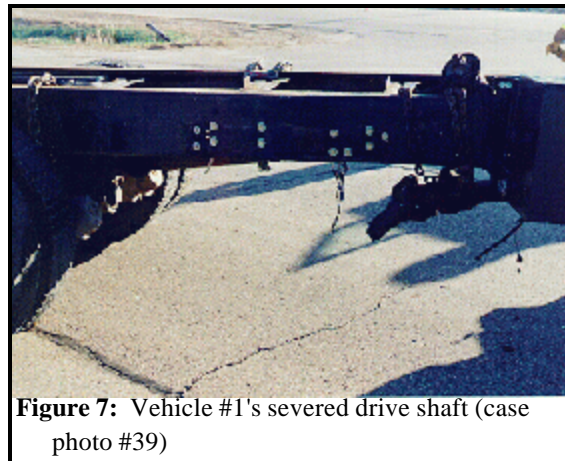
Figure 7: Vehicle #1's severed drive shaft (case photo #39)
