REMOTE AIR BAG DEPLOYMENT REPORT

CASE NUMBER - IN99-010

VEHICLE - 1998 TOYOTA COROLLA

CRASH DATE - March 1998

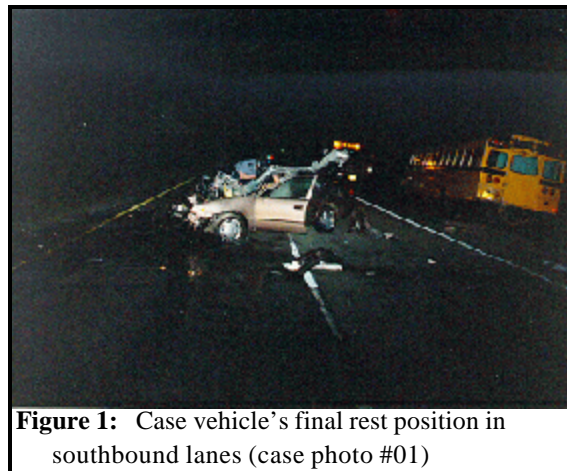
The case vehicle was traveling south in an unknown lane of a two-lane, southbound roadway that was part of a four-lane, divided rural interstate highway (**Figure 1**). Vehicle #2 was disabled and unoccupied on the west asphalt shoulder of the same interstate, headed south. Ambient conditions were dark, overcast, and dry pavement with no roadway defects. The roadway was bituminous, straight, and level, with a single solid yellow edge line on the left (east), a single solid white edge line on the right (west), and a single broken white centerline separating the two southbound lanes. The posted speed limit was 105 km.p.h. (65 m.p.h.). The case vehicle drifted off the right (west) edge line onto the west shoulder. There is no evidence that the case vehicle's driver attempted to make any avoidance maneuvers.

Figure 1: Case vehicle's final rest position in southbound lanes (case photo #01)

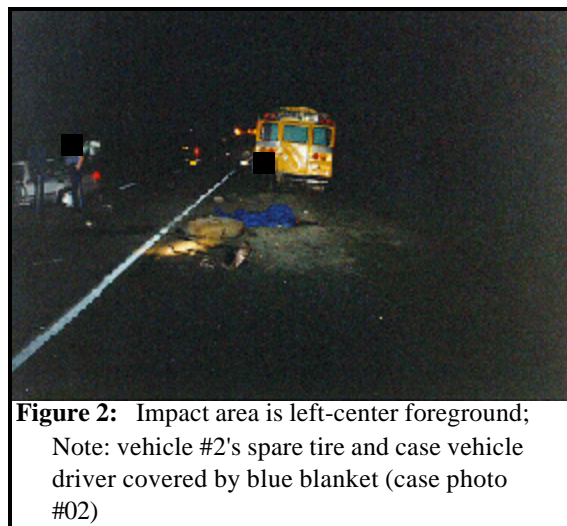
The crash occurred on the right (west), asphalt shoulder (**Figure 2**). The front of the case vehicle impacted the back of vehicle #2, causing the case vehicle's driver and front right passenger supplemental restraints (air bags) to deploy. The case vehicle went under vehicle #2's back bumper, in a classic rear underride collision scenario, with the back surface of the bus shearing off almost all structures above the beltline on the case vehicle. The case vehicle penetrated under vehicle #2 enough to dislodge the bus's rear axle and the drive train. The case vehicle separated from vehicle #2, rotated clockwise

Figure 2: Impact area is left-center foreground; Note: vehicle #2's spare tire and case vehicle driver covered by blue blanket (case photo #02)

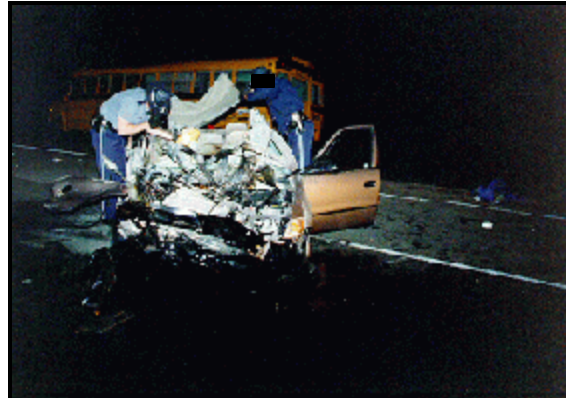
The case vehicle sustained direct contact damage consisting of heavy crushing of the front bumper and grille into the engine compartment and rearward shearing of the sheet metal from behind the front bumper to the backlight, leaving only the left upper A-, B-, and C-pillars, as well as the left roof rail, standing above the beltline (**Figure 3**). This damage resulted from the case vehicle underriding the rear left third of vehicle #2, and with sufficient depth to dislodge both vehicle #2's rear axle and its drive train. Case vehicle damaged components include: the front bumper, left and right headlamp assemblies, the grille, the hood, the right front fender, the windshield, the right upper A-, B-, and C-pillars, the roof and right roof rail, the right front and right rear doors, and the backlight (**Figure 4**). The CDC for the case vehicle, estimated from police photographs, is **12-FZAA-9**. This crash is out-of-scope for the WinSMASH reconstruction program. The crash severity for the case vehicle was high [greater than 40 km.p.h. (25 m.p.h.)]. The crash damage and post-impact travel of the case vehicle and the post-impact travel of vehicle #2 indicate that the pre-impact travel speed of the case vehicle was at least the posted

Figure 3: Case vehicle's front damage; Note: roof pushed back over trunk (case photo #04)

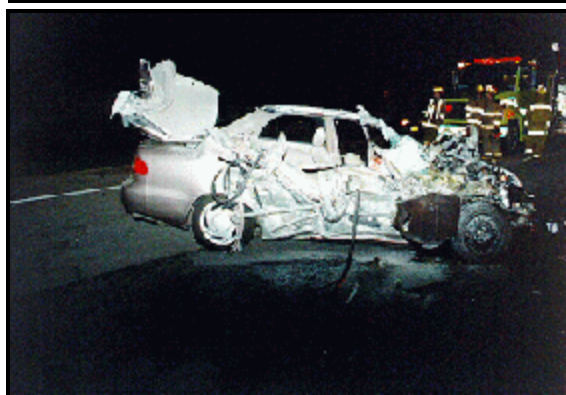
Figure 4: Case vehicle's top and right side damage; Note: damaged hood, windshield, and roof areas (case photo #08)

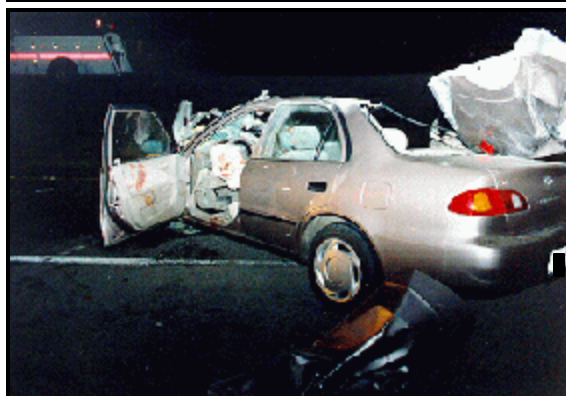
Figure 5: Case vehicle's driver seat area and missing roof; Note: visible blood stain locations (case photo #07)

The catastrophic destruction of the case vehicle’s passenger compartment above the beltline included all structures to the right of the left roof rail and those components were pushed rearward. Intrusion to the driver’s seating area below the beltline is not well visualized in the available photographs, with the exception of the toe pan being pushed rearward and the post-impact position of the driver’s seat back being rearward of the left upper B-pillar. The right side of the instrument panel was pushed rearward and the front right passenger’s seat back was broken and laid backwards. Both the driver and front right passenger air bag fabrics showed several areas of blood stain, as did the left front door interior panel and the interior top of the left rocker panel (**Figure 5** above).

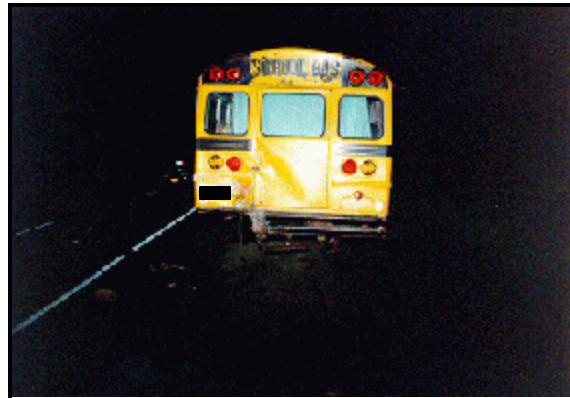
Vehicle #2 was a 1970 Dodge S600 conventional school bus (VIN: J67FG0S-----), with a gasoline engine, converted for use as a recreational vehicle. An odometer reading was not reported. Vehicle #2 was towed from the scene due to disabling damage. Vehicle #2 was previously disabled, stopped on the southbound roadway's west shoulder outside of the travel lanes and unoccupied. The left third of vehicle #2's back bumper was sheared off (**Figure 6**), with direct contact the left rear wheel and tire, separation of the drive shaft and induced damage to the body panels on the back surface. The underslung spare tire was broken off (**Figure 2** above).

Figure 6: Vehicle #2's rear plane damage; Note: damage limited to left third of rear plane (case photo #10)
