**TRANSPORTATION SCIENCES
CRASH RESEARCH SECTION**

**VERIDIAN REMOTE ALLEGED INADVERTENT DEPLOYMENT INVESTIGATION
VERIDIAN CASE NO. CA99-017
VEHICLE: 1995 PLYMOUTH NEON
LOCATION: NEW JERSEY
CRASH DATE: MAY 1999**

14. <i>Sponsoring Agency Code</i>	
15. <i>Supplementary Notes</i> Remote investigation of an alleged inadvertent air bag deployment.			
16. <i>Abstract</i> This remote investigative effort focused on a driver's allegation of an inadvertent deployment of the frontal air bag system in a 1995 Plymouth Neon. The driver initiated a left turn at a 3-leg T intersection and reported to the investigating officer that the bags deployed without impact. The local NASS team inspected the vehicle and noted several areas of possible contact to the undercarriage. At the scene of the event, a raised manhole may have contributed to the undercarriage contact. The driver and the front right passenger of the vehicle sustained minor soft tissue injuries from the deployment of the air bag system.

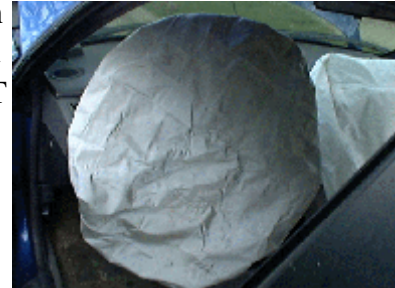
This remote investigative effort focused on a driver's allegation of an inadvertent deployment of the frontal air bag system (**Figure 1**) in a 1995 Plymouth Neon. The driver initiated a left turn at a 3-leg T intersection and reported to the investigating officer that the frontal air bags deployed without impact. The local NASS team inspected the vehicle and noted several areas of possible contact to the undercarriage. At the scene of the event, a raised manhole may have contributed to the undercarriage contact. The driver and the front right passenger of the vehicle sustained minor soft tissue injuries from the deployment of the air bag system.

Figure 1. Deployed frontal air bags in the 1995 Neon.

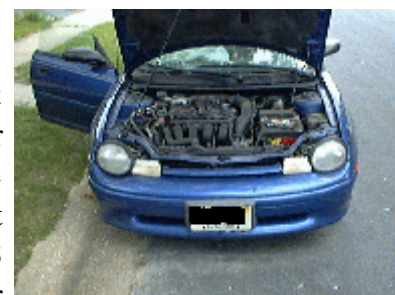
The involved 1995 Plymouth Neon was equipped with frontal air bags for the driver and passenger positions. This system consisted of front mounted electro-mechanical sensors (**Figure 2**) with a safing sensor and a diagnostic control module. The vehicle was identified by vehicle identification number 1P3ES47C6SD (production number deleted). At the time of the NASS inspection, the odometer reading was 197,943 km (123,000 miles). The Neon was purchased by the current owner in September, 1998, as a high mileage used vehicle. The previous history of the vehicle was unknown. At the time of purchase, the Neon was equipped with P185/70-13 radial tires mounted on OEM steel wheel rims.

Figure 2. Engine compartment of the Neon which houses the frontal crash sensors.

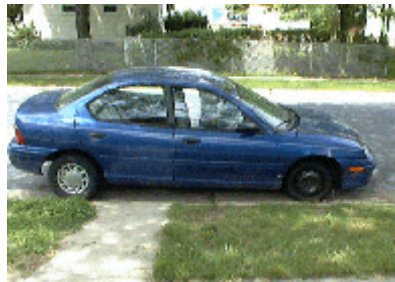
The day prior to this event, the owner/driver experienced a flat front right tire. The tire/wheel was temporarily replaced with the space saver spare tire and wheel which was of a smaller diameter than the

original P185/70-13 radial tire. This temporary use spare resulted in a lower ride height of the vehicle at the front right axle position. This spare tire was in use at the time of this deployment event (**Figure 3**).

Figure 3. Space saver spare on the front right position.

The center engine mount abrasion appeared to be recent damage. In addition, the separated air deflector was dragging on the pavement surface which supported this as recent damage. The bottom aspect of the lower control arm mounting bracket appeared to have been abraded recent to the vehicle inspection. This, and the center engine mount damage, probably resulted from contact with the protruding manhole rim as the vehicle initiated the left turn. The front right suspension of the Neon would have compressed during the left turn maneuver. The height was originally compromised by the lower profile space saver spare tire that was installed of the front right of the vehicle.

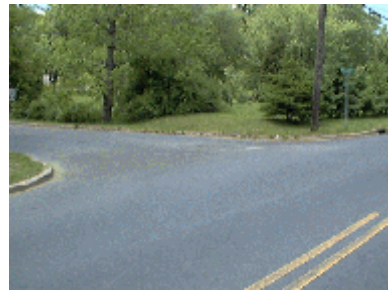
Figure 4. Three - leg T intersection.

The event occurred at a 3-leg T intersection (**Figure 4**) in a urban residential area. The driver was initially traveling on a two-lane urban collector roadway that was straight with a negative grade of approximately 1 percent. Asphalt shoulders bordered both travel lanes. She initiated a left turn onto a narrow two lane street. There were no shoulders, however, concrete curbs bordered the asphalt travel lanes. A segment of asphalt had been removed from the mouth of the intersecting street which created a elevation change between the roads. As a result of the resurfaced collector roadway, a pavement sag resulted at the mouth of the intersection (**Figure 5**). The posted speed limit in the area was 40 km/h (25 mph).

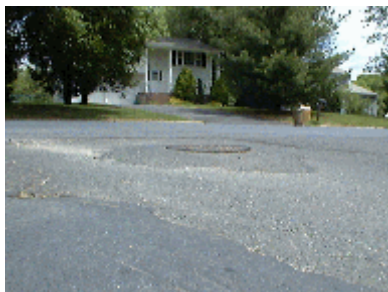
Figure 5. Look back view of the raised manhole and pavement edge.

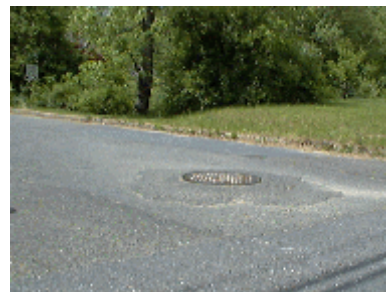
A raised manhole was located at the mouth of the intersecting street in the path of left turning traffic. An asphalt “ramp” was built around the perimeter of the manhole (**Figure 6**) in an attempt to prevent vehicle contact with the manhole. The iron rim of the manhole protruded approximately 2.5 cm (1.0”) above the asphalt ramp. **Figure 6** is a look back view of the raised manhole with the exposed rim.

Figure 6. Raised manhole in the left turn path of the Plymouth Neon.

The NASS researchers noted that there was no evidence of vehicle undercarriage contact to the manhole rim, cover, or asphalt build-up around the unit. It was possible that the protruding cast iron rim of the manhole could have snagged an undercarriage component without yielding evidence of contact (i.e., abrasion, gouging).

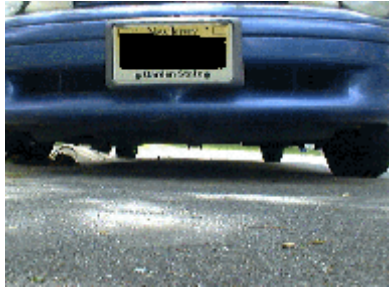
- C The front bumper fascia (**Figure 7**) was abraded in two areas on the right aspect (**Figure 8**). The first abrasion consisted of vertically oriented abrasions to the lower face of the fascia. The second area of abrasions were laterally oriented on the bottom surface of the fascia at the right corner. These abrasions appeared to have been previous to this event. There was no compression of the energy absorbing bumper system associated with these abrasion patterns.

Figure 7. Front bumper fascia of the Neon.

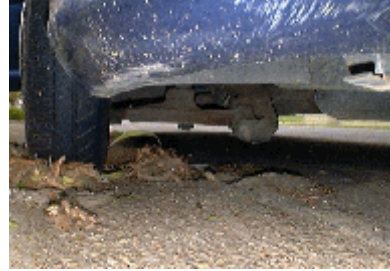
Figure 8. Abrasions to the bumper fascia.

The abrasive damage to the bumper fascia was ruled out as possible contact in this event by the NASS researchers. They concluded that the damage appeared “old” to the pliable material with a layer of road film overlying the damage.

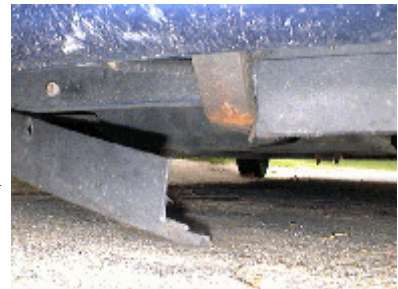
C The lower air deflector affixed to the lower radiator support panel was abraded, fractured, and partially separated from the radiator support panel (**Figure 9**). The mid point of the deflector was resting on the driveway and had pulled through a mounting plug located right of center. In this state, the deflector would have dragged on the road surface, therefore it was believed that this resulted from contact with the raised manhole at the scene of this event. The deflector was formed to fit around a forward engine mount that was bolted to the radiator support panel. This mount appeared to be a cast iron component with a rubber isolator incorporated into the unit. The forward aspect of the engine mount was abraded from recent contact (**Figure 9**). There was no deformation to the lower radiator support panel.

Figure 9. Abraded engine mount and the fractured air deflector.

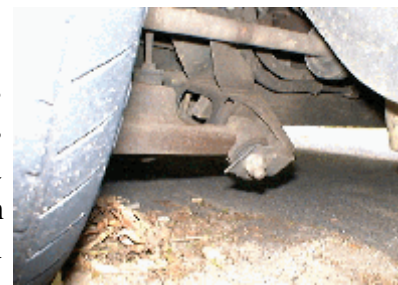
C The most noteworthy undercarriage damage involved the forward mounting bracket for the front right lower control arm. The steel bracket was welded to the engine cradle/cross member of the Neon. The lower control arm/bushing was retained in the bracket by a bolt that was originally in a horizontal position. Although there was minimal abrasion contact to the inboard leading edge of the bracket, the forward aspect of the bracket was rotated approximately 30 degrees in a downward direction (**Figure 10**). In addition, the impact that rotated the mounting bracket resulted in torsional bending of the leading edge of the lower control arm. The team could not determine fully if this damage was related to contact with the manhole.

Figure 10. Rotated control arm bushing mount.

Although the engine mount contact was minor in severity, the snagging of the control arm bracket could have produced a sufficient longitudinal pulse to deploy the frontal air bag system. If the vehicle was susceptible to an oversensitive deployment threshold, these contacts would have provided a sufficient pulse for deployment.
