**VERIDIAN ON-SITE AIR BAG/SEATBELT FATALITY
INVESTIGATION**

VERIDIAN CASE NO. CA99-18

VEHICLE - 1995 FORD ESCORT LX

LOCATION - STATE OF NEW YORK

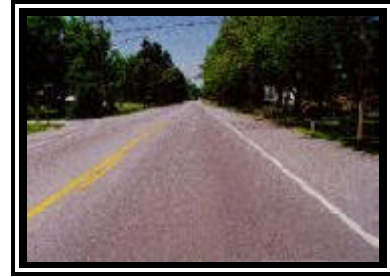
The 18 year old female driver of the 1995 Ford Escort LX was operating the vehicle northbound (**Figure 1**) proceeding straight at a (witness) reported speed of 64 km/h (40 mph). The driver apparently fell asleep following a prom and post-prom activities and allowed the vehicle to depart the right (east) pavement edge, tracking throughout its pre-crash trajectory. Witnesses reported that the vehicle drove off the east pavement edge as if the driver was pulling over but never slowed down (no brake lights observed) prior to entering the drainage ditch.

Figure 1. Northbound approach for the 1995 Ford Escort LX.

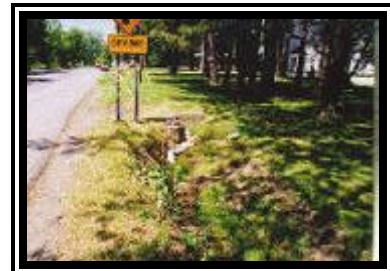
As the Escort departed the right (east) pavement edge of the two lane roadway, the front bumper struck a small diameter mailbox post which resulted in minor damage. The Collision Deformation Classification (CDC) for this impact to the mailbox post was 12-FCEN-1. The post was displaced from the ground as the mailbox struck the hood resulting in minor (non-horizontal) top damage. The CDC for this impact to the mailbox was 00-TFYW-5. At this point, the vehicle traveled 12.0 meters (39.4 feet) and entered a 40.0 cm (15.7 in) deep drainage ditch where the front left area struck a concrete culvert (**Figure 2**) resulting in moderate

Figure 2. Impacted concrete culvert.

(overlapping) damage. The bumper overrode the culvert as the vehicle continued forward which engaged the transaxle and fractured the casing. The impact induced deceleration was sufficient to deploy the Escort's air bag system. The WinSMASH damage and trajectory algorithm computed an impact speed of 40.9 km/h (25.4 mph) with a (barrier equivalent) velocity change of 31.4 km/h (19.5 mph). The specific longitudinal component was -31.4 km/h (-19.5 mph). The CDC for the culvert impact was 12-FYEW-3. Following the impact with the culvert, the vehicle rotated counterclockwise 24 degrees and came to rest against the culvert facing northwest.

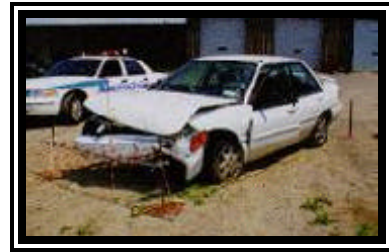
The Ford Escort sustained moderate frontal damage as a result of the impact with the culvert (**Figure 3**). The direct contact damage began at the front left bumper corner and extended 60.0 cm (23.6 in) inboard. The impact deformed the full frontal width resulting in a combined direct and induced damage length (Field L) of 118.0 cm (46.5 in). Six crush measurements were taken at the level of the bumper: C1= 63.0 cm (24.8 in), C2= 27.0 cm (10.6 in), C3= 18.0 cm (7.1 in), C4= 11.0 cm (4.3 in), C5= 6.0 cm (2.4 in), C6= 1.0 cm (0.4 in). Induced damage was noted to both fenders with the left front wheel restricted and deflated. Reduction in the left side wheelbase measured 21.0 cm (8.3 in). Roof buckling was noted between the B and C-pillars. Grass and mud deposits were documented to all four wheels. Superficial damage was found on the rear aspect of the hood from the mailbox impact along with a red paint transfer to the center portion of the hood lip (forward aspect). The windshield was fractured at the left upper A-pillar from exterior forces and the right lower windshield area from the (interior) front right air bag module cover flap. The transaxle casing was fractured from the culvert override with fluid leaked onto the left front axle and surrounding area.

Figure 3. Frontal damage to the 1995 Ford Escort LX.

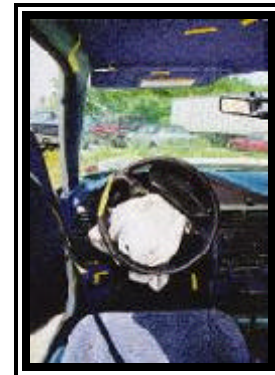
Interior damage to the Escort identified through the vehicle inspection was minor and was attributed to occupant contact (**Figure 4**). Superficial routine wear marks were noted to the latchplate of the manual lap restraint system, but the webbing was found in pristine condition and therefore presumed not used. Routine wear marks were also noted to the aft side of the 2-point motorized automatic shoulder restraint webbing along with (impact related) fabric transfers to the upper and lower sections of the webbing. Blood transfers were identified on the (left) upper and lower quadrants of the driver air bag along with blood spattering on the (right) upper and lower quadrants. Possible scuff marks were documented on the exterior surface of the upper air bag module cover flap. No contact evidence was identified on the front right air bag or exterior surface of the module cover flap, but the windshield was fractured by the flap during the deployment sequence. No loading evidence was found on the knee bolster (rigid plastic type), but a 6.0 cm (2.4 in) scratch mark was documented on the steering column to the right of the centerline. Loading to the lower portion of the steering wheel rim (fixed column) shifted the entire wheel downward 1.5 cm (0.6 in) and compressed the energy absorbing column 3.0

Figure 4. Driver area.

cm (1.2 in). In addition, the left spoke was deformed forward 1.5 cm (0.6 in). A deep scratch mark was noted to the left roof side rail and was located 15.0 cm (5.9 in) rearward of the A-pillar. Possible scuff marks were also noted to the front left roof panel and visor with blood spattering documented on the sun visor. The floor pedals protruded rearward 29.0 cm (11.4 in) into the driver space from 27.0 cm (10.6 in) of toepan intrusion. Additional longitudinal intrusions included 6.0 cm (2.4 in) of left instrument panel displacement and 4.0 cm (1.6 in) of center instrument panel displacement. The floorpan intruded 4.0 cm (1.6 in) vertically into the driver space.

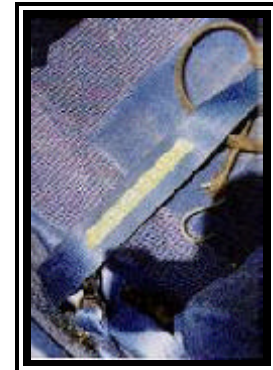
The 1995 Ford Escort LX was equipped with 2-point motorized belts for the front outboard positions. The front systems consisted of an upper anchorage point that traveled along a motorized track located in the roof side rail. This mechanism guided the restraint to the forward A-pillar to allow egress from the vehicle. At inspection, the motorized track was found to be inoperative with the upper anchorage point retracted to the B-pillar (used) position. An electrical systems check during the inspection revealed that the motorized track was in fact, inoperative. This was also supported by the on-scene police photos (post-crash) which shows the automatic belt retracted to the B-pillar position. Wear marks were noted to the aft side of the 2-point motorized automatic shoulder restraint webbing with a 13.0 cm (5.1 in) fabric transfer located 42.0 cm (16.5 in) from the upper anchorage point. A possible fabric transfer was documented on the forward side of the restraint webbing which measured 16.0 cm (6.3 in) long and was located 18.0 cm (7.1 in) from the upper anchorage point (**Figure 5**).

Figure 5. Driver automatic shoulder belt.

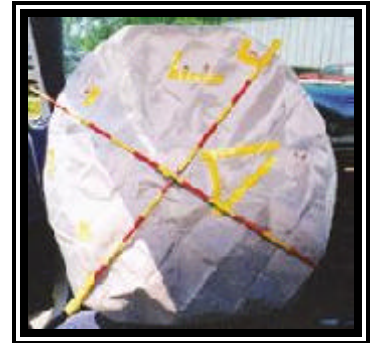
The driver air bag was housed in the center of the steering wheel with a horizontally oriented flap tear seam (H-configuration). The upper flap measured 23.5 cm (9.3 in) in width and 10.5 cm (4.1 in) in height while the lower flap measured 18.5 cm (7.3 in) in width and 5.5 cm (2.2 in) in height. The flaps were narrower in width at the tear seam and measured 17.0 cm (6.7 in). Two small scuff marks were identified on the exterior surface of the upper module cover flap and measured 2.0 cm (0.8 in) square and 1.0 cm (0.4 in) square. No contact evidence was found on the lower module cover flap. The diameter of the driver air bag measured 56.0 cm (22.0 in) in its deflated state (**Figure 6**). The bag was tethered by two internal straps and vented by two 4.0 cm (1.6 in) diameter ports located at the 11 o'clock and 1 o'clock sectors on the rear aspect of the air bag. Blood transfers were documented on the (left) upper and lower quadrants of the driver air bag along with blood spattering on the (right) upper and lower quadrants. Black vinyl transfers were noted to the rear aspect of the air bag from expansion within the module.

Figure 6. 1995 Ford Escort LX driver air bag.

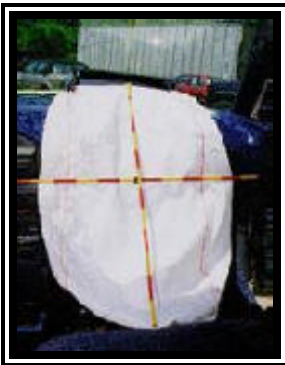
Figure 7. 1995 Ford Escort LX passenger air bag.

The front right passenger air bag deployed from the right mid-instrument panel area with a single cover flap design hinged at the top aspect which opened in an upward direction towards the windshield (windshield fractured from flap). There was no contact evidence identified on the exterior surface of the module cover flap which was rectangular in shape and measured 31.7 cm (12.5 in) in width and 17.0 cm (6.7 in) in height. There was no contact evidence identified on the passenger air bag which measured 41.0 cm (16.1 in) in width and 71.5 cm (28.1 in) in height in its deflated state (**Figure 7**). No internal tether straps were present. The air bag was vented by two ports located below the 10 o'clock and 2 o'clock sectors on the side aspect of the air bag and measured 5.5 cm (2.2 in) each.

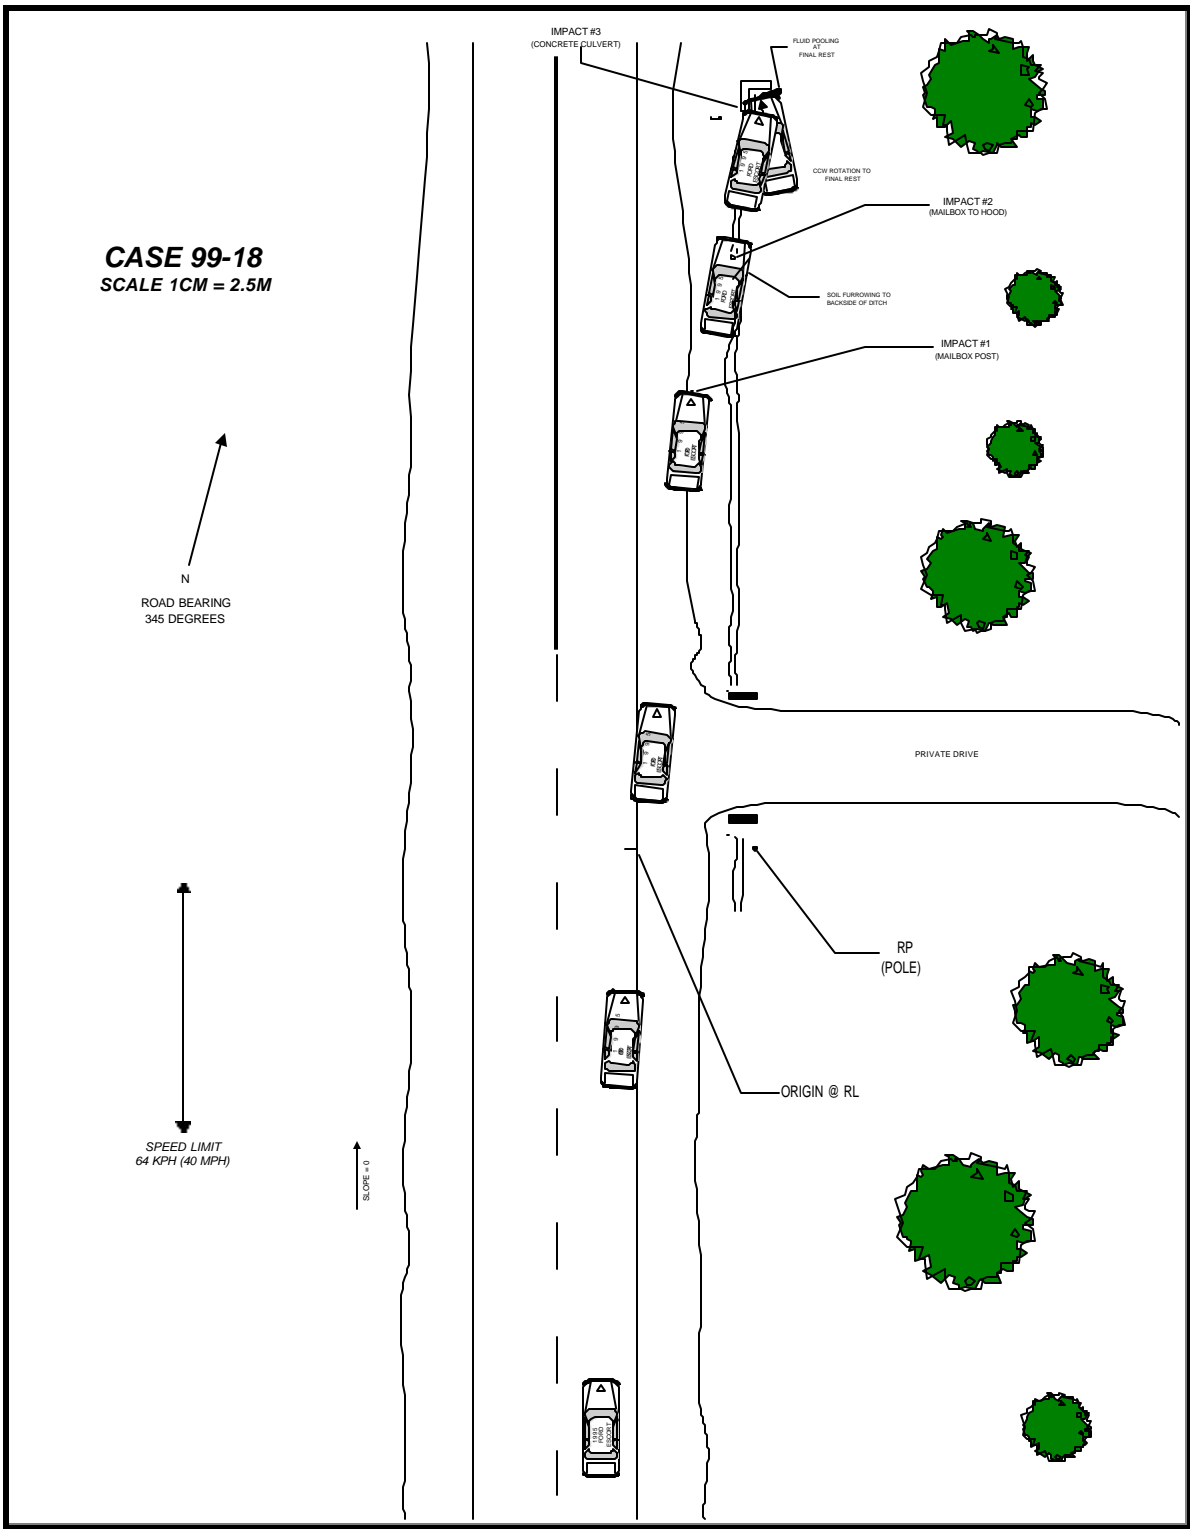
Figure 8. Scene Diagram

The crash occurred during the morning hours of June, 1999. At the time of the crash, it was daylight with no adverse conditions as the roads were dry. The crash occurred off the east pavement edge of a level two lane north/south (asphalt) roadway (see **Figure 8 - page 8**). Environmental features included a 40.0 cm (15.7 in) deep drainage ditch with a 125.0 cm x 40.0 cm (49.2 in x 15.7 in) "L" shaped concrete storm sewer receiver. No traffic controls were present at the scene which had a posted speed limit of 64 km/h (40 mph).
