REMOTE AIR BAG DEPLOYMENT REPORT

CASE NUMBER - IN99-019

VEHICLE - 1998 FORD ESCORT LX

CRASH DATE - May 1998

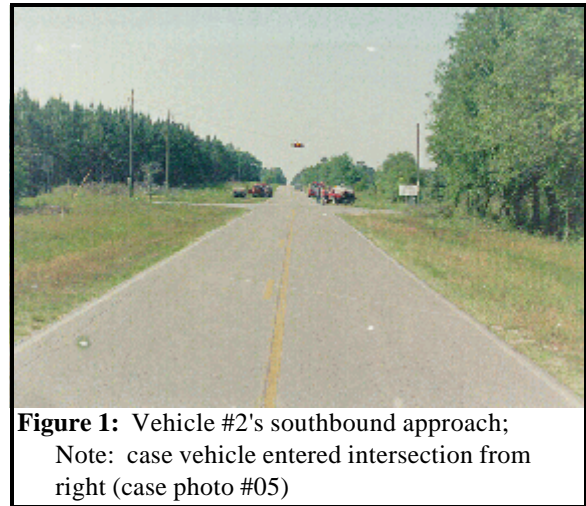
Figure 1: Vehicle #2's southbound approach; Note: case vehicle entered intersection from right (case photo #05)

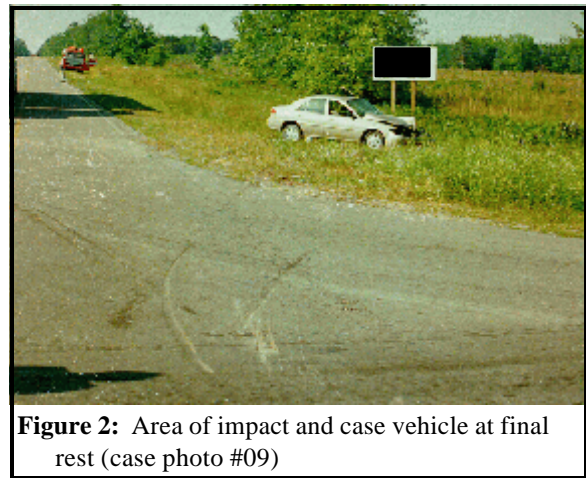
Figure 2: Area of impact and case vehicle at final rest (case photo #09)

right side of vehicle #2. The case vehicle slid in a south-westerly direction and came to rest off of the roadway at the south-west corner of the intersection headed northwest (**Figure 2**), having rotated approximately 230 degrees clockwise from its pre-impact heading. Vehicle #2 rotated a few degrees counterclockwise, traveled approximately 24.7 meters (81 feet) in a south-southeasterly direction and the front of vehicle #2 impacted the front of vehicle #3. Vehicle #2 came to rest heading south on the east shoulder of the north-south roadway, lodged against vehicle #3. The crash severity for the case vehicle was high (greater than 40 km.p.h [25 m.p.h.]).

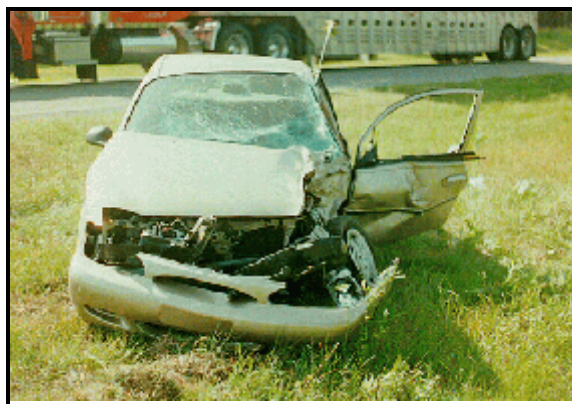
The case vehicle sustained heavy impact damage on the left side, from the front corner to the leading edge of front door (**Figures 3 and 4**). The left front wheel and tire were tilted inward at the top and it appeared that the axle/suspension was broken. The headlight and grille assembly shattered and the bumper cover was torn loose on the left. The front bumper's left corner was bent inward and rearward, the fender was crushed laterally into the engine compartment and the left edge of the hood was crushed and folded. There was direct contact to the left "A"-pillar above the belt line, with lateral movement of the upper "A"-pillar and buckling of the windshield header. The windshield glazing was fractured across the entire width and the left front door window glazing was shattered (kernalized). There was additional minor damage in the area of the left rear wheel and at the left rear corner, due to the second (side-slap) impact. The right side of the case vehicle was essentially undamaged (**Figure 5**). The CDC for the first impact, estimated from police on-scene photographs, is **10-LYAW-3**, with principal direction of force (PDOF)

Figure 3: Front of case vehicle (case photo #10)

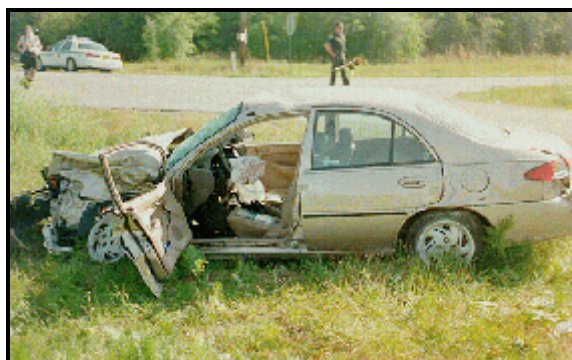
Figure 4: Left side of case vehicle (case photo #12)

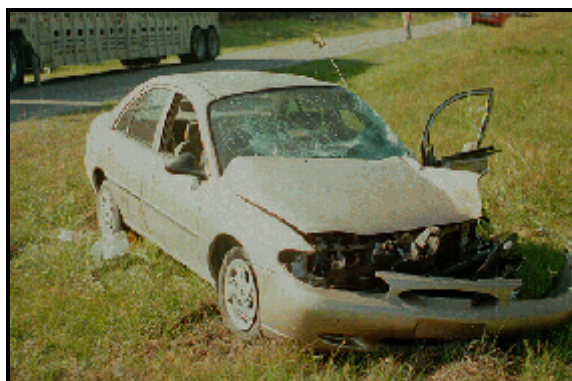
Figure 5: Right side and front of case vehicle (case photo #18)

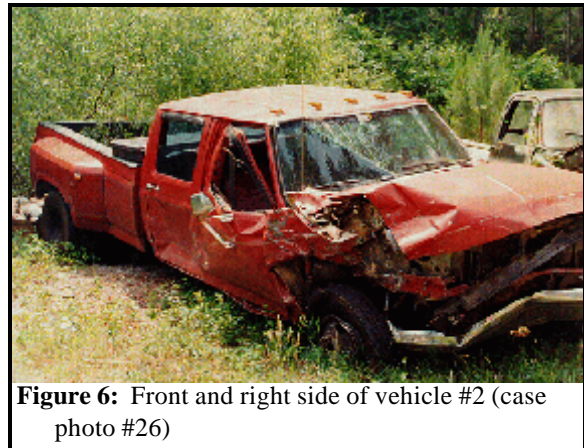
Vehicle #2 (**Figures 6 and 7**) is a rear wheel drive 1987 Ford F350 Crew Cab (four-door) pickup truck (VIN: 2FTJW3510HC-----) equipped with a 6.9 liter V-8 Diesel engine. Vehicle #2 had tandem rear wheels and a wheelbase of 428 centimeters (168.4 inches). The odometer reading is not known. Vehicle #2 was towed from the scene due to disabling damage. There were four adult male occupants in vehicle #2. The driver sustained police-reported possible injuries and the three passengers all sustained police-reported incapacitating injuries. The CDC for vehicle #2's first impact, estimated from police on-scene and tow yard photographs, is **01-FZEW-3**, with principal direction of force (PDOF) 20 degrees. The WinSMASH reconstruction program was used to calculate Delta V based on the vehicle #2 and case vehicle CDCs. These CDC-only calculations provide a borderline reconstruction but the results appear reasonable. The Total, Longitudinal, and Lateral Delta Vs are, respectively: 17 km.p.h (11 m.p.h.), -16 km.p.h (-10 m.p.h.) and -6 km.p.h (-4 m.p.h.).

Figure 6: Front and right side of vehicle #2 (case photo #26)

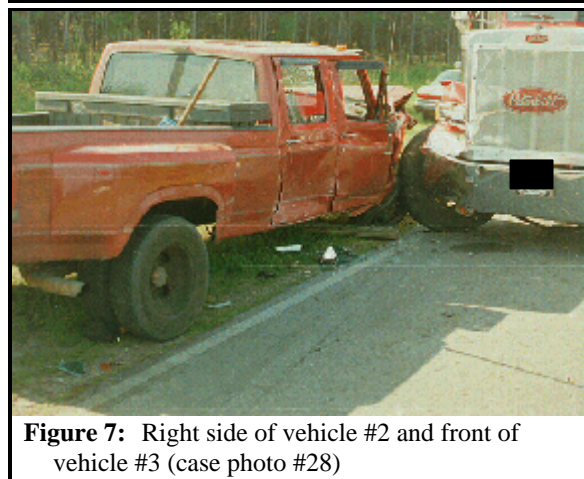
Figure 7: Right side of vehicle #2 and front of vehicle #3 (case photo #28)

Vehicle #3 (**Figure 7** above) was a 1998 Peterbilt model 379 cab-behind-engine 6 x 4 truck-tractor (VIN: 1XP5DB9X8WD-----) that was towing a livestock semi-trailer. Vehicle #3 was towed from the scene due to disabling damage. The driver (sole occupant) was not injured.
