**VERIDIAN ON-SITE REDESIGNED AIR BAG DEPLOYMENT/
CHILD PASSENGER FATALITY INVESTIGATION**

VERIDIAN CASE NO. CA99-25

**VEHICLES - 1998 PONTIAC GRAND PRIX SE
1999 FORD RANGER XLT**

LOCATION - STATE OF OHIO

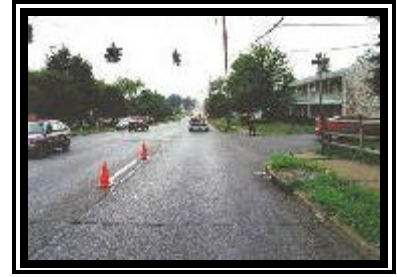
The 36 year old female driver of the 1998 Pontiac Grand Prix was transporting her 7 year old son to purchase ice cream. The driver was traveling in a westerly direction on the inboard lane of the minor arterial roadway. As she approached the signalized intersection, a westbound non-contact vehicle was stopped on the inboard travel lane waiting to turn left onto the local street. The driver of the Pontiac maneuvered the vehicle into the curb lane to proceed straight through the intersection (**Figure 1**). The overhead signal system was in a green phase for east/westbound traffic flow.

Figure 1. Westbound approach for the 1998 Pontiac Grand Prix SE.

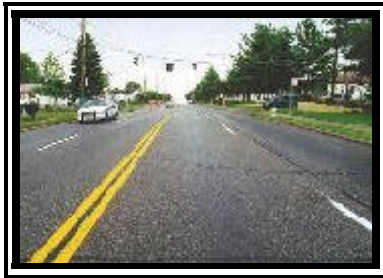
Figure 2. Eastbound approach for the 1999 Ford Ranger XLT pickup truck.

The driver of the 1999 Ford Ranger XLT pickup truck was traveling in an easterly direction on the minor arterial roadway and was decelerating in preparation for a left turn onto the local street (**Figure 2**). The stopped non-contact westbound vehicle apparently obstructed the driver's view of the approaching Pontiac as he initiated his turn across the path of the Pontiac at a (passenger reported) speed of 8.0 km/h (5.0 mph). The driver of the ABS equipped Pontiac Grand Prix braked in an attempt to avoid the crash.

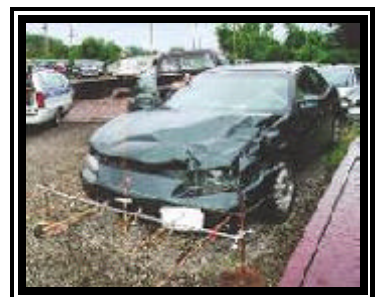
The Pontiac sustained moderate frontal damage as a result of the impact with the Ford Ranger pickup truck (**Figure 3**). The direct contact damage began at the front left bumper corner and extended 66.0 cm (26.0 in) inboard. The combined direct and induced damage length measured 154.0 cm (60.6 in). Six crush measurements were documented at the level of the bumper:

Figure 3. Frontal damage to the 1998 Pontiac Grand Prix SE.

C1= 0 cm, C2= 7.0 cm (2.8 in), C3= 5.0 cm (2.0 in), C4= 0 cm, C5= 0 cm, C6= 0 cm. Crush measurements were also documented 10.0 cm (3.9 in) above the level of the bumper to capture the underride damage which resulted in an *averaged* profile of: C1= 8.0 cm (3.1 in), C2= 16.0 cm (6.3 in), C3= 12.0 cm (4.7 in), C4= 0 cm, C5= 0 cm, C6= 0 cm. Paint transfers were documented along the hood and bumper fascia. The windshield fractured at the left lower A-pillar from exterior impact forces and the right mid-windshield fractured from (interior) front right passenger contact and the air bag module cover flap. Direct contact damage was documented to the left quarter panel from the secondary impact which began 42.0 cm (16.5 in) forward of the rear left bumper corner and extended 13.0 cm (5.1 in) forward. Direct contact damage was also documented to the right fender from the utility pole impact which began 34.0 cm (13.4 in) aft of the front right bumper corner and extended 38.0 cm (15.0 in) rearward.

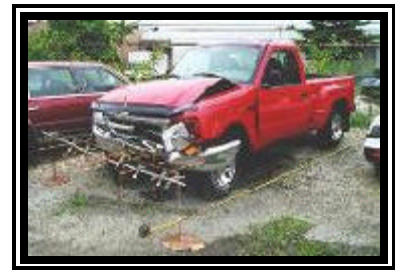
The Ford Ranger pickup truck sustained moderate frontal damage as a result of the impact with the Pontiac Grand Prix (**Figure 4**). The direct contact damage began at the front right bumper corner and extended 108.0 cm (42.5 in) inboard. The impact deformed the full frontal width resulting in a combined direct and induced damage length (Field L) of 141.0 cm

(55.5 in). Six crush measurements were documented at the level of the bumper: C1= 26.0 cm (10.2 in), C2= 23.0 cm (9.1 in), C3= 30.0 cm (11.8 in), C4= 33.0 cm (13.0 in), C5= 17.0 cm (6.7 in), C6= 1.0 cm (0.4 in). The end structure was displaced approximately 28.0 cm (11.0 in) to the left from the impact force. An indentation was documented to the center portion of the bumper from the front left bumper corner of the Pontiac. A circular imprint was also documented to the right portion of the bumper from the left front wheel of the Pontiac which occurred during sustained contact between the vehicles during spinout. The windshield was undamaged with all tempered glazing intact. Superficial scratch marks were documented to the side aspect of the front right bumper apex which was attributed to the secondary impact.

Figure 4. Frontal damage to the 1999 Ford Ranger XLT.

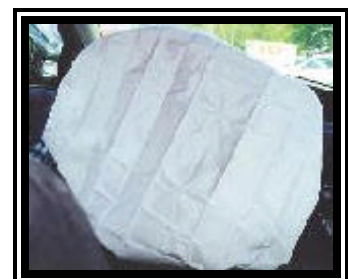
The Pontiac was equipped with redesigned frontal air bags for the driver and right passenger positions. The air bags deployed as a result of the crash. The driver air bag module was identified by the General Motors part number: *16760359* with a bar coded lot number of *TCAP70553904*. The driver air bag was housed in the center of the steering wheel with a vertically oriented flap tear seam (I-configuration). The flaps were symmetrical in shape and measured 8.0 cm (3.1 in) in width and 10.5 cm (4.1 in) in height. A scuff mark and possible skin transfer which measured 4.0 cm x 3.5 cm (1.6 in x 1.4 in) were documented on the exterior surface of the left cover flap. Although no contact evidence was identified on the air bag, multiple black vinyl transfers were noted to the face of the air bag from expansion within the module. The diameter of the driver air bag measured 61.5 cm (24.2 in) in its deflated state (**Figure 5**). No internal tether straps

Figure 5. 1998 Pontiac Grand Prix redesigned driver air bag.

were present. The bag was vented by two ports located at the 10 o'clock and 2 o'clock (centered) sectors on the rear aspect of the air bag.

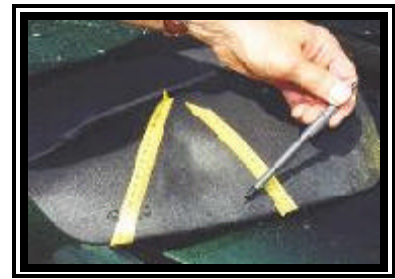
The front right passenger air bag deployed from the right top instrument panel area with a single cover flap design hinged at the forward aspect which opened in an upward direction towards the windshield. The cover flap was asymmetrical in shape and measured 33.0 cm (13.0 in) in width along the rear aspect of the flap and 40.6 cm (16.0 in) along the forward aspect. The flap measured 27.9 cm (11.0 in) in height along the left edge of the flap and 24.1 cm (9.5 in) along the right edge. Glass fragments were noted to the right section of the cover flap with a 1.0 cm (0.4 in) deep indentation attributed to the passenger's chin contact (**Figure 6**). Tissue transfers and white scuff marks were also documented on the cover flap which began left of the centerline and extended onto the face of the flap. The right mid-windshield area was fractured with a scuff mark (attributed to the module cover flap) surrounding the damage.

Figure 6. Passenger contact damage to the front right air bag module cover flap.

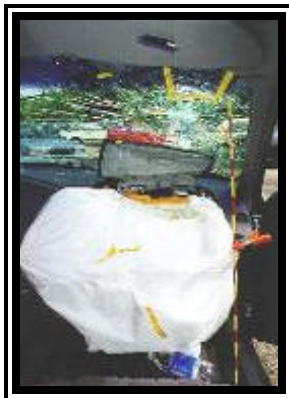
Figure 7. 1998 Pontiac Grand Prix redesigned passenger air bag.

The passenger air bag module was identified by the General Motors part number: *16757542-57* with a bar coded lot number of: *TRA170019154*. The passenger air bag measured 63.5 cm (25.0 in) in width and 58.4 cm (23.0 in) in height in its deflated state (**Figure 7**). The bag was tethered by two internal straps sewn to the top seam and vented by two ports located at the 10 o'clock and 2 o'clock sectors on the side aspect of the air bag. Tissue transfers were identified on the left side of the bag and below the right vent port which measured 3.2 cm (1.3 in) in length. A series of light brown tissue transfers were also documented along the right vertical seam of the air bag. Numerous loose "cut" hair strands were identified along the top of the air bag and instrument panel. Black vinyl transfers were found on the top and side aspects of the air bag from expansion within the module.

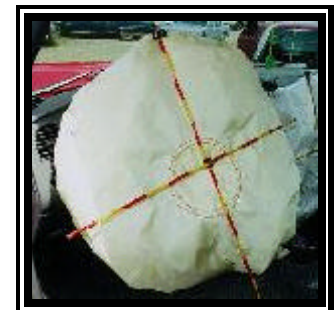
The Ford was equipped with redesigned frontal air bags for the driver and right passenger positions. The air bags deployed as a result of the crash. The driver air bag was housed in the center of the steering wheel with a horizontally oriented flap tear seam (H-configuration). The flaps were asymmetrical in shape as the upper flap measured 17.5 cm (6.9 in) in width and 8.0 cm (3.1 in) in height while the lower flap measured 17.5 cm (6.9 in) in width and 4.0 cm (1.6 in) in height. No contact evidence was identified on the air bag or exterior surface of the module cover flaps. The diameter of the driver air bag measured 63.5 cm (25.0 in) in its deflated state (**Figure 8**). The bag was tethered by two internal straps and vented by two ports located at the 11 o'clock and 1 o'clock sectors

Figure 8. 1999 Ford Ranger XLT redesigned driver air bag.

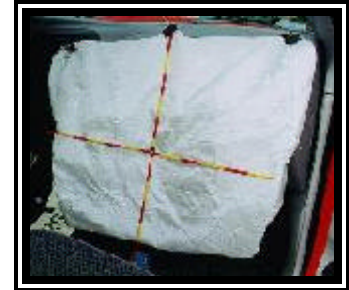
The front right passenger air bag deployed from the right mid-instrument panel area with a single cover flap design hinged at the top aspect. The cover flap was rectangular in shape and measured 37.0 cm (14.6 in) in width and 17.5 cm (6.9 in) in height. No contact evidence was identified on the air bag or exterior surface of the module cover flap. The passenger air bag measured 66.0 cm (26.0 in) in width and 56.0 cm (22.0 in) in height in its deflated state (**Figure 9**). No internal tether straps were present. The bag was vented by two ports located at the 10 o'clock and 2 o'clock sectors on the side aspect of the air bag.

Figure 9. 1999 Ford Ranger XLT redesigned passenger air bag.

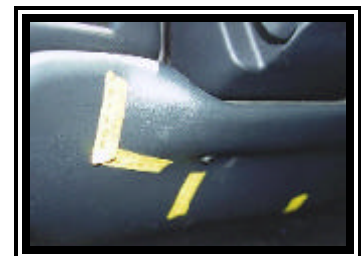
The 36 year old female driver of the 1998 Pontiac Grand Prix was unrestrained and presumed to be in an upright posture with the seat track adjusted 17.0 cm (6.7 in) aft of the forward most position. At impact, she initiated a forward trajectory in response to the 12 o'clock impact force and loaded the deployed redesigned driver air bag and knee bolster (**Figure 10**). There was no loading evidence on the driver air bag, however, the knee bolster yielded several scuff marks from knee contact. Following the collision, she was assisted from the vehicle by the driver of the Ford Ranger. She was not reported by police as injured.

Figure 10. Scuff marks to the driver knee bolster.

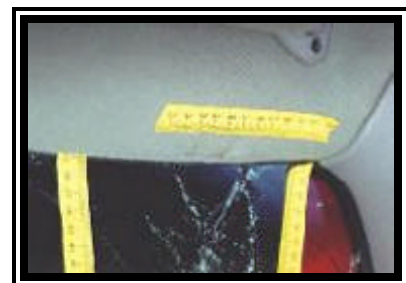
The cover flap contact and the expanding air bag displaced the unrestrained child vertically into the windshield. His head fractured the laminated glazing which contained hair strands. This pattern continued vertically into the windshield header area. During this upward movement, the child passenger’s head rotated in a counterclockwise direction. The upper left parietal area of his scalp impacted the header (**Figure 11**) which resulted in a 11.0 cm (4.3 in) laceration and a linear/depressed skull fracture that measured 4.0 x 1.0 cm

Figure 11. Passenger contact damage to the right windshield header.

(1.6 x 0.4 in) . The child sustained additional brain trauma to include an underlying cerebral subdural and subarachnoid hemorrhage, diffuse axonal injury to the corpus callosum and brain stem, cerebral and cerebellar petechial hemorrhages, contusions of the left frontal/parietal lobes and contra-coup contusions to the right inferior temporal lobe.

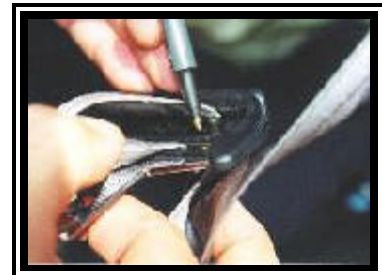
Figure 12. Loading marks to the sliding latchplate.

The 19 year old male driver of the 1999 Ford Ranger XLT was properly restrained by the 3-point manual lap and shoulder belt system, seated in an upright posture with the seat track adjusted to the full rearward position. Belt usage was confirmed by the loading marks documented to the sliding latchplate (**Figure 12**) and stretched webbing noted at the lower attachment point. At impact, he initiated a forward/lateral trajectory in response to the 1 o'clock impact force and loaded the manual belt and deployed redesigned driver air bag. The driver was not injured in the collision. The combination of restraint options prevented contact with frontal components and possible injury.
