**CALSPAN ON-SITE SIDE IMPACT AIR BAG DEPLOYMENT
INVESTIGATION**

CALSPAN CASE NO. CA99-26

VEHICLE #1 - 1998 LEXUS LS 400

VEHICLE #2 - 1997 DODGE 3500 PICKUP TRUCK

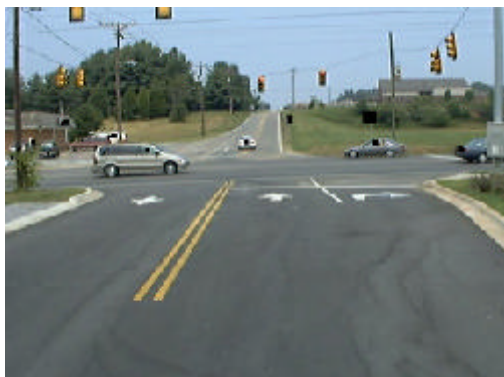
Figure 1 View of the Lexus' northbound trajectory just prior to the point of impact (POI)

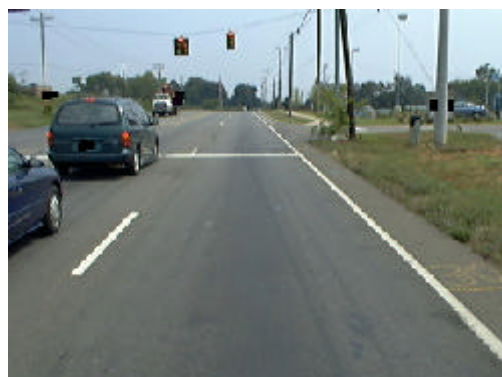
Figure 2 View of the trajectory for the Dodge 30 m from the POI

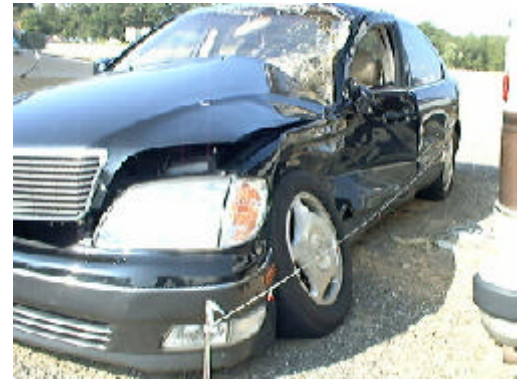
The frontal plane of the Dodge struck the left side plane of the Lexus at a WinSMASH computed impact speed of 40.9 km/h (25.4 mph). The Lexus sustained direct damage to the left side which began near the left front bumper corner and ended at the rear edge of the driver's door. The maximum crush of 40.6 cm (16.0") was located mid door just below the rearview mirror. The maximum intrusion of the interior side structure in this area measured 33 cm (13"). The generated collision deformation classification code (CDC) was 10-LYAW-3 (**refer to Figure 3**).

Figure 3 Left front angular corner view of the Lexus illustrating the length of contact and depth of crush

Lexus Crush Profile			
Impact with the Dodge	$C_1 = 0$	$C_2 = 4.4 \text{ cm (1.75")}$	$C_3 = 33.7 \text{ cm (13.25")}$
	$C_4 = 27.9 \text{ cm (11.0")}$	$C_5 = 19.1 \text{ cm (7.5")}$	$C_6 = 0.6 \text{ cm (0.25")}$

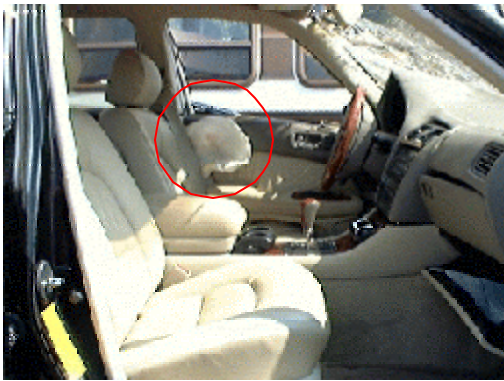
The Lexus was equipped with a supplemental restraint system (SRS) which included dual front air bags and side impact air bags mounted in the outboard aspects of the front seat back supports. The driver's side air bag was the only air bag which deployed during the crash sequence (refer to **Figure 4**). The side impact air bag was cylindrical in design and deployed forward a measured distance of 27.9 cm (11.0") from the forward leading edge of the seat back support. There was a tether sewn between the inboard and outboard surfaces of the air bag which measured 7.6 cm (3.0") in length. The vertical height of the air bag measured 29.2 cm (11.5") located at the stitching for the tethers (refer to **Figure 5**). There were no visible contact points on the surface of the air bag.

Figure 4 Lateral view of the front seat row of the 1998 Lexus showing the deployed left front side impact air bag

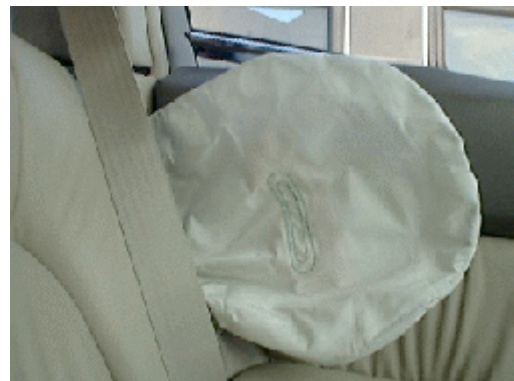
Figure 5 Closer view of the deployed left front side impact air bag

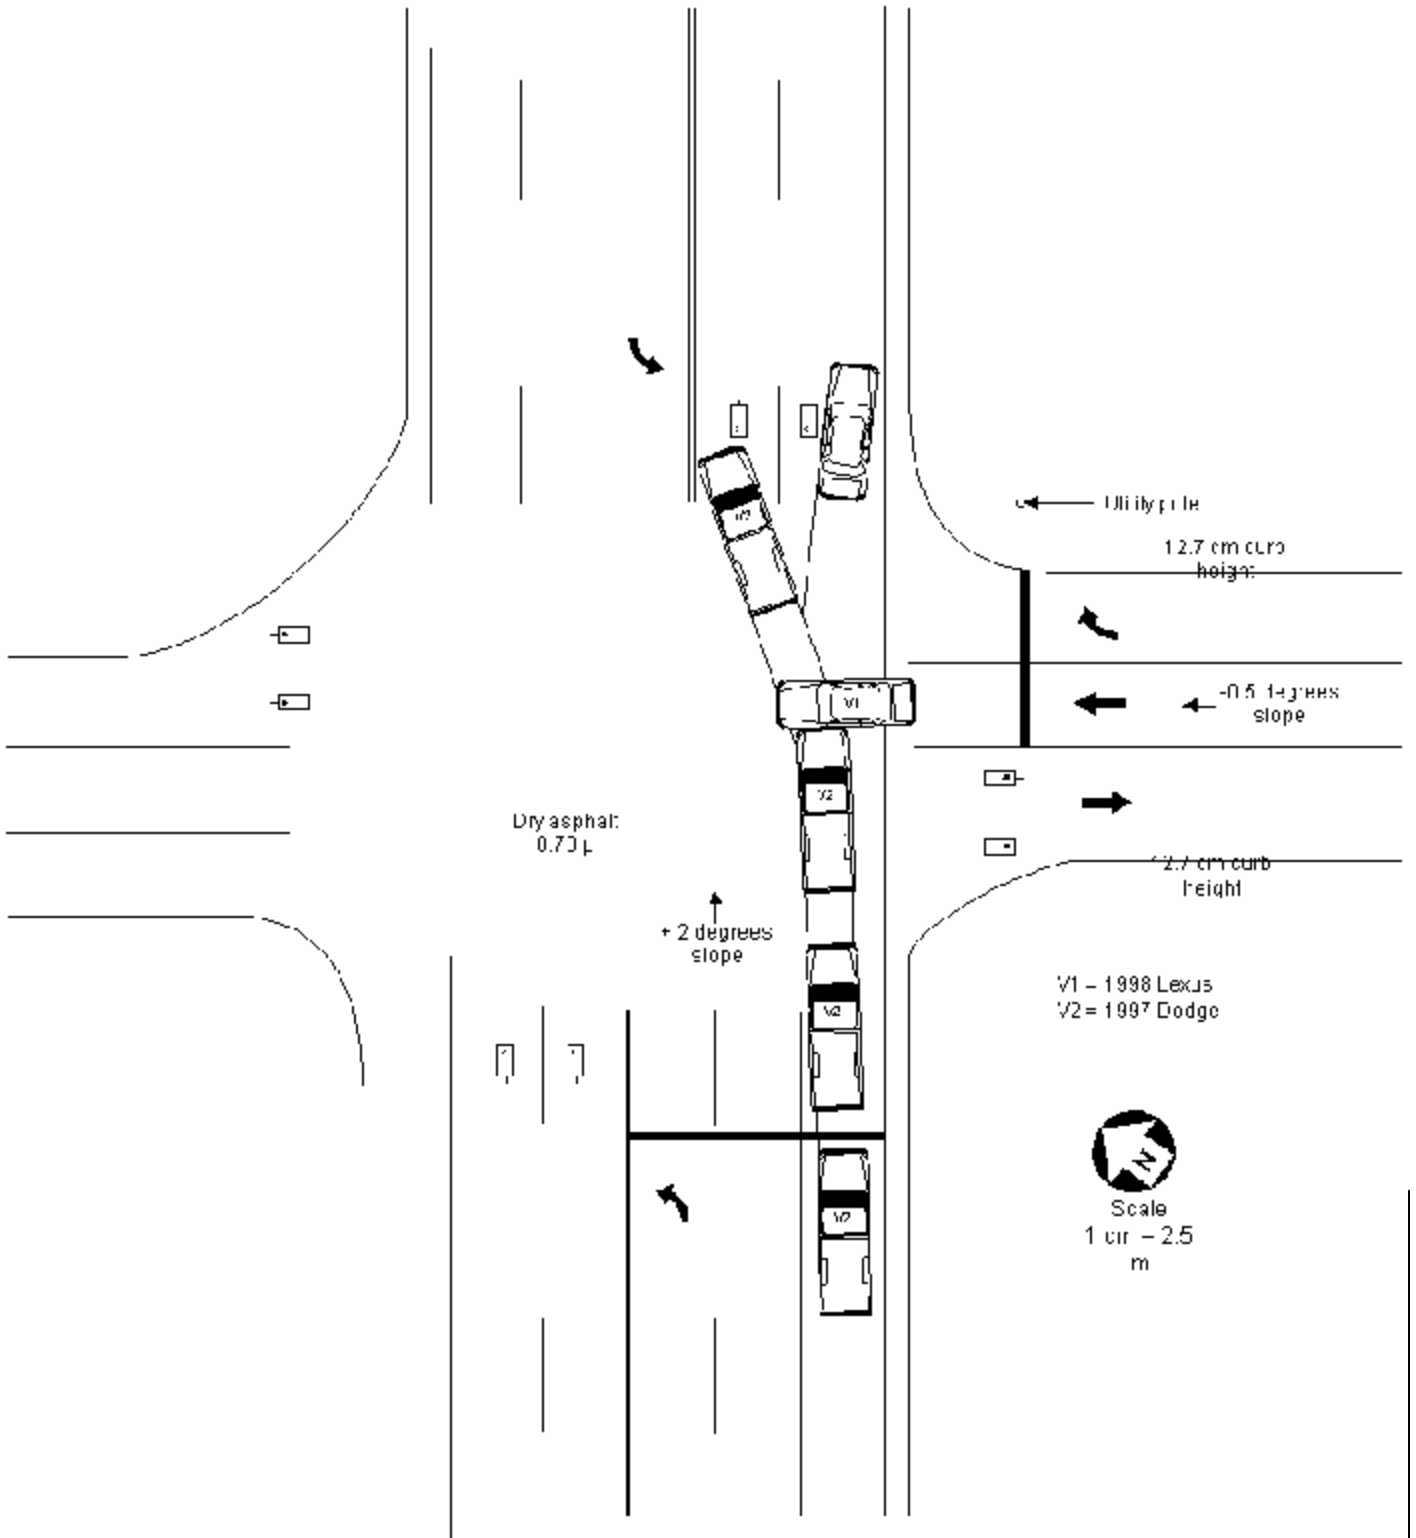
Figure 6- Scaled scene schematic

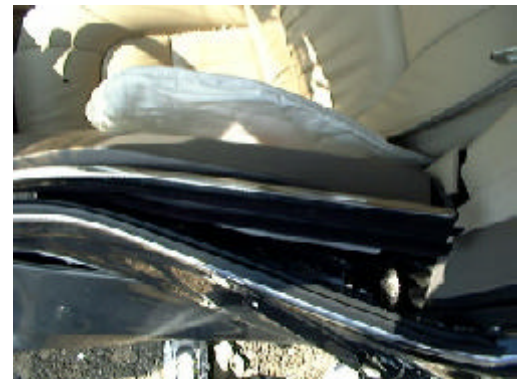
Interior vehicle damage to the 1998 Lexus LS 400 was attributed to the deployment of the Supplemental Restraint System (SRS) and extensive lateral vehicle intrusion from the first impact sequence with the Dodge 3500 pickup truck (**refer to Figure 7**). Intruded components included: the left front door armrest; the A-pillar; the left front seat cushion; the left floor sill; the left front door pane; and the left B-pillar (**refer to Figures 8&9**). The following table lists the intruded values of these components.

Figure 7 Overhead view of the intrusion in the vicinity of the left front side impact air bag

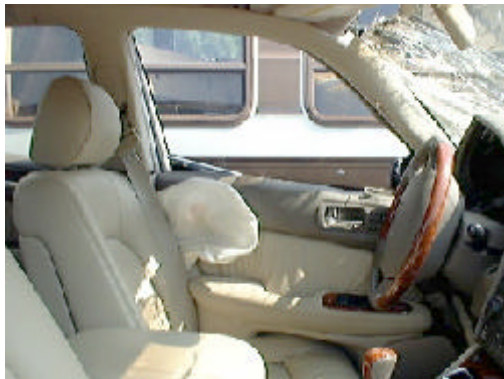
Component	Intruded Value
Leading edge of left front door armrest at the location of the window control panel	33.0 cm (13.0")
Left front door panel above the door release handle at the beltline	22.2 cm (8.75")
Door surface at A-pillar	16.5 cm (6.5")
A-pillar	11.4 cm (4.5")
B-pillar	8.9 cm (3.5")
Driver seat cushion	12.7 cm (5.0")
Left floor sill	6.4 cm (5.0")

Figure 9 View of the left side of the vehicle illustrating the intruded components

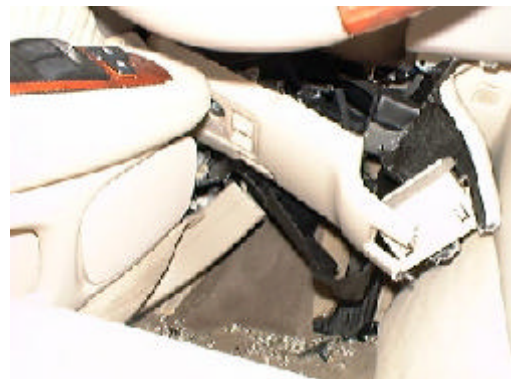
Figure 10 View showing the intrusion of the left side components from the driver's seat looking forward

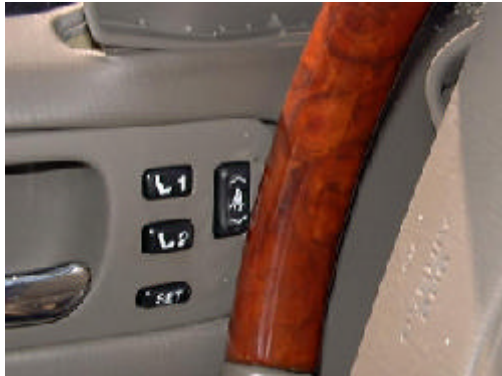
The control switches for the seat memory adjustment and torso belt height adjustment on the left front door showed scuff marks from contact with the lateral aspect of the steering wheel rim as the door panel intruded laterally during the crash (refer to **Figure 10**). The steering wheel did not exhibit any deformation or loading by the driver.

Figure 11 View of the contact evidence on the control pane for the seat positioning

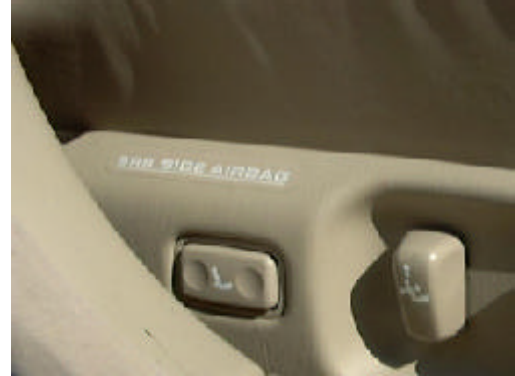
Figure 12 View of the side impact air bag label located above the seat adjustment controls on the outboard surface of the seat

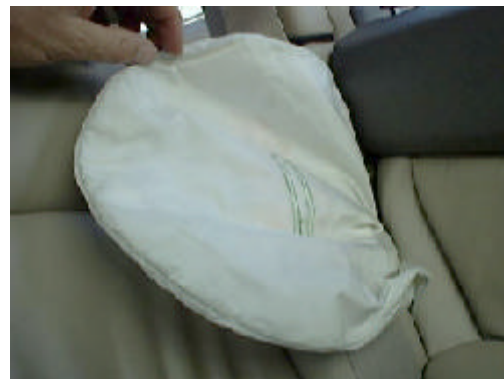
The left front side impact air bag was mounted in the outboard aspect of the driver’s seat back support (called the seat back bolster). During the SRS actuation sequence, the air bag exerted pressure against the leather seat covering resulting in a vertical tear that allowed the forward excursion of the air bag. The tear was located 5.1 cm (2.0") rearward from the leading edge of the seat support and 8.9 cm (3.5") below the top of the back support. The tear in the seat support covering measured 25.4 cm (10.0") vertically.

The air bag was a cylindrical cone shape with the width measuring 25.4 cm (10.0") at the seat back support and 29.2 cm (11.5") at the tether located 14.6 cm (5.75") from the end of the air bag. Stretching the air bag laterally at the tether, the air bag width measured 7.6 cm (3.0"). The longitudinal length of the air bag measured 33.0 cm (13.0"). The tether was secured to the air bag by green colored thread which formed a pattern which measured 2.2 cm (0.875") wide and 8.9 cm (3.5") vertically (**refer to Figure 12**). The material of the air bag appeared to be a heavy denier with a fine mesh weave. There were no visible vent ports. An inspection

Figure 12 Side surface of the driver’s side air bag facing the left front door panel

of the air bag fabric did not reveal any obvious driver contact evidence. An air bag identification number was inked printed on the surface facing the door panel which read:
