REMOTE AIR BAG DEPLOYMENT REPORT

CASE NUMBER - IN99-027

VEHICLE - 1998 LEXUS ES300

CRASH DATE - July 1998

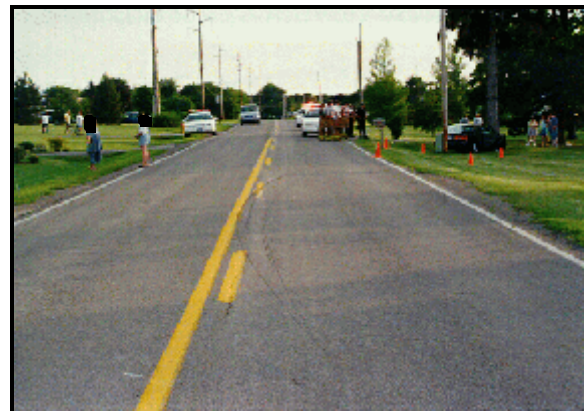
The case vehicle was originally traveling southwest in the southwestbound lane of a two-lane, undivided, county roadway (**Figure 1**). It was daylight and clear. The roadway was bituminous, dry, straight, and level with no defects. The posted speed limit was 64 km.p.h. (40 m.p.h.). A pre-crash speed estimate of 90 km.p.h. (56 m.p.h.) for the case vehicle was reported by the investigating officer. The officer also coded the "apparent contributing factors" section of the Police Crash Report as *unsafe speed* and *alcohol involvement*. Traffic control devices present were a SPEED LIMIT regulatory sign for southwestbound traffic (Manual on Uniform Traffic Control Devices, R2-1), a single broken yellow centerline with a single solid yellow "no passing" line for northbound traffic, and a single solid white edge line on each side of the roadway. All were clearly visible. The Police Crash Report and accompanying scene diagram indicated that, as the southwestbound case vehicle was completing a right-hand curve, it drifted onto the left (west) shoulder, the driver overcorrected via right steering and crossed both travel lanes onto the right (east) shoulder. He overcorrected a second time with left steering and began to approach the centerline where he, for the third time, overcorrected by steering right and causing a clockwise rotation. The case vehicle exited the right (east) road edge and shoulder, straightened its trajectory, and struck a large tree head-on. Just prior to the tree impact, the case vehicle narrowly missed striking a utility pole with its left side. Steering is the only avoidance maneuver mentioned by the investigating officer. The crash occurred off the right (east) roadside.

Figure 1: Southbound view of case vehicle's travel path; Note: left side rotational tire marks on pavement (case photo #02)

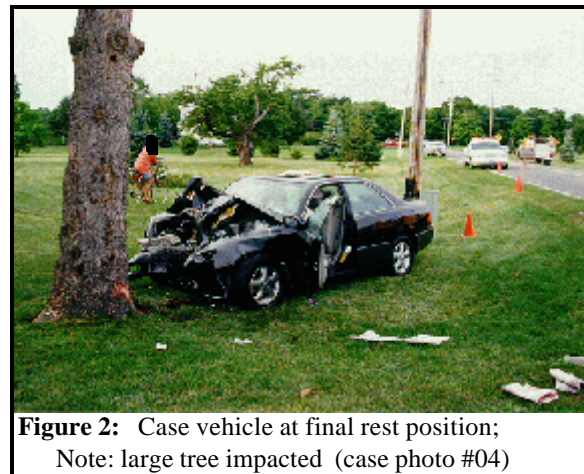
Figure 2: Case vehicle at final rest position; Note: large tree impacted (case photo #04)

The front right of the case vehicle impacted a large tree (**Figure 2**, above), causing the case vehicle's

driver and front right passenger air bags to deploy. At maximum engagement, the case vehicle rotated approximately 30 degrees clockwise and rebounded nearly 0.9 meters (three feet) from the tree. It was facing south-southeast at final rest. The crash severity for the case vehicle was high [greater than 40 km.p.h. (25 m.p.h.)].

The case vehicle impacted a large tree with a diameter of approximately 61 centimeters (24 inches). There was slight surface scraping and peeling of the tree’s bark in the area of impact, but there is no evidence that the tree fractured or moved.

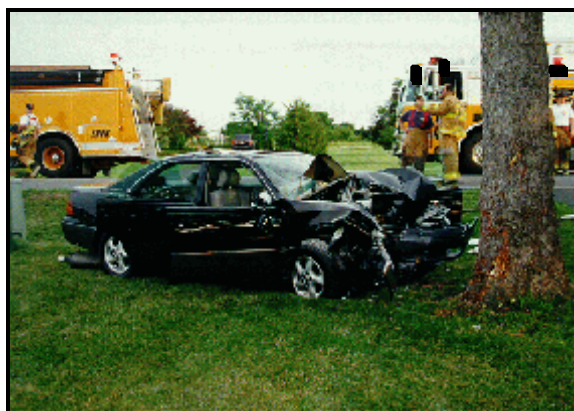
The case vehicle sustained direct contact damage to the right two-thirds of the frontal plane (**Figure 3**). Damaged components included: the air dam, front bumper and fascia, grille, engine compartment brackets, radiator, and hood were all displaced rearward; not known is damage to the left front headlamp assembly, the right front headlamp is still intact. Induced damage included the left front and right front fenders pulled inward; the right front tire and wheel displaced rearward into the lower right A-pillar; the rear edge of the hood contacted the bottom portion of the windshield, folding and splintering it; both upper A-pillars were slightly buckled; the right side of the roof was slightly buckled forward of the B-pillar; the right roof rail rearward of the B-pillar was slightly buckled; the right side of the sun roof was buckled; and the right upper C-pillar was slightly buckled. Glazing for the right front door is not visible post-impact, but it is unknown if it was shattered (kernelized) or simply is in the “down” position (no broken glass can be seen on the ground or in the front right passenger seating area); all other glazing, except the windshield, was in place. Based on police photographs, the CDC for the case vehicle was estimated as: **12-FZEW-3**, with a principal direction of force of 360 degrees (000). The WinSMASH reconstruction program, CDC-only algorithm, provided a borderline reconstruction, but the results appear reasonable. The case vehicle’s estimated

Figure 3: Front right damage to the case vehicle;
Note: scrape marks to tree and windshield damage from rear edge of hood (case photo #07)

Total, Longitudinal, and Lateral Delta Vs are, respectively: 52.6 km.p.h. (32.7 m.p.h.), -52.6 km.p.h. (-32.7 m.p.h.), and 0.0 km.p.h. (0.0 m.p.h.).

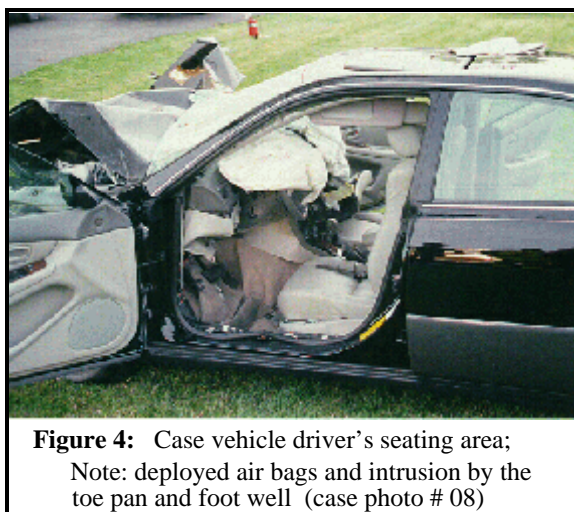
Figure 4: Case vehicle driver's seating area;
Note: deployed air bags and intrusion by the toe pan and foot well (case photo # 08)

Interior damage to the case vehicle consisted of intrusion by the lower left instrument panel, the center instrument panel, the left toe pan, and the left foot well (**Figure 4**, above and **Figure 5**). The bottom of the left front door rubber gasket was slightly tented. The steering column was pushed up and the steering wheel rim was deformed (**Figure 6**). There was a substantial driver contact scuff to the left, underneath side of the steering column. The right side instrument panel intruded into the front right passenger's seating area. The glove compartment was open but it is unknown if crash forces or a post-impact document search was the cause.

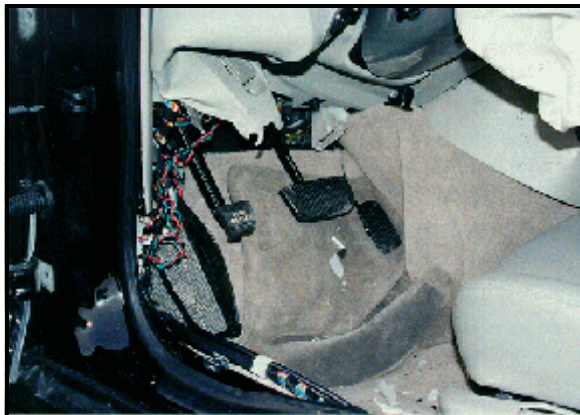
Figure 5: Case vehicle driver's lower seating area; Note: toe pan and foot well intrusion and contact to the left side of the steering column (case photo #10)

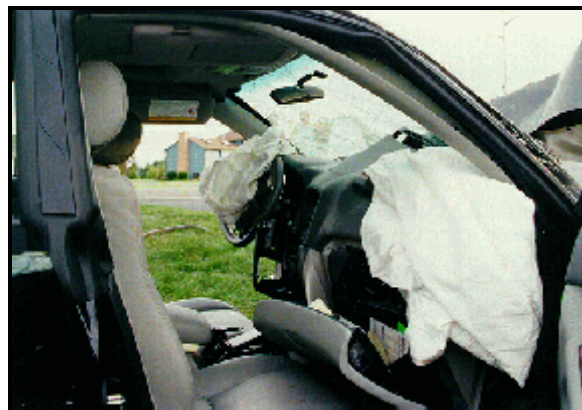
Figure 6: Case vehicle's interior from right front door; Note: steering wheel deformation and deployed air bags (case photo #12)
