**REMOTE REDESIGNED AIR BAG DEPLOYMENT INVESTIGATION
SCI TECHNICAL SUMMARY REPORT**

VERIDIAN CASE NO. CA99-029

RABSS VEHICLE -1998 CHEVROLET 1500 SERIES PICKUP TRUCK

LOCATION - STATE OF MARYLAND

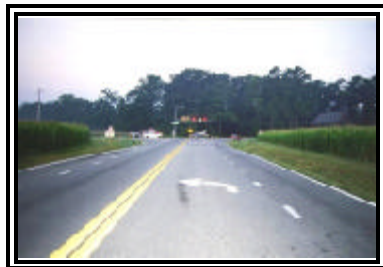
The 24-year-old female driver of the 1998 Chevrolet pickup was operating the vehicle northbound on approach to the 3-leg intersection (**Figure 1**). As the pickup truck approached the intersection, the driver became inattentive while probing with her hand around the driver's seat and floor area for a misplaced object, and failed to detect the intersection and traffic control devices (**Figure 2**). According to a witness, the overhead traffic signal system was in the red phase for the northbound pickup truck. The vehicle traveled through the intersection and departed the roadway at the top side of the T-intersection. The vehicle was reported by police as traveling approximately 56 km/h (35mph) as it traveled through the intersection. There were no identifying marks within the vehicle's trajectory to indicate any driver avoidance maneuvers.

Figure 1. Northbound approach for the Chevrolet pickup truck

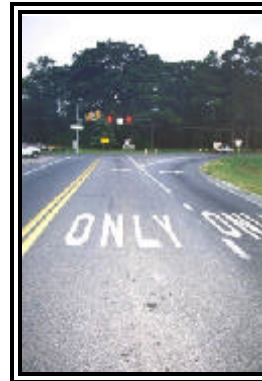
Figure 2. 3-leg intersection and traffic controls

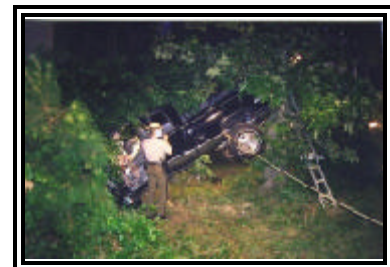
Figure 3. Final rest position of the Chevrolet pickup truck

simultaneously rotated approximately 30 degrees in a counterclockwise (CCW) direction. The pickup truck came to final rest with the front aspect near the base of the impacted tree and the rear bumper wedged against the other tree (**Figure 3**). At rest, the vehicle was at an angle of 30 degrees to the ground.

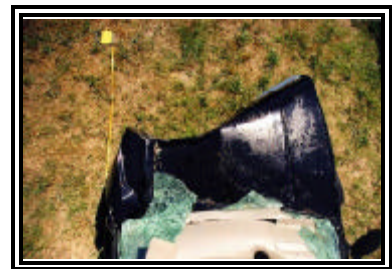
The 1998 Chevrolet pickup truck sustained severe frontal damage as a result of the impact with the tree (**Figure 4**). The Collision Deformation Classification (CDC) for the impact to the Chevrolet pickup was 12-FYEW-3. The direct contact damage began approximately 20.0 cm (8.0") to the right of the centerline of the vehicle, and extended approximately 80.0 cm (31.5") across the front plane to the left bumper corner. The combined direct and induced damage length (Field L) involved the entire frontal width of the pickup truck. A crush profile was estimated from the police photographs and used to compute a WINSMASH delta-v. The profile was as follows:

Figure 4. Overhead view of the frontal damage

C1= 46.0 cm (18.0"), C2= 66.0 cm (26.0"), C3= 69.0 cm (27.0") C4= 55.0 cm (22.0") C5= 35.0 cm (14.0"), C6= 6.0 cm (2.0").

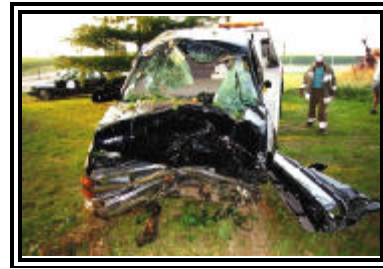
Both front tires were restricted and the left front deflated from the rearward displacement against the frame. There was a significant reduction in both left and right wheelbases. The windshield was holed in the middle due to the ejection of the rear center passenger. The tempered glass in the left door and left rear window was shattered due to the displacement of the left A-pillar. The center of the windshield header had buckled, and was displaced upward approximately 15.0 cm (6.0") (Figure 5).

Figure 5. Frontal damage to Chevrolet pickup truck

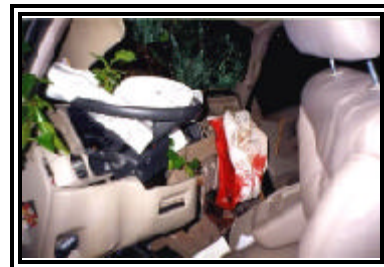
Interior damage to the Chevrolet pickup truck was moderate, and was attributed to occupant contact and passenger compartment intrusion (Figure 6). Intrusions were estimated from police photographs. Major longitudinal intrusions to the passenger compartment included (estimates) the left A-Pillar [13.0 cm (5.0")], left instrument panel [15.0 cm (6.0")], left toepan [20.0 cm (8.0")], center instrument panel [10.0 cm (4.0")], and center toepan [15.0 cm (6.0")]. The steering column was deformed vertically approximately 30 degrees, with no deformation observed to the steering wheel rim. Deformation was noted on the knee bolster and glove box door. The driver's seat was displaced slightly forward and to the left from impact forces. The front right passenger seat and center arm rest were both displaced forward and to the left due to impact forces and contact from the passengers seated in the rear of the vehicle.

Figure 6. Interior view of Chevrolet pickup truck

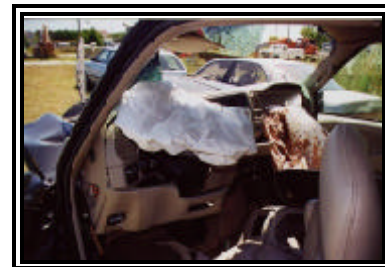
The 1998 Chevrolet pickup truck was equipped with redesigned frontal air bags for the driver and front right passenger positions. The air bags had deployed as a result of the impact with the tree (Figure 7). Air bag warning labels were affixed to each sun visor. The driver airbag was housed in the center of the steering wheel with a vertically oriented tear seam (I-configuration). The flaps were symmetrical in shape. Based on inspection of an exemplar vehicle, each measured approximately 9.0 cm (4.0") in width and 9.0 cm (4.0") in height. Vent ports were visible on the rear aspect of the air bag. The air bag was tethered by internal straps. No contact evidence was visible on the air bag or module cover flaps.

Figure 7. Deployed frontal air bag system

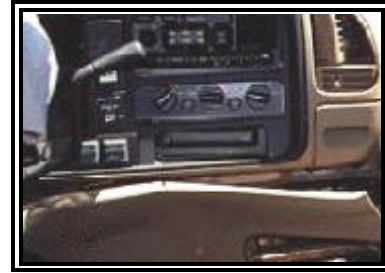
The front right passenger air bag deployed from the right mid instrument panel area with a horizontally oriented flap tear seam (H-configuration). The cover flaps were rectangular and symmetrical in shape. Based on inspection of an exemplar vehicle, each flap measured approximately 30.0 cm (12.0") in width and 6.0 cm (2.0") in height. There was no contact evidence visible on the surface of the cover flaps, but a large amount of pooled blood was observed on the left aspect of the air bag. A cutoff switch was visible on the mid instrument panel to the right of the steering column and was set to the "on" position (**Figure 8**).

Figure 8. Front right passenger's air bag cutoff switch

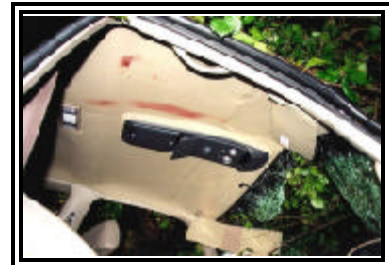
At impact with the tree, the passenger initiated a forward trajectory in response to the 12 o'clock impact force. He loaded through the deployed redesigned front right passenger's air bag, compressed the air bag against the instrument panel and deflected it through the open windshield. His head struck the windshield header and sun visor resulting in facial abrasions, inter-orbital lacerations, nasal bridge compression, and sub-arachnoid hemorrhage. He loaded the upper instrument panel and right A-pillar with his thoracic region, resulting in a left flail chest with rib fractures, crepitus in the left axilla, and internal abdominal hemorrhage. He struck the glove box with his lower extremities resulting in an open fracture of the left tibia. He rebounded rearward evidenced by the blood streak on the head liner (**Figure 9**),

Figure 9. Interior of Chevrolet pickup truck showing blood streak on the headliner

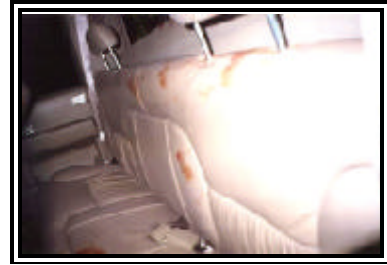
The 21-year-old male rear right passenger was in a semi-seated position in the extended cab of the Chevrolet pickup truck. He was restrained by the available 3-point manual lap and shoulder belt system. At impact with the tree, he initiated a forward trajectory in response to the 12 o'clock impact force. He loaded the manual restraint system (**Figure 10**) and struck the rear aspect of the front right seat with his head, and was redirected into the right B-pillar. He was reported to have exited the vehicle through the rear sliding window under his own power. He was found lying near the roadway, and was transported to a regional medical center and admitted with unspecified non-incapacitating injuries.

Figure 10. Rear seat with evidence of loading to the rear right 3-point seat belt
