## REMOTE AIR BAG DEPLOYMENT REPORT

CASE NUMBER - IN99-035

VEHICLE - 1998 SATURN SL2

CRASH DATE - April 1998

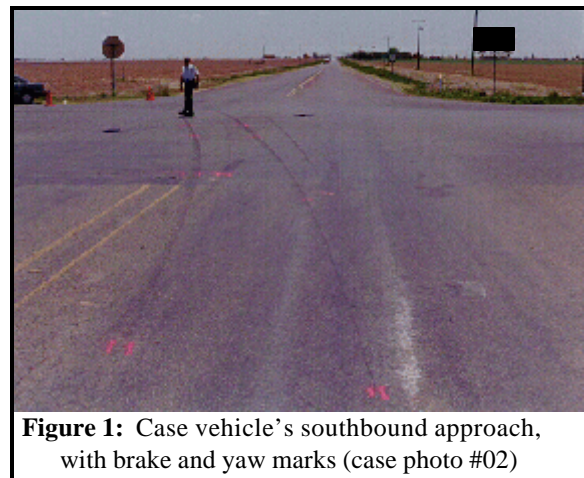
The case vehicle (vehicle #2) was traveling south in the southbound lane of a two-lane undivided local rural road, approaching a four-leg intersection and apparently intending to pass through the intersection and continue south. Vehicle #1 was traveling east in the eastbound lane of the intersecting two-lane undivided local rural road, intending to pass through the intersection and continue east. It was daylight, the weather was clear, the bituminous surface was dry and there were no roadway defects. The speed limit was 113 km.p.h. (70 m.p.h.) for the case vehicle and 97 km.p.h. (60 m.p.h.) for vehicle #1. The intersection was controlled by stop signs for north-south traffic with an overhead beacon flashing red for north-south and amber for east-west traffic. The control devices were functioning correctly. The case vehicle approached the intersection at high speed. The case vehicle's driver braked with full lockup, steered left and yawed counterclockwise (**Figure 1**). Vehicle #1's driver braked with full lockup and steered right.

**Figure 1:** Case vehicle's southbound approach, with brake and yaw marks (case photo #02)

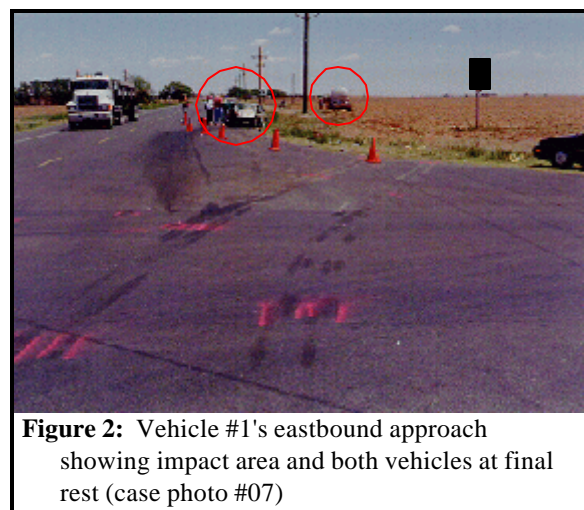
The crash occurred within the intersection (**Figure 2**). The case vehicle's front right corner impacted the left side of vehicle #1's power unit, causing the case vehicle's driver and front right passenger air bags to deploy. Initial contact with vehicle #1 included the trailing edge of the left front fender and the leading edge of the fuel tank beneath the driver's door. The case vehicle rotated counterclockwise and the right side of the case vehicle impacted the left side of vehicle #1 (side slap-type impact), contacting the steps attached to the fuel tank, the door sill and the lower edge of the door plus the

**Figure 2:** Vehicle #1's eastbound approach showing impact area and both vehicles at final rest (case photo #07)

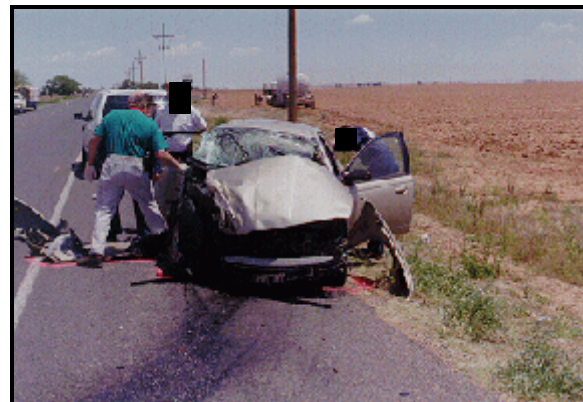
The case vehicle sustained direct contact damage at the front right corner, the entire right side and the back (**Figures 3, 4 and 5**). The front bumper cover was torn off with the right end of the front bumper crushed rearward and downward and the left end levered forward. The grille and headlight assemblies were shattered and broken away. The hood was buckled, bent down in the front, crushed inward on the right and the entire hood was displaced to the left. The left front fender was broken off and hanging loose. The right front wheel's suspension was broken, with the wheel and tire pushed rearward and the top edge tilted slightly inward. The windshield was fractured across the entire width and separated from its mounting at the left and right A-pillars. The right front fender and the outer panel of the right front door were torn away but the right front door remained closed. There was direct contact to the upper right A-, B- and C-pillars; the right front and rear door glazing and backlight were shattered (kernalized); and the right roof rail and roof were crushed down and inward. The

Figure 3: Front of case vehicle (case photo #13)

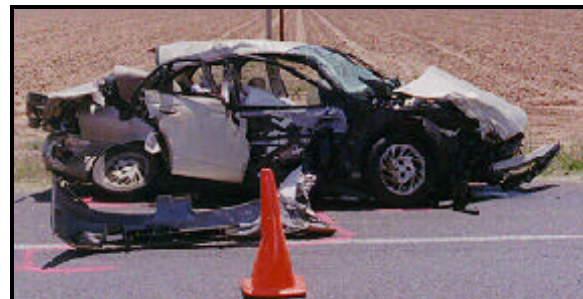
Figure 4: Right side of case vehicle (case photo #16)

right rear door was distorted and came open. The right rear axle was broken with the top edge of the wheel tilted inward at approximately a 45 degree angle. There was direct contact at the right rear corner area, with the quarter panel crushed inward, the rear bumper cover torn loose and the trunk lid distorted and shifted to the right. The back bumper cover had a heavy black tire scrub just to the right of center. There was substantial intrusion along the entire right side, but the available photographs do not show specific intruding components. The CDCs for the case vehicle's three impacts with vehicle #1 (estimated from photographs) are: first **02-FREE-3**; second **03-RDAW-3**; third **06-BCLN-1**. This crash is out of scope for the WinSMASH reconstruction program. The crash severity for the case vehicle was high (greater than 40 km.p.h. [25 m.p.h.]).

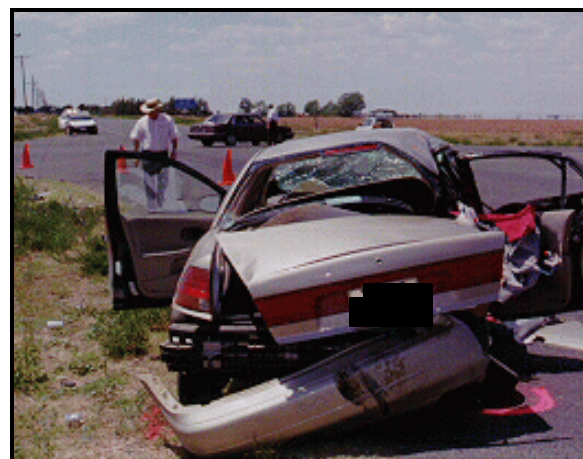
Figure 5: Back of case vehicle (case photo #15)

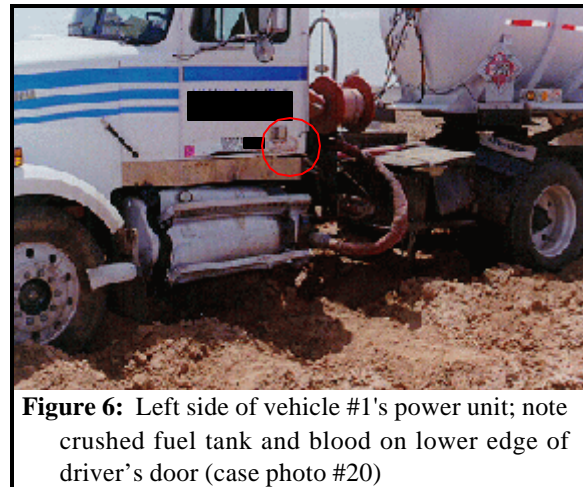
Vehicle #1 was a 1996 Western Star 4900-series cab-behind-engine 6-by-4 truck-tractor (VIN: 2WKPDCXH6TK-----) towing a tank semi-trailer. The tank semi-trailer had hazardous materials cargo placarding with commodity code number 1267 (petroleum crude oil). There was no damage to the trailer or its cargo. Damage to the truck-tractor consisted of: the trailing edge of the left front fender had minor damage; the left fuel tank (immediately beneath the driver’s door) was dented along its entire length, but the tank retained its integrity and there was no fuel leakage; the steps to climb up into the cab (fastened to the fuel tank) had minor crush damage and were slightly displaced; the bottom edge of the driver’s door and the door sill were dented, with blood and other tissue on the lower edge of the driver’s door, indicating direct contact with the case vehicle’s front right passenger; various components attached to the frame behind the cab were damaged; and the splash guard for the left forward tandem wheels was displaced. Vehicle #1’s TDCs for the three impacts are estimated as: first **08-LYEW-2**; second **09-LKEW-2**; third **12-FLWN-9**.

**Figure 6:** Left side of vehicle #1's power unit; note crushed fuel tank and blood on lower edge of driver's door (case photo #20)
