Remote, Redesigned Air Bag Special Study
Dynamic Science, Inc., Case Number (DS99035)
1999 Mitsubishi Eclipse/1998 Ford Escort
California
December/1998

1. Report No. DS99035		2. Government Accession No.		3. Recipient Catalog No.	
4. Title and Subtitle				5. Report Date July 7, 2000	
				6. Performing Organization Report No.

Summary

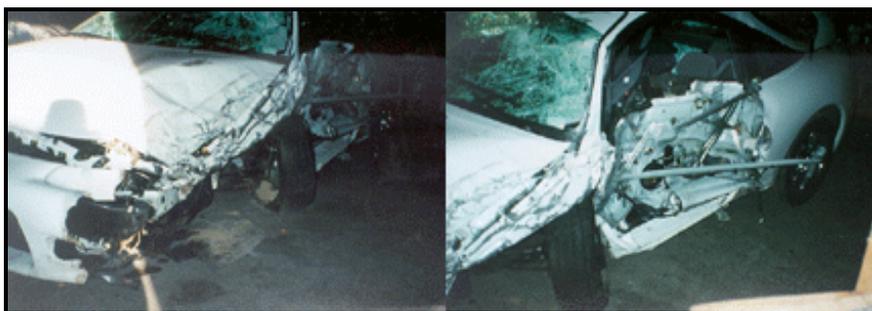
Figure 1. Left front corner, 1999 Mitsubishi Eclipse

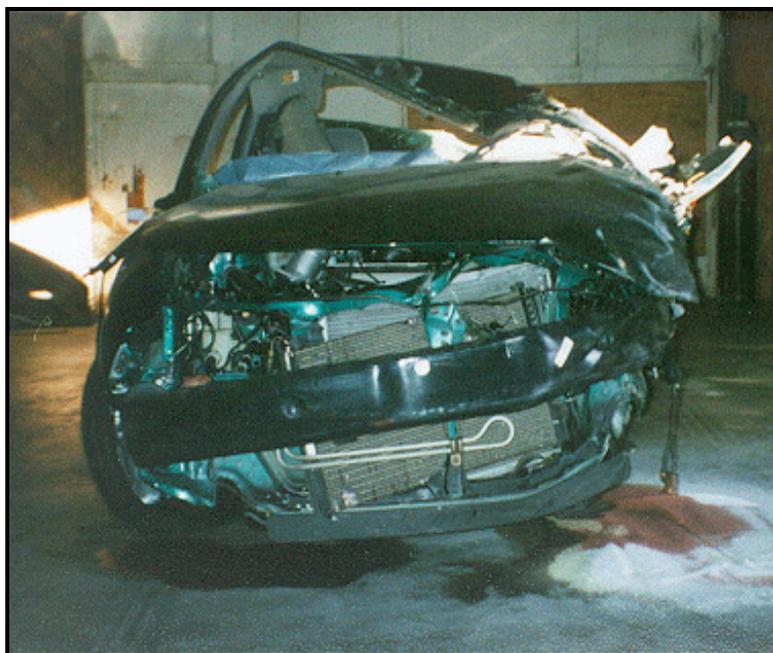
Figure 2. Exterior, 1998 Ford Escort

The interior of the case vehicle sustained moderate damage. The driver's seat was twisted to the left. The steering column had been detached from the instrument panel—indicating shear capsule separation. The left side driver's floorboard had been pushed into the driver's seat. The left side door panel was bowed outward. The front left side glass disintegrated from the impact forces.

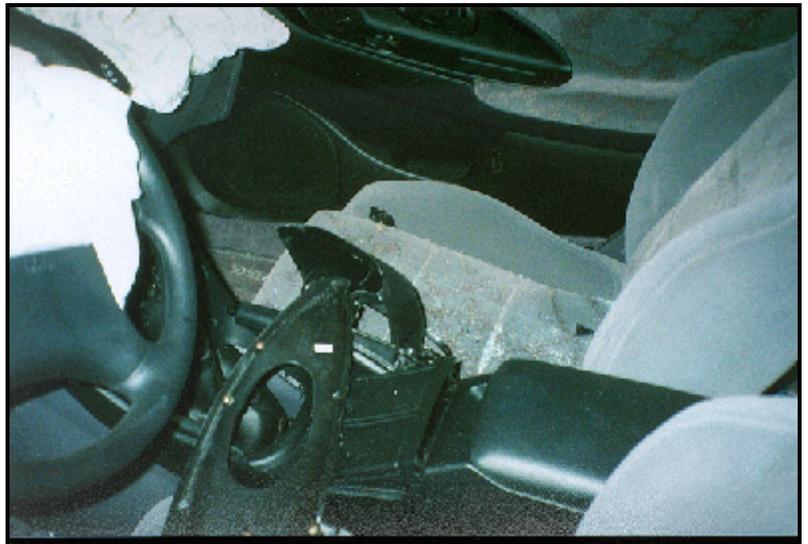
Figure 3. Front right seat position, Vehicle 1

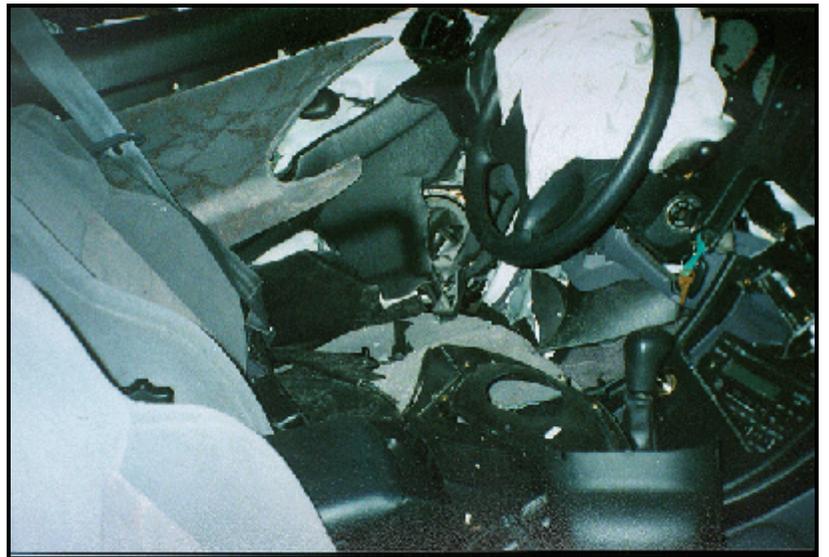
This vehicle is equipped with lap and shoulder belts in the front left and front right seating positions. Both shoulder belts are height adjustable. The investigating officer found that the plastic on the latch plate assembly of the driver's seatbelt was melted from friction with the webbed portion of the belt. The webbed portion of the belt showed areas of minor stretching. There were no signs of stretching on the front passenger seat belt or the right rear passenger seat belt.

Figure 4. Front left seat position, Mitsubishi Eclipse

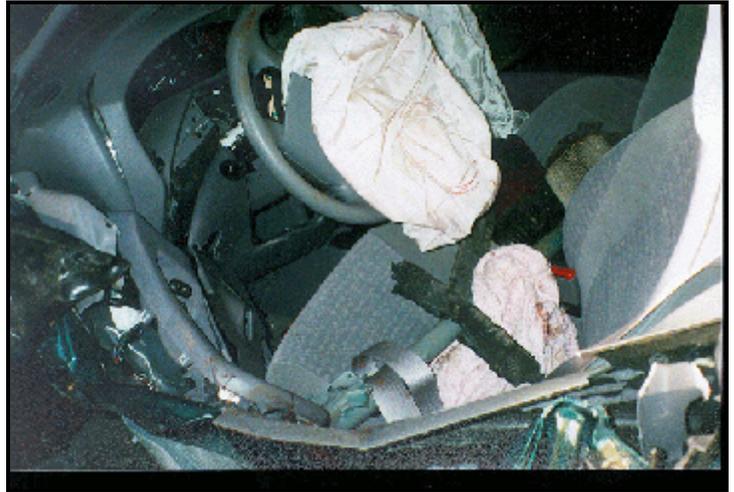
Figure 5. Front left seating position

The driver of the Ford Escort was seated in the front left seat position. She was wearing the available manual lap and shoulder belt incorrectly. The shoulder portion of the belt was situated under the left arm pit rather than over the shoulder. The front right occupant was wearing the available lap and shoulder belt. Seat belt usage was determined by the post-crash position of the seat belt for the driver and the “replace belt” tags for both seat belts.

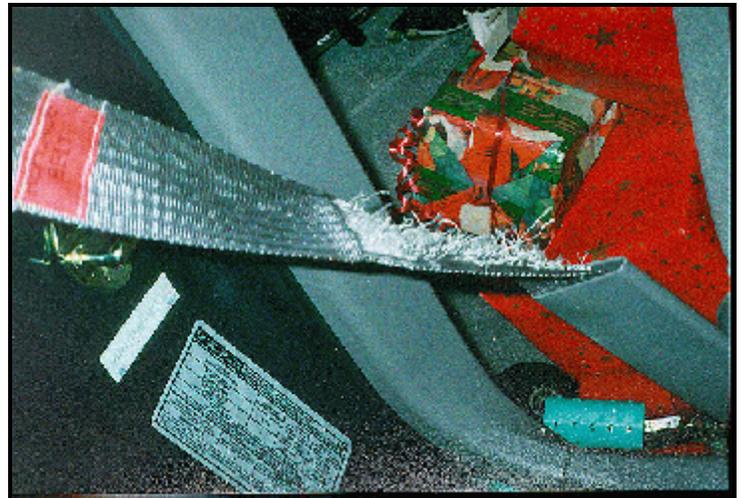
This vehicle is equipped with lap and shoulder belts in the front left and front right seating positions. The investigating officer indicated that both belts showed signs of stretching and displayed the seat belt use indicators (red replace seat belt tags).

Figure 6. Front right seat belt—replace seat belt tag exposed (Ford Escort)

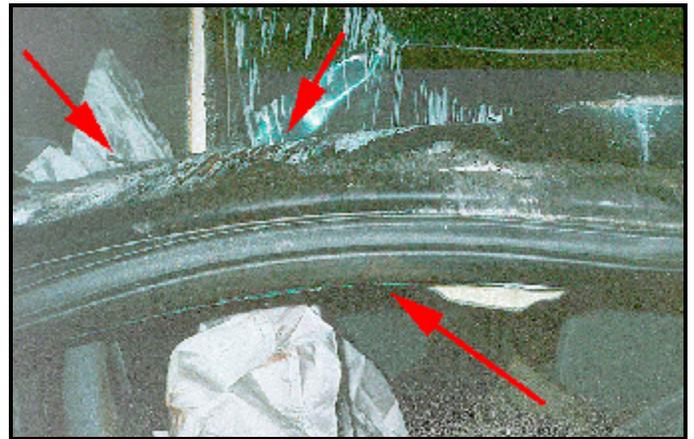
At impact, the driver reacted to the 350 degree principle direction of force by moving forward and loading the lap and shoulder belt. She engaged the deployed air bag and loading it to a sufficient extent as to cause a shear capsule separation. As the vehicle began a sharp counterclockwise rotation, the driver was pitched to the left, striking the door side panel. Portions of her body—including her head—extended outside of the vehicle. As the rotation continued, the vehicle tripped and rolled over. As the left A-pillar / left roof rail came into contact with the roadway the driver’s head came between the roadway and the various vehicle components—causing the skull and facial fractures. The driver was declared dead at the scene by a fire department official.

Figure 7. Hair/blood/tissue transfers to A-pillar area (Ford Escort)
