**TRANSPORTATION SCIENCES  
CRASH DATA RESEARCH CENTER**

**ON-SITE AIR BAG RELATED ADULT DRIVER FATALITY INVESTIGATION  
SCI TECHNICAL SUMMARY REPORT**

**VERIDIAN CASE NO. CA99-048**

**VEHICLE - 1997 MERCURY SABLE**

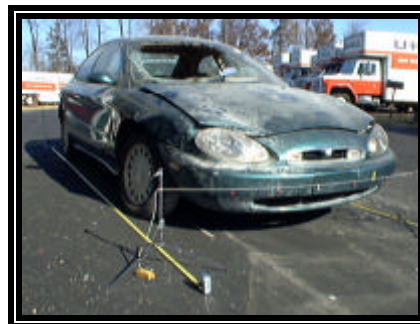
**Figure 1. Damaged 1997 Mercury Sable**

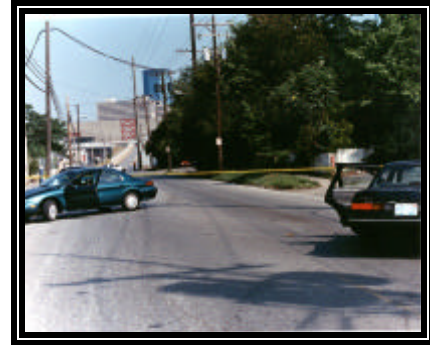
This two-vehicle crash occurred during the daylight hours in July 1999. At the time of the crash, the weather was cloudy and the asphalt roadway surface was dry. The crash occurred at a three-leg T-intersection of two local roadways (**Figure 2**). The east/west roadway comprised the top aspect of the “T” and was configured with one travel lane in each direction, separated by a dashed yellow centerline. The intersecting north/south roadway was configured with one travel lane in each direction but did not have a painted centerline. Both roadways were straight with level grades. Each roadway was bordered by concrete curbs. The roadside environment consisted of small grassy areas, sidewalks, trees, and commercial properties. Traffic control for the intersection consisted of a stop sign for northbound traffic entering the intersection. The posted speed limit for the east/west roadway was 56 km/h (35 mph). The scene schematic is included as **Figure 13** of this report.

**Figure 2. Eastbound view of the crash site showing final rest of both vehicles**

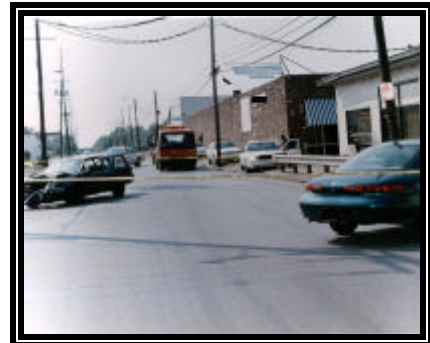
The 44-year-old female driver of the Mercury Sable was operating the vehicle westbound on approach to the T-intersection (**Figure 3**). The 1988 Ford Tempo was traveling eastbound on approach to the intersection. The driver of the Sable apparently did not detect the approaching Tempo. The Sable reportedly slowed as she entered the intersection and initiated a left turn maneuver across the path of the Tempo. For unknown reasons, the driver of the Sable slowed and/or stopped the vehicle in the intersection while making the left turn. The driver of the Tempo detected the Sable turning across its path and applied the brakes in full lockup and steered right in an attempt to avoid the collision. Skid marks were present in the pre-crash trajectory of the Tempo. The skid marks were documented by police and measured 11.3 m (37.0') in length.

**Figure 3. Pre-crash trajectory for the Mercury Sable**

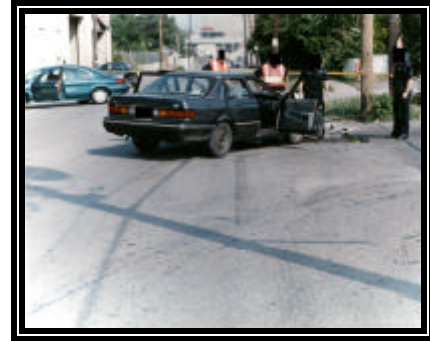
The front aspect of the Tempo impacted the front right corner of the Sable. Impact resulted in moderate damage to both vehicles. The principal direction of force was in the 12 o'clock sector for the Sable and in the 11 o'clock sector for the Tempo. The damage algorithm of the WinSMASH program computed a delta-V of 16.4 km/h (10.2 mph) for the Sable and 18.7 km/h (11.6 mph) for the Tempo. The impact was sufficient to deploy the frontal air bag system in the Sable. The longitudinal and lateral components for the Sable were -14.2 km/h (-8.9 mph) and -8.2 km/h (-5.1 mph), respectively. The longitudinal and lateral components for the Tempo were -16.2 km/h (-10.0 mph) and 9.3 km/h (5.8 mph), respectively. The Tempo came to rest in the intersection facing southeast (**Figure 4**). The Sable traveled in a northeast direction across its original travel lane and struck the north curb after rotating approximately 250 degrees in a counterclockwise (CCW) direction. The Sable came to rest with the right front tire against the face of the curb on the north side of the roadway.

**Figure 4. Trajectory of the 1988 Ford Tempo showing pre-crash skid marks, deflection point, and final rest**

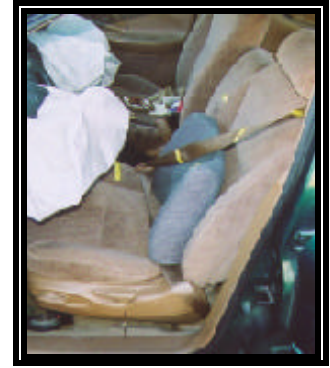
The 44-year-old female driver was utilizing a contoured lumbar pillow/wing back support which was positioned between her back the forward aspect of the driver's seat back (**Figure 5**). The pillow measured 34.9 cm (13.8") in width and 33.0 cm (13.0") in height. The forward aspect was contoured and measured 10.8 cm (4.2") in depth on the outboard aspects and 5.7 cm (2.3") in depth at the center aspect.

**Figure 5. Close-up view of lumbar support pillow**

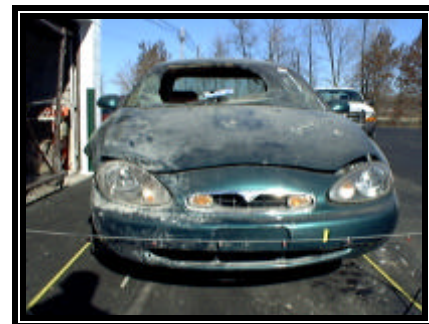
The 1997 Mercury Sable sustained moderate damage to the front right aspect as a result of the impact with the Ford Tempo (**Figure 6**). The one-piece bumper/grille fascia was slightly displaced and direct contact abrasions were noted on the front bumper fascia. The direct damage was located 32.4 cm (12.8") to the left of center along the front bumper fascia and extended 104.1 cm (41.0") laterally to the right bumper corner. The combined direct and induced damage involved the entire frontal width of the Sable and measured 140.3 cm (55.3"). The hood was displaced slightly

**Figure 6. Frontal damage to the 1997 Mercury Sable**

upward and rearward. The left front fender was crushed rearward and laterally inward from direct contact. The left front fender was buckled outward slightly 76.2 cm (30.0") rear of the front right bumper corner from induced damage. The right front wheel cover was abraded from contact with the concrete curb. The Collision Deformation Classification (CDC) for the impact with the Ford Tempo was 01-FDEW-1. Six crush measurements were taken along the front bumper and were as follows: C1 = 0.0 cm, C2 = 0.0 cm, C3 = 0.5 cm (0.2"), C4 = 0.5 cm (0.2"), C5 = 3.1 cm (1.2"), C6 = 4.3 cm (1.7").

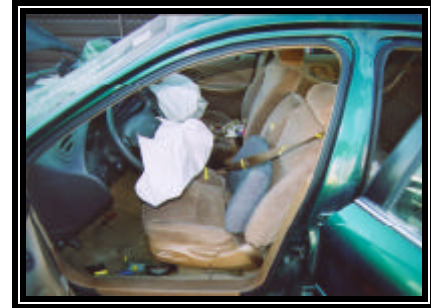
Interior damage to the 1997 Mercury Sable was moderate and attributed to occupant contact (**Figure 7**). The steering wheel rim was deformed forward 1.3 cm (0.5") on the top half from occupant loading. The cruise control switch which was mounted on the left aspect of the steering wheel hub was separated. Two heavy tissue transfers were located on the knee bolster to the right and left of the steering column as a result of the loading of the driver's knees (**Figure 8**). The left transfer was located 38.1 cm (15.0") left of the centerline and measured 7.0 cm (2.8") in width and 1.3 cm (0.5") in height. The right transfer was located 25.4 cm (10.0") left of the centerline and measured 5.1 cm (2.0") in width and 4.8 cm (1.9") in height. The steering column was compressed, evidenced by shear capsule displacement. The left shear capsule was displaced forward 2.5 cm (1.0") and the right shear capsule was displaced forward 2.0 cm (0.8"). Body fluid (blood) was present on the lower right quadrant of the driver's air bag, and driver's shoulder belt, inboard aspect of the driver's seat back and was collected on the center console. Multiple short black hair fibers were present on the head liner above the driver's seat over an area that measured 20.3 cm (8.0") in width and 17.8 cm (7.0") in length. A longitudinal abrasion was present along the head liner inboard of the hair deposit. It was unknown if the abrasion was crash related.

**Figure 7. Interior view of the Mercury Sable**

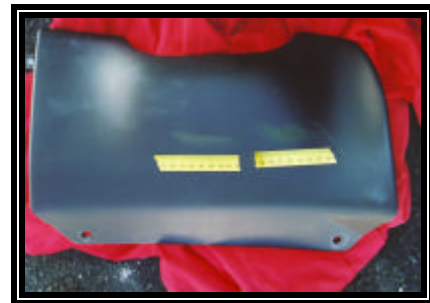
**Figure 8. View of knee bolster and tissue transfers**

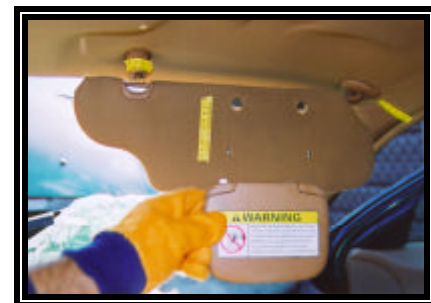
The right aspect of the windshield was fractured as a result of the front right passenger's air bag and tethered cover flap. Based on interior damage patterns in the vehicle, it appeared that the front right passenger's sun visor was rotated downward with the vanity mirror exposed to the interior of the vehicle pre-crash. The front right passenger's air bag deployment most likely displaced it upward and rearward which resulted in the fracture of the inboard clip and the separation of the vanity mirror (**Figure 9**). The right A-pillar plastic trim panel was fractured at the top aspect 1.9 cm

**Figure 9. View of damaged front right sun visor**

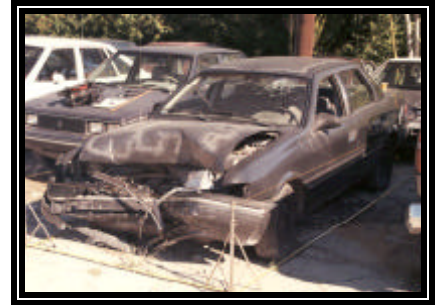
The 1988 Ford Tempo sustained moderate frontal damage as a result of the impact with the Mercury Sable (**Figure 10**). The direct damage was distributed across the entire frontal width of the vehicle. The front bumper and grille area were crushed rearward. The hood was displaced slightly upward and the leading edge was buckled rearward. The combined direct and induced damage measured 152.4 cm (60.0") from bumper corner to bumper corner. The outboard aspects of the bumper fascia were separated from the side aspects of the vehicle. The left and right front fenders sustained induced buckling from the frontal impact. The CDC for this impact was 11-FDEW-2. Six crush measurements were taken along the front bumper and were as follows: C1 = 7.6 cm (3.0"), C2 = 25.4 cm (10.0"), C3 = 40.6 cm (16.0"), C4 = 25.4 cm (10.0"), C5 = 7.6 cm (3.0"), C6 = 0.0 cm.

**Figure 10. Damaged 1988 Ford Tempo**

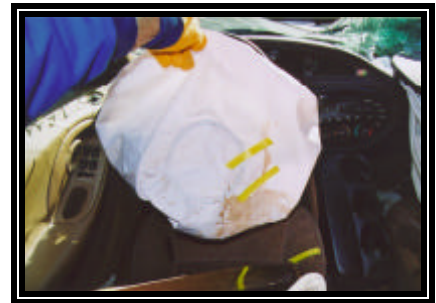
The 1997 Mercury Sable was equipped with frontal air bags for the driver and front right passenger positions. The air bag system deployed as a result of the frontal impact with the Ford Tempo. The driver's air bag (**Figure 11**) was housed in the center of the steering wheel with asymmetrical H-configuration cover flaps which were constructed of 0.5 cm (0.2") thick vinyl. The top flap measured 7.6 cm (3.0") in height and 14.0 cm (5.5") in width at the tear seam. The bottom flap measured 6.4 cm (2.5") in height and 14.0 cm (5.5") in width at the tear seam. The driver's air bag measured 67.3 cm (26.5") in diameter. The air bag was tethered by four internal straps and there were no vent ports. Two red lipstick transfers were located on the 3 o'clock aspect of the air bag which measured 5.4 cm (2.3") in

**Figure 11. View of driver's air bag in the Mercury Sable**

length, 0.6 cm (0.3") in thickness, and were spaced 3.8 cm (1.5") apart. The transfers began on the inboard aspect of the circular tether stitching and extended to the right in an upward diagonal fashion. A collection of body fluid (blood) which measured 15.2 cm (6.0") in width and 20.3 cm (8.0") in height was also present on lower right quadrant of the air bag.

At impact with the Ford Tempo, the frontal air bag system deployed in the Mercury Sable. The expanding air bag struck the driver in the face and neck areas which resulted in "punch-out" type injuries to the head, neck and chest. The air bag contact resulted massive edema with obliterated basal cisterns, an intracerebral contusion, a left temporal subdural hemorrhage, bilateral pulmonary contusions, an arterial bleed of cranio-facial origin (likely internal carotid), an intracranial pneumocephalus, a left temporal subarachnoid hemorrhage, bilateral pneumothorax, a pneumomediastinum, a tracheal/bronchial injury, an open mandibular symphysiseal fracture, an open fracture of the left superior lateral nose (maxilla), and soft tissue injuries to the face, neck and chest. The force from the air bag deployment was transferred through the skull which caused a temporal/petrous bone fracture. She subsequently initiated a forward trajectory in response to the frontal impact force and loaded the knee bolster. The combination of air bag expansion against the driver and her forward trajectory resulted in compression of the steering column. Her knees struck the knee bolster, evidenced by two pronounced tissue transfers on either side of the steering column and she loaded the manual restraint. She rebounded rearward into the lumbar support pillow. Due to the space between her upper torso and the driver's seat back which resulted from the use of the lumbar pillow, her head probably continued to hyper-extend rearward which allowed the occipital region of her scalp to contact the driver's head restraint. She sustained an occipital contusion as a result of the probable head restraint contact. The driver's right arm was displaced as a result of the air bag deployment. She sustained a fling-type ecchymosis of the right upper extremity which may have resulted from the displacement of her right arm from the driver's air bag and contact with the head liner or instrument panel.

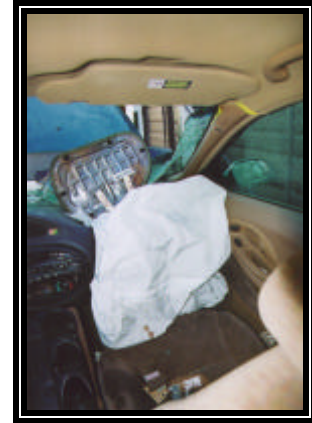
**Figure 12. View of front right passenger's air bag and cover flap**

The front right passenger's air bag deployed from a top-mount module configured with a tethered cover flap (**Figure 12**). The cover flap measured 25.4 cm (10.0") in height on the left aspect, 17.8 cm (7.0") on the right aspect, and 43.2 cm (17.0") in width. The composition of the cover flap was 1.3 cm (0.5") metal backed vinyl. The cover flap was tethered by two straps that measured 24.1 cm (9.5") in length. The left and right tethers were attached to the underside of the cover flap 10.2 cm (4.0") and 7.6 cm (3.0") rear of the forward edge, respectively, and spaced 12.7 cm (5.0") apart. The edge of the cover flap sustained abrasions from contact with the windshield.

The front right passenger's air bag measured 61.0 cm (24.0") and 48.3 cm (19.0") in height. The air bag was not vented by external ports. Minor body fluid (blood) spatter was present on the lower left aspect of the air bag.
