REMOTE AIR BAG DEPLOYMENT REPORT

CASE NUMBER - IN99-049

VEHICLE - 1998 HONDA CIVIC LX

CRASH DATE - January 1998

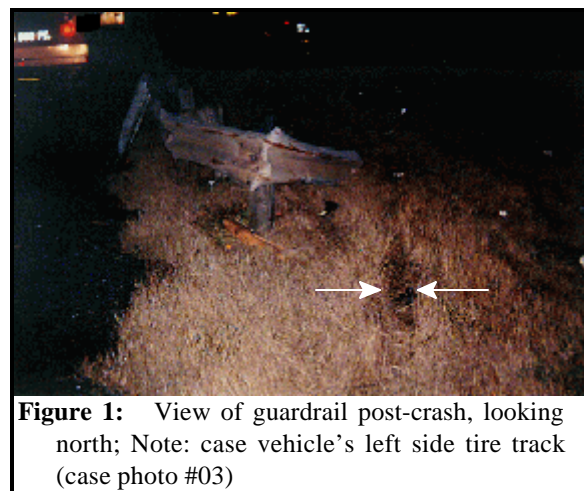
According to the Police Crash Report, the case vehicle drifted right (northeast) off the east pavement edge, crossed the east improved shoulder, and impacted the end treatment of a W-beam steel guardrail (**Figure 1**). There were no pre-impact skidmarks or steering maneuvers noted by the investigating officer. Approximately 3.0 to 4.6 meters [10 to 15 feet] of guardrail were damaged through contact by the case vehicle. The case vehicle then descended an embankment in a clockwise yaw that reached full broadside, traveling almost 49 meters [160 feet] from the guardrail to two trees. The two trees were impacted (unknown sequence) by the left side of the case vehicle, where it came to rest facing east-southeast (approximately perpendicular to the roadway). The crash severity for the case vehicle's guardrail impact was estimated as moderate (24-40 km.p.h. [15 to 25 m.p.h.]). Because of photographic perspectives, the crash severity for the two tree impacts cannot be estimated.

The case vehicle first impacted the end treatment of a steel W-beam guardrail supported by I-beam posts embedded in the ground, with large wooden spacers between the guardrail and the posts. Approximately 3.0 to 4.6 meters [10 to 15 feet] of guardrail were displaced through contact by the case vehicle (**Figure 1**). The Police Crash Report indicated two trees halted the case vehicle’s clockwise yaw and descent down the embankment. The diameters of those trees are not known. Possible damage to the trees is also not known.

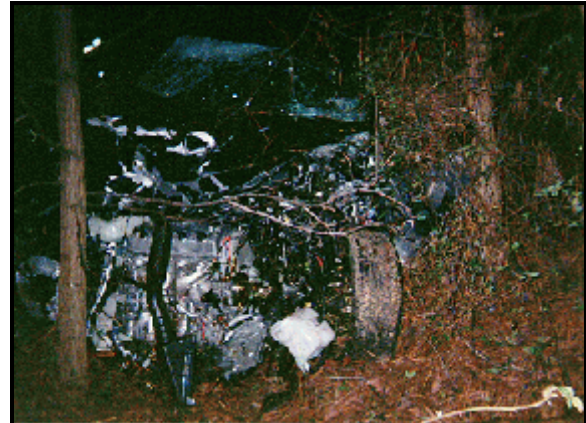
The case vehicle sustained direct damage across its entire front plane from contact with the guardrail. The front bumper fascia, front bumper reinforcement bar, front grille, left and right headlamp assemblies, front sheet metal brackets, and radiator were separated from the case vehicle (**Figure 2**). The left half of the hood was displaced rearward and to the right. The left front fender was scraped rearward and to the left, exposing the left front wheel and tire (**Figure 3**). Top engine components were damaged by the bottom of the guardrail. The guardrail contacted the windshield and left upper A-pillar. The front left corner of the roof was pulled downward.

A CDC for the case vehicle from contact with the guardrail was estimated from police photographs as: **11-FDAW-6 (320)**. The guardrail impact was outside the scope of WinSMASH (yielding object). The available photographs did not include any views of the left side of the case vehicle, such that CDCs for the tree impacts could not be estimated.

Figure 2: Case vehicle's front damage; Note: missing bumper fascia and left front fender displaced to the left (case photo #07)

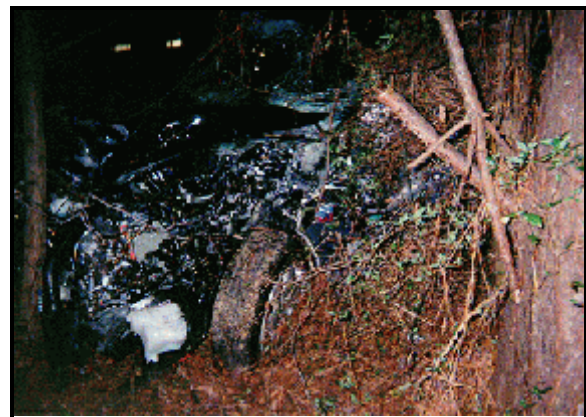
Figure 3: Oblique view of case vehicle's front left damage; Note: exposed left front tire and wheel and position of left front fender (case photo #08)

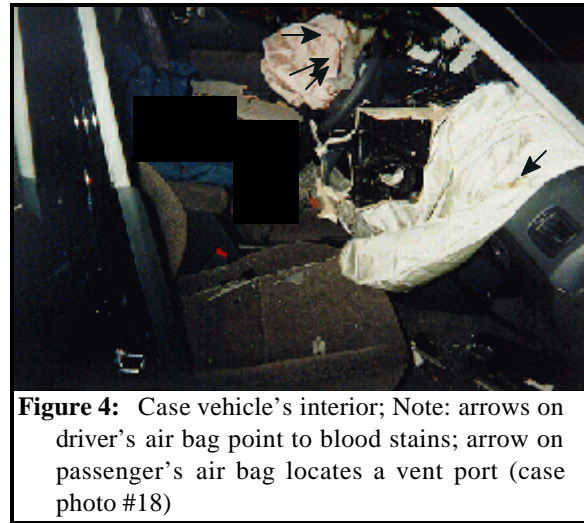
Police photographs show the case vehicle driver's air bag was located in the steering wheel hub and the front right passenger's air bag module was located in the top of the instrument panel on the right. Photographs verify that both air bags deployed (**Figure 4**). Photographs also seem to indicate that the driver's module cover flaps were in the H-configuration with unknown symmetry. No clear photograph of the passenger module's cover flap is available. There are three visible blood stains on the driver's air bag fabric (**Figure 4**) but, because of the fabric's post-crash disarray, their exact location on a fully-inflated bag is unknown.

Figure 4: Case vehicle's interior; Note: arrows on driver's air bag point to blood stains; arrow on passenger's air bag locates a vent port (case photo #18)

The case vehicle's driver air bag shape is not known. No view of the driver's air bag was sufficient to estimate if it was equipped with tethers or vent ports. As with the driver's air bag, the front right passenger's air bag shape, owing to its fabric's post-crash disarray, is also unknown. No view of the passenger's air bag is sufficient to determine if it was equipped with tethers, but one vent port was visible.

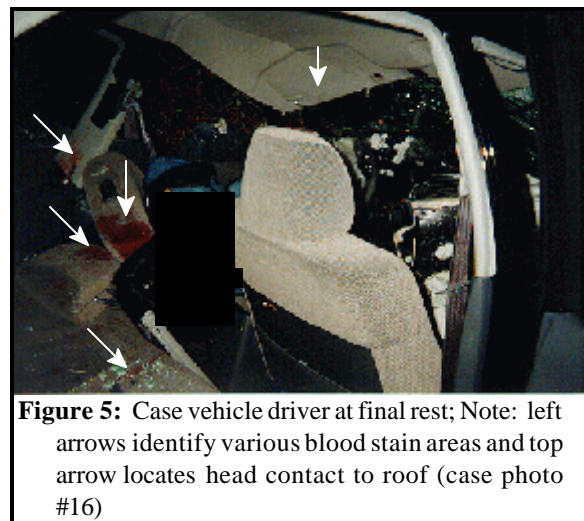
Figure 5: Case vehicle driver at final rest; Note: left arrows identify various blood stain areas and top arrow locates head contact to roof (case photo #16)

impacted the two trees. The air bag deflated and the windshield, left upper A-pillar, the front left corner of the roof, the left half of the instrument panel, and the steering wheel intruded into the driver’s seat area. Three blood stains were noted on the driver’s air bag fabric. As well, skin transfers to the right portion of the steering wheel rim were detected. Her head contacted the left sunvisor with sufficient force to dislodge it from its anchor. There were body oil transfers immediately to the right of the left sunvisor anchor on the roof. She sustained a vertical laceration to her forehead, above her left eye. As the case vehicle separated from the guardrail, began to descend down the embankment and initiated its clockwise rotation, she moved further to her left. When the case vehicle struck the two trees, she probably contacted the left side interior surface. She rebounded back into the right half of her bucket seat. The seat back was twisted to the right and rearward, and the adjustable head restraint was dislodge from its mounting, probably a result of left side intrusion and the force of her rebound. At final rest, she was slumped to her right, with her head between the two bucket seats (**Figure 5**). Blood stains can be seen on the upper B-pillar vinyl cover, the top right of the driver’s seat back, the separated driver’s head rest, and the center front portion of the rear bench seat.
