ON-SITE SIDE IMPACT INFLATABLE OCCUPANT PROTECTION INVESTIGATION

CASE NUMBER - IN99-071
LOCATION - ILLINOIS
VEHICLE - 1999 TOYOTA AVALON XLS
CRASH DATE - April, 1999

February 25, 2003

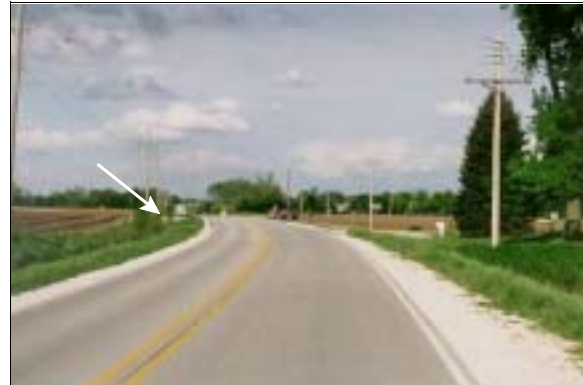
The case vehicle was traveling east-southeast in the eastbound lane of a two-lane, undivided, county roadway and was negotiating a left-hand curve (**Figure 1**) when the driver over steered to the left, putting the vehicle into a counterclockwise yaw (**Figure 2**). The case vehicle's driver lost control. According to the investigating police agency, the case vehicle was traveling at a high rate of speed [i.e., 125.5 km.p.h. (78.0 m.p.h.) per police reconstruction]. The case vehicle subsequently crossed the westbound lane while in the yaw (**Figure 3**) and departed the north side of the roadway, facing essentially northward while the vehicle's center of gravity moved primarily in a northeasterly direction just prior to impact (**Figure 4**). Based on the scene evidence, the case vehicle's driver did not attempt any avoidance maneuvers prior to the crash. The case vehicle deposited 72.2 meters (237 feet) of yaw marks prior to impact. The crash occurred off the roadway on the north roadside; see **CRASH DIAGRAM** below.

Figure 1: Case vehicle's east-southeasterly travel path in left-hand curve; Note: arrow marks location of impact (case photo #01)

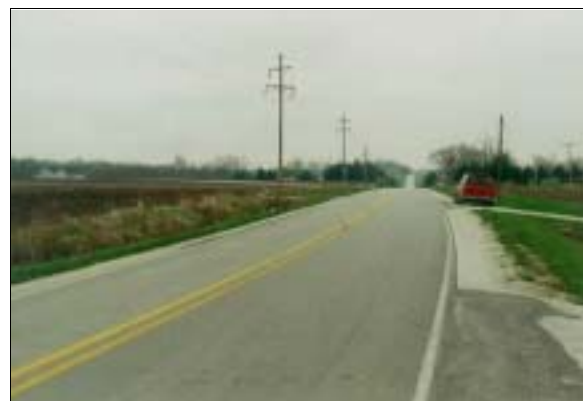
Figure 2: Coroner's photo of case vehicle's yaw marks starting in easterly lane leading into impact with culvert/embankment (case photo #44)

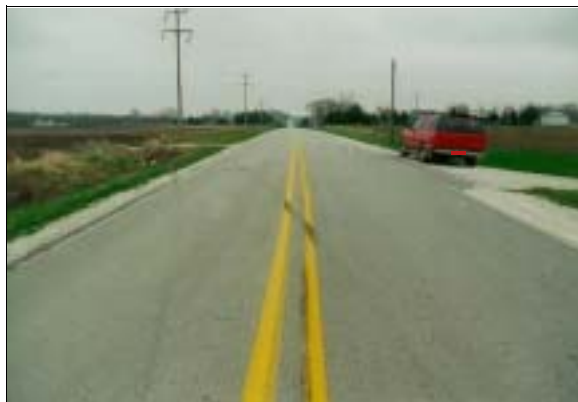
Figure 3: Coroner's photo of case vehicle's travel path in yaw across centerline leading into impact with culvert/embankment (case photo #45)

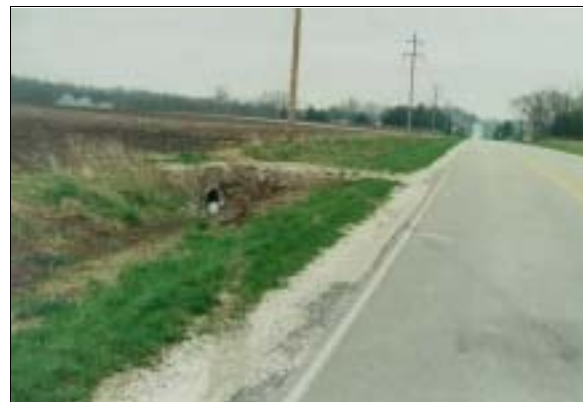
Figure 4: Coroner's photo of case vehicle's travel path onto north roadside leading into impact with culvert/embankment (case photo #46)

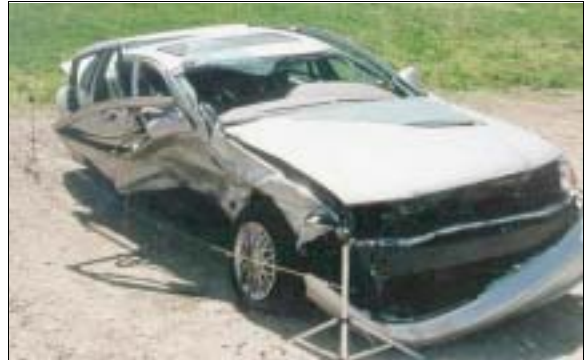
Figure 5: Case vehicle's right side damage from impact with culvert/embankment; Note: stringline adjusted for protruding door (case photo #22)

The right side (**Figure 5**) of the case vehicle impacted a metal culvert and the gravel driveway embankment (**Figures 6 and 7**) it ran under, causing the case vehicle's right front, side impact air bag to deploy. At impact the case vehicle was facing north-northeastward (25 degrees) with its front end angled downward. After the impact the case vehicle continued to rotate counterclockwise an additional 50 degrees and traveled over the 7.9 meter (26 foot) wide gravel drive. The back of the case vehicle impacted the drainage ditch on the east side of the gravel drive and, as a result, it came to rest in the drainage ditch, heading primarily west (**Figure 8** below) with its back right bumper corner embedded in the soft dirt (**Figure 9** below) and its front end atop the east side of the gravel drive and the culvert (**Figure 10** below).

The case vehicle's initial contact with the culvert/embankment involved the entire right side (Figure 5 above, Figure 10 and Figure 11 below). Direct damage extended from the front right

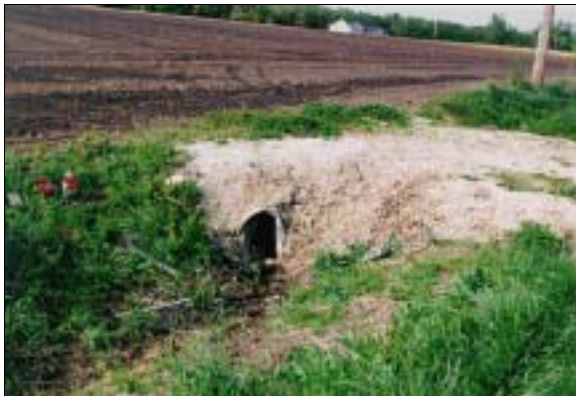
Figure 6: Culvert's embankment on north roadside that was impacted by case vehicle; Note: case vehicle came to rest on other (east) side of gravel drive (case photo #05)

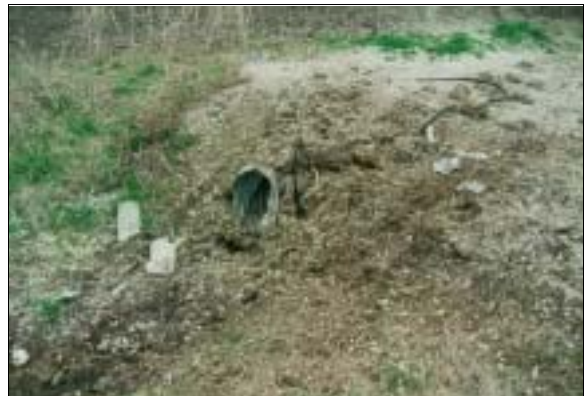
Figure 7: Coroner's photo, looking northeastward, showing culvert/embankment impacted by case vehicle; Note: disruption of embankment that occurred during crash (case photo #48)

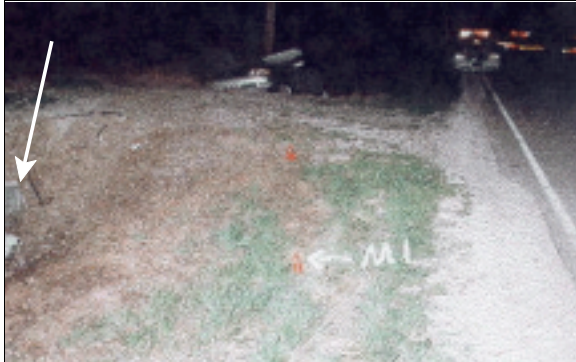
Figure 8: On-scene eastward view of case vehicle's final rest in drainage ditch on eastern side of gravel access road; arrow marks culvert's location (case photo #53)

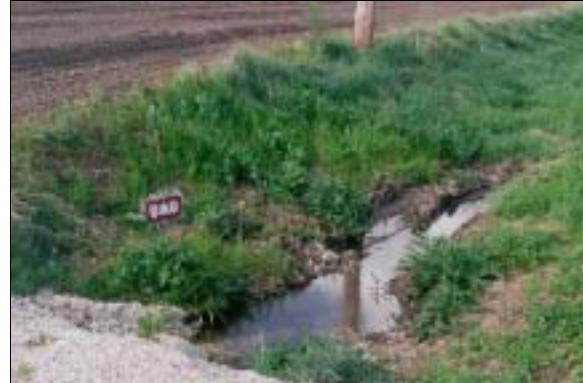
Figure 9: Northeastward view of case vehicle's final rest position in drainage ditch (case photo #07)

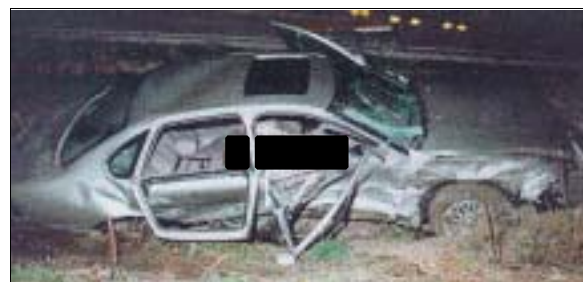
Figure 10: On-scene southward view of case vehicle at final rest, heading west, on north roadside; Note: extensive damage to right side of vehicle (case photo #54)

embedded in the embankment of the soft earthen ditch. At final rest the front right passenger’s head was leaning back over his seat back, and his torso was leaning to the right (i.e., sanitized portion of **Figure 10** above shows occupant at final rest).

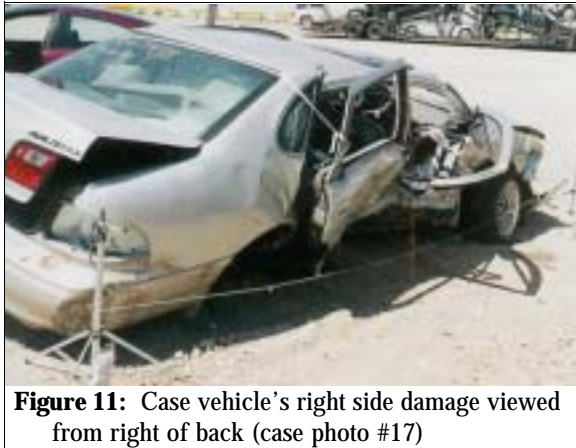
bumper corner to the back right bumper corner, a measured distance of 458 centimeters (180.3 inches). Residual maximum crush was measured as 43 centimeters (16.9 inches) and was located approximately 5 centimeters (2.0 inches) above the bottom of the sill and 45 centimeters (17.7 inches) forward of C₃. The case vehicle's second impact involved the back right bumper corner. The direct damage started at the back right bumper corner and extended, a measured distance of 72 centimeters (28.3 inches), along the bumper to the left. Maximum crush was measured as 10 centimeters (3.9 inches) at the back right bumper corner. The distance of the direct contact damage forward along the right quarter panel was masked from the case vehicle's initial impact.

Figure 11: Case vehicle's right side damage viewed from right of back (case photo #17)

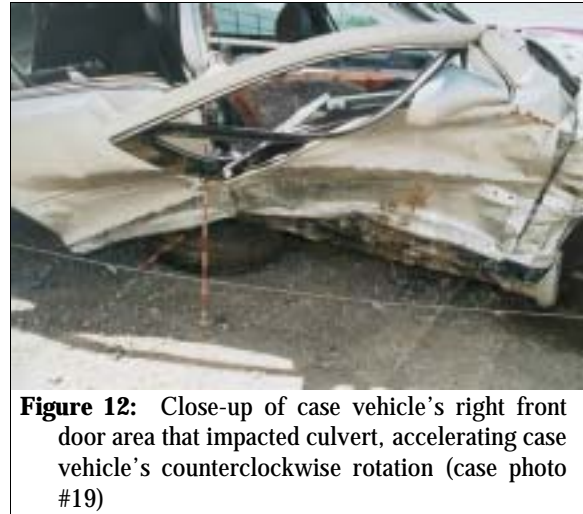
Figure 12: Close-up of case vehicle's right front door area that impacted culvert, accelerating case vehicle's counterclockwise rotation (case photo #19)

The case vehicle's wheelbase on the case vehicle's right side was shortened 8 centimeters (3.1 inches). Both "A"-pillars and both "B"-pillars were cut, and the roof was peeled back to allow for extrication. The windshield was folded over the front hood. The case vehicle's right front and rear doors, right fender, and right quarter panel were directly damaged and crushed inward. The right quarter panel sustained only minor damage. This damage pattern indicates that the brunt of the impact with the metal culvert and embankment occurred primarily into the passenger seating area on right side (**Figure 12**). There was also direct damage to the back right bumper fascia. The case vehicle's right front tire was deflated but not physically restricted from the impact. The right rear tire was completely torn off as the vehicle's undercarriage bottomed out against the embankment supporting the gravel driveway. Induced damage occurred to both the right and left headlight and turn signal assemblies as well as both taillight/stop light assemblies. The front bumper fascia was torn away. Remote buckling was found on the roof and left quarter panel as a result of extrication.

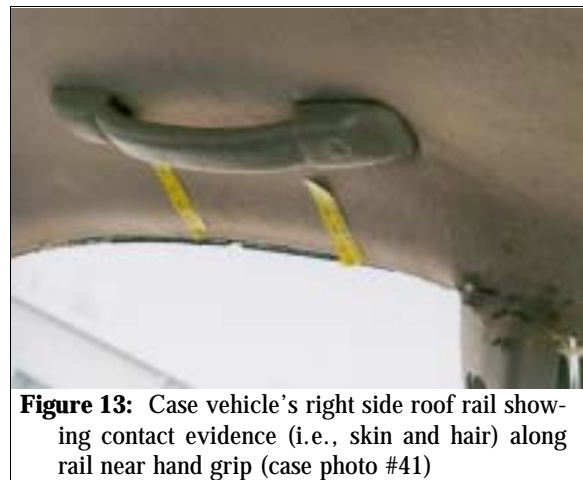
Figure 13: Case vehicle's right side roof rail showing contact evidence (i.e., skin and hair) along rail near hand grip (case photo #41)

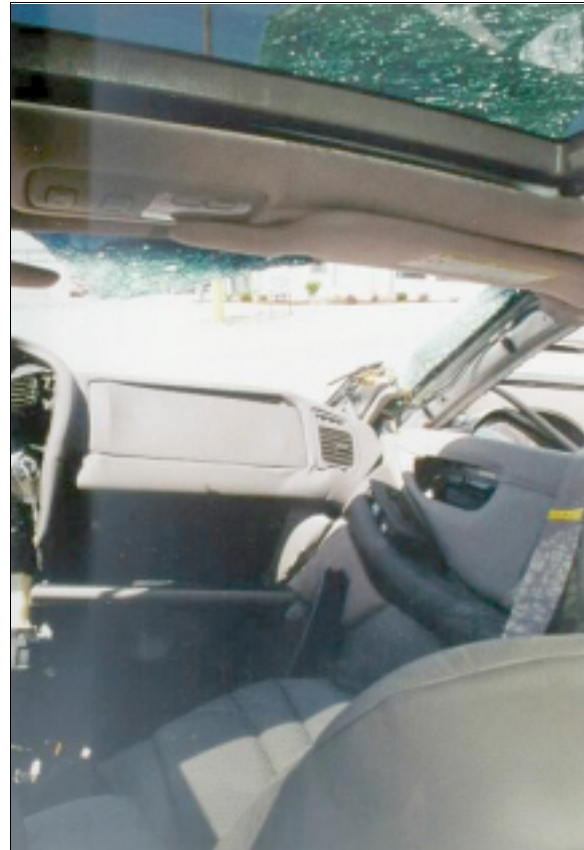
Figure 14: Vertical view of case vehicle's front right seating area showing no obvious contact evidence to right instrument panel or greenhouse area and significant intrusion to seating area from interior surface of right front door (case photo #34)

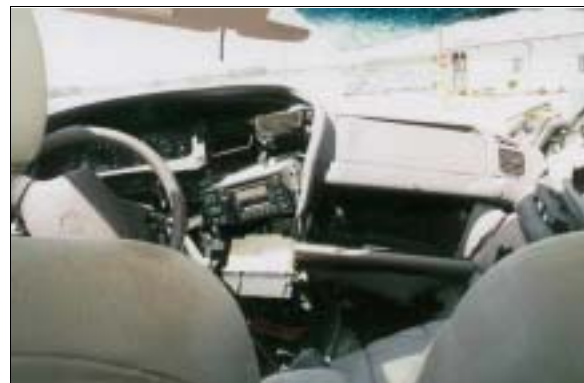
Figure 15: Case vehicle's front seating area showing non-deployed driver and front right passenger air bags and distortion and damage to instrument panel from right side intrusions (case photo #33)

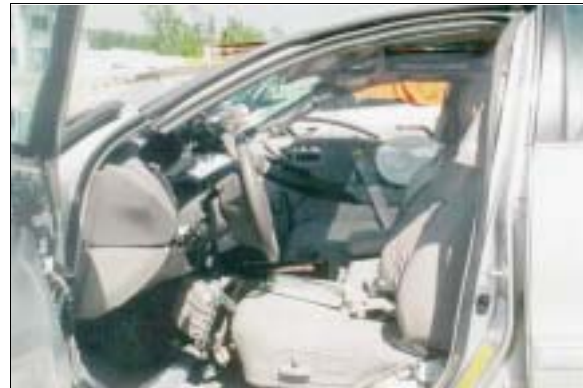
The case vehicle was equipped with a Supplemental Restraint System (SRS) that contained frontal air bags at the driver and front right passenger positions. In addition, the vehicle was equipped with front, seat back-mounted, side impact air bags. The case vehicle's driver and front right passenger air bags did not deploy as a result of the right side impact (**Figure 15** above). The right front passenger's seat back-mounted, side air bag deployed as a result of the case vehicle's right side impact with the culvert/embankment (**Figure 16**).

Figure 16: Case vehicle's front seating area showing deployed right front side impact air bag and contact evidence on front right safety belt's webbing (case photo #25)

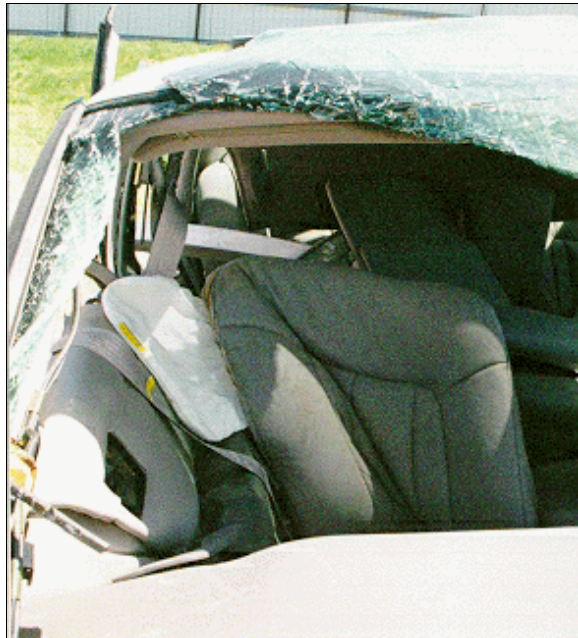
Figure 17: Case vehicle's deployed right front side impact air bag viewed through windshield; Note: intrusion to front right seat and seating area from right front door's interior surface (case photo #35)

The case vehicle's right front, seat-mounted, side impact air bag was located in the outboard side of the front right passenger's seat back (**Figure 17**). When deployed the uppermost vertical edge of the side air bag measured 18 centimeters (7.1 inches) below the top of the front right seat back. The single chambered right side air bag was designed without any tethers or vent ports. The deployed side impact air bag was rectangular with a height of 28.5 centimeters (11.2 inches) and a width of approximately 32.5 centimeters (12.8 inches). There was contact evidence, though not readily apparent, on the interior surface of the side air bag (**Figures 17 and 18**). This

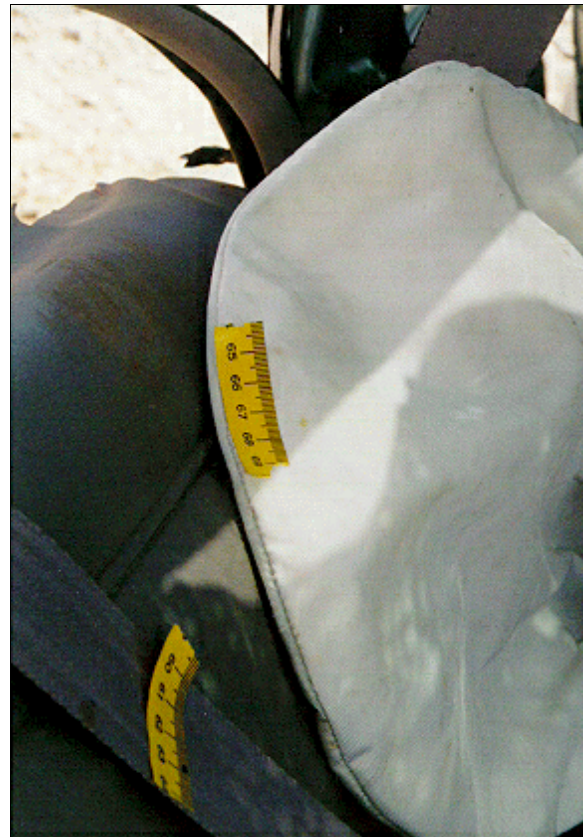
Figure 18: Close-up of interior surface of case vehicle's right front side impact air bag showing unknown fluid dot to right of tape on bag's fabric (case photo #37)

contractor identified a yellowish dot (unknown substance), minimal evidence of mud splattered, and what appeared to be a spot of some type of body fluid on the upper portion (**Figure 18** above and **Figure 19**). Furthermore, there was a half-moon-shaped gray leather transfer and mud on the bag's exterior surface. There was no apparent evidence of damage to the air bag shell.

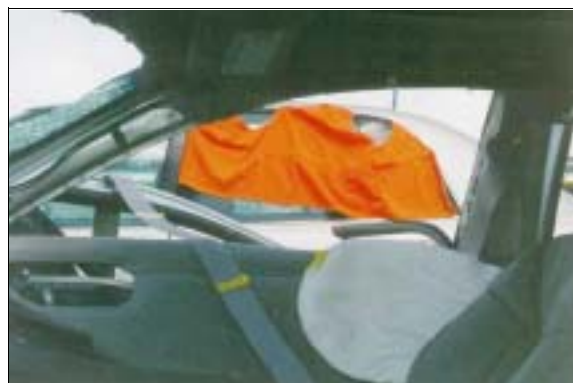
Figure 19: Case vehicle's deployed right front side impact air bag and front right safety belt's webbing showing stretching and blue transfers (case photo #36)

The case vehicle's front right passenger was restrained by his available, active, three-point, lap-and-shoulder, safety belt system. Furthermore, based on his autopsy, there was evidence of belt pattern bruising to the base of the front right passenger's neck and on his lower abdomen. The inspection of the front right passenger's seat belt webbing, "D"-ring, and latch plate also showed evidence of loading. Specifically, the safety belt had been cut by rescue personnel, 21 centimeters (8.3 inches) down from the right "D"-ring, the belt was significantly stretched from use, and there was a 30 centimeter (11.8 inch) area of blue transfers on the webbing from passenger's blue denim jeans (**Figure 19**).
