TRANSPORTATION RESEARCH CENTER

ON-SITE AIR BAG NON- DEPLOYMENT INVESTIGATION

CASE NUMBER - IN99-074
LOCATION - MISSISSIPPI
VEHICLE - 1995 CHEVROLET ASTRO MINIVAN
CRASH DATE - January, 1999

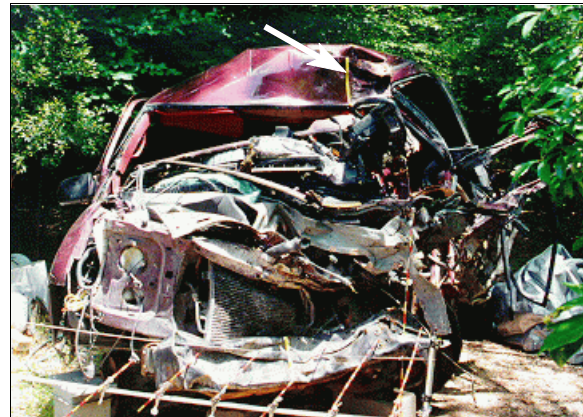
The front left half of the case vehicle (**Figure 1**) impacted the front left (unknown lateral area) of the Mack truck; however, the case vehicle's driver (only) supplemental restraint (air bag) did not deploy. After maximum engagement, based on the police investigation, the case vehicle rotated approximately 225 degrees counterclockwise and came to rest in the northbound lane heading southeastward. The Mack truck continued southward after impact and subsequently drove completely across the northbound lane and off the east side of the roadway. The Mack truck came to rest heading south-southeastward on the east roadside.

Figure 1: Case vehicle's frontal deformation from impact with Mack truck; Note: direct contact (yellow tape & arrow) to roof near left "A"-pillar (case photo #02)

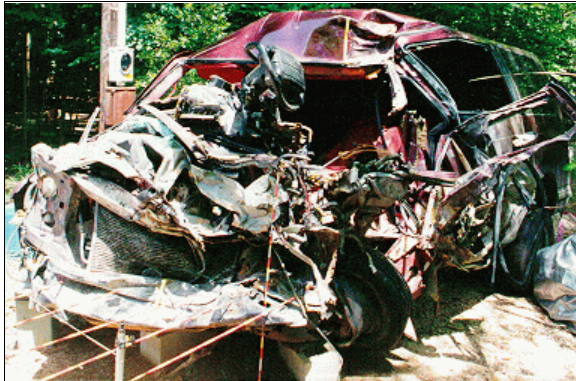
Figure 2: Extensive deformation to case vehicle's front and left side from impact with Mack truck, viewed from left of front (case photo #06)

The case vehicle's initial contact with the Mack truck involved its front left half (**Figures 2 and 3**). Direct damage began at the front left bumper corner and extended to the right, a measured distance of 71 centimeters (28.0 inches). The case vehicle's front right frame rail was shifted to the left approximately 15 centimeters (5.9 inches). Direct contact damage extended down the case vehicle's left side 185 centimeters (72.8 inches). Furthermore, there was direct contact and deformation to the left "A"-pillar, roof, and windshield. In addition, the direct contact extended laterally 30 centimeters (11.8 inches) inward from the left "A"-pillar. The average residual maximum crush was 83.5 centimeters (32.9 inches) at C_1 . The wheelbase on the case vehicle's left side was shortened 73 centimeters (28.7 inches) because of the direct contact to the case vehicle's left front wheel assembly. The wheelbase on the right side was extended 7 centimeters (2.8 inches). The case vehicle's front bumper, bumper fascia, grille, hood, radiator, left "A"-pillar, roof (**Figure 1** above), right and left headlight and turn signal assemblies, left fender, left front door, and left front wheel assembly were directly damaged and crushed rearward. In fact, the case vehicle's left front wheel assembly was pushed rearward into and under the driver's toe pan (**Figures 2 and 4**). As a result, the case vehicle's left front tire was damaged, deflated, and physically restricted. The case vehicle's right front tire was missing at the time of this contractor's inspection. There was induced damage as well to the left side and quarter panels, right fender, and right front door. The windshield and both the left front and left middle side window glazings were broken out as a result of the crash.

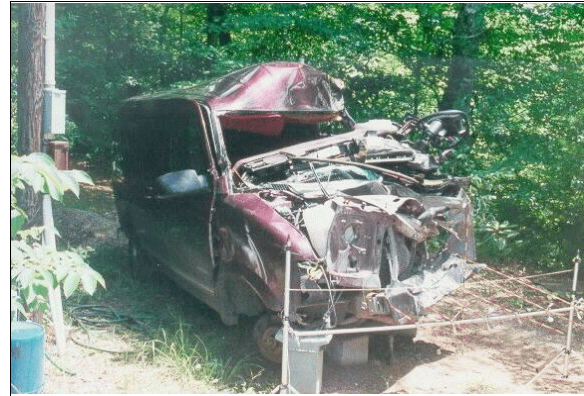
Figure 3: Case vehicle's front left damage viewed from right of front (case photo #13)

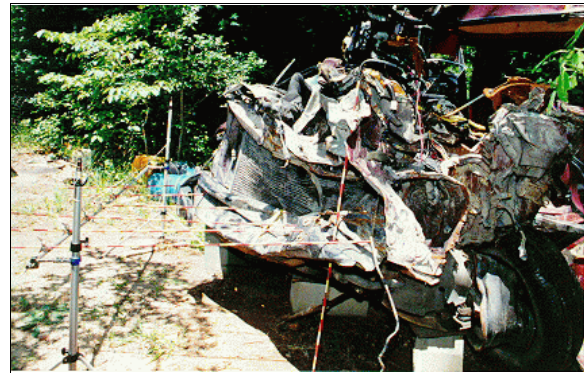
Figure 4: Reference line view from left of deformation to case vehicle's front left (case photo #05)

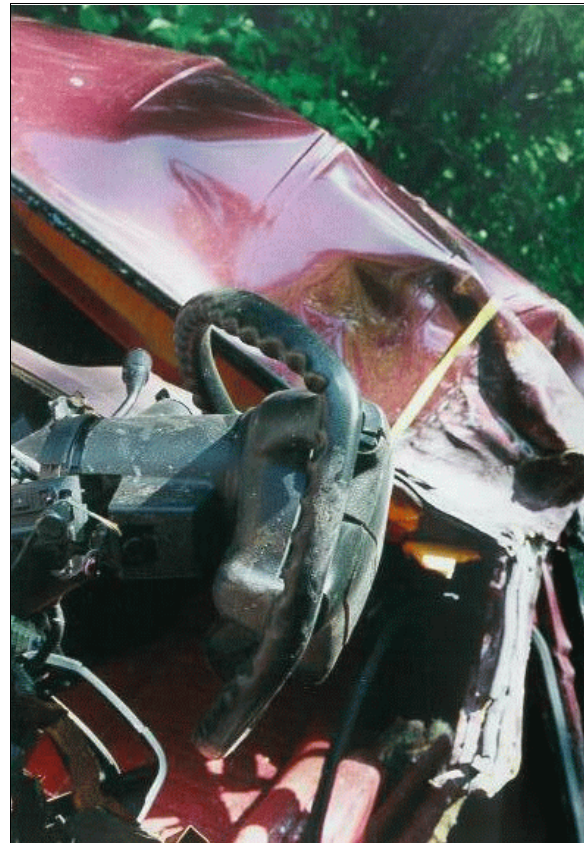
interior revealed contact evidence on the driver's knee bolster, both left and right of the steering column. Also, the steering wheel rim was deformed both above and below the hub with a 16 centimeters (6.3 inches) of deformation to the top half of the rim (Figure 5). Finally, there was a deposit of skin and hair on the driver's front windshield header (Figures 6 and 7), and the driver's sun visor was completely torn off.

Figure 5: Close-up looking along case vehicle's left side showing steering column which was rotated perpendicular to the vehicle's left side and distortion to steering wheel's rim (case photo #19)

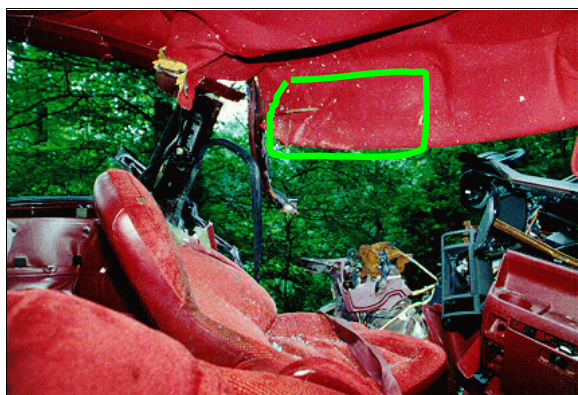
Figure 6: Case vehicle's driver seating area; Note: intrusion and deformation to seating area and direct contact to roof/front header (highlighted) from driver's head/face (case photo #21)

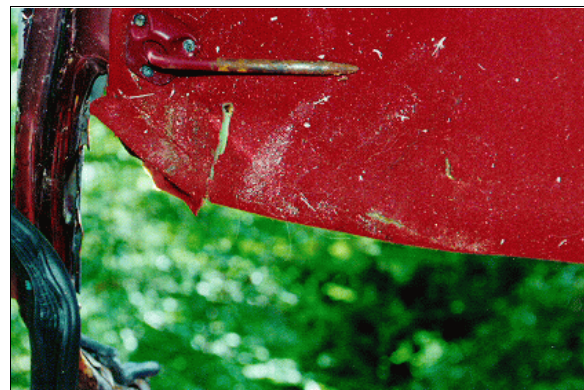
Figure 7: Close-up of skin and hair on case vehicle's roof/front header from contact by driver's head and face; Note: driver's sun visor has been completely torn away from its pivot bar (case photo #22)

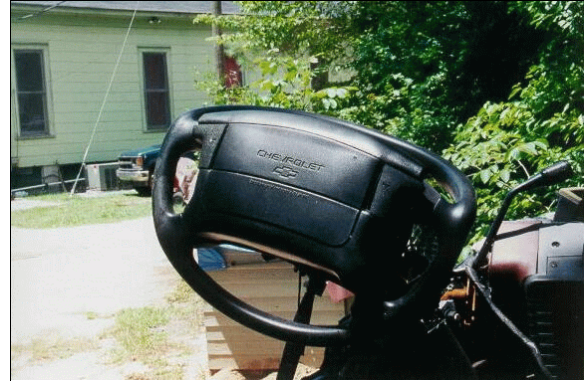
Based on the vehicle inspection the CDC for the case vehicle was determined to be: **12-FYAW-7 (350)**. The WinSMASH reconstruction program, barrier algorithm, was used on the case vehicle's highest severity impact because the Mack truck is out-of-scope. The Total, Longitudinal, and Lateral Delta Vs are, respectively: 61.4 km.p.h. (38.2 m.p.h.), -60.5 km.p.h. (-37.6 m.p.h.), and +10.7 km.p.h. (+6.6 m.p.h.). In this contractor's opinion the actual Delta V is closer to 40-48 km.p.h.(25-30 m.p.h.). Regardless of the actual Delta V, the air bag's deployment threshold was surely achieved, and the case vehicle's driver air bag should have deployed. The case vehicle was towed due to damage.

manufacturer installed air bag. The case vehicle's driver air bag was located in the steering wheel hub. An inspection of the air bag module confirmed that the air bag did not deploy (**Figure 8**). Because of the intrusion of the steering column and the collapse of the steering wheel rim due to loading, the module's cover flaps were directly contacted but showed no evidence of scratching or cloth transfers.

Figure 8: Case vehicle's non-deployed driver air bag (case photo #18)

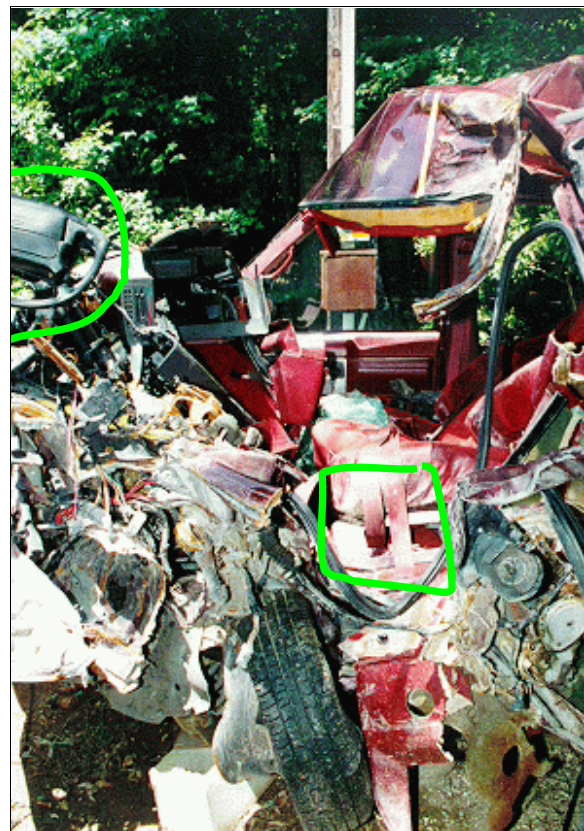
The case vehicle's driver was restrained by his available, active, three-point, lap-and-shoulder, safety belt system. The inspection of the driver's seat belt webbing, "D"-ring, and latch plate showed extensive evidence of loading. In addition, and it is visibly apparent that the belt was cut off the driver by rescue personnel at the scene (**Figure 9**).

Figure 9: Case vehicle's driver seating area viewed through what once was the driver's door; Note: cut seat belts and twisted steering wheel with non-deployed driver's air bag (case photo #15)
